Geotechnical Policy – Kosciuszko Alpine Resorts Form 4 – Minimal Impact Certification

PROPOSED ALTERATIONS + ADDITIONS TO SCHUSS LODGE, THREEDOO

REPORT
TO
SCHUSS SKI CLUB LIMITED
ON
GEOTECHNICAL ASSESSMENT
FOR
PROPOSED ALTERATIONS AND ADDITIONS
AT
SCHUSS LODGE, ALPINE WAY, THREDBO, NSW

7 May 2015
Ref: 28265RHRpt

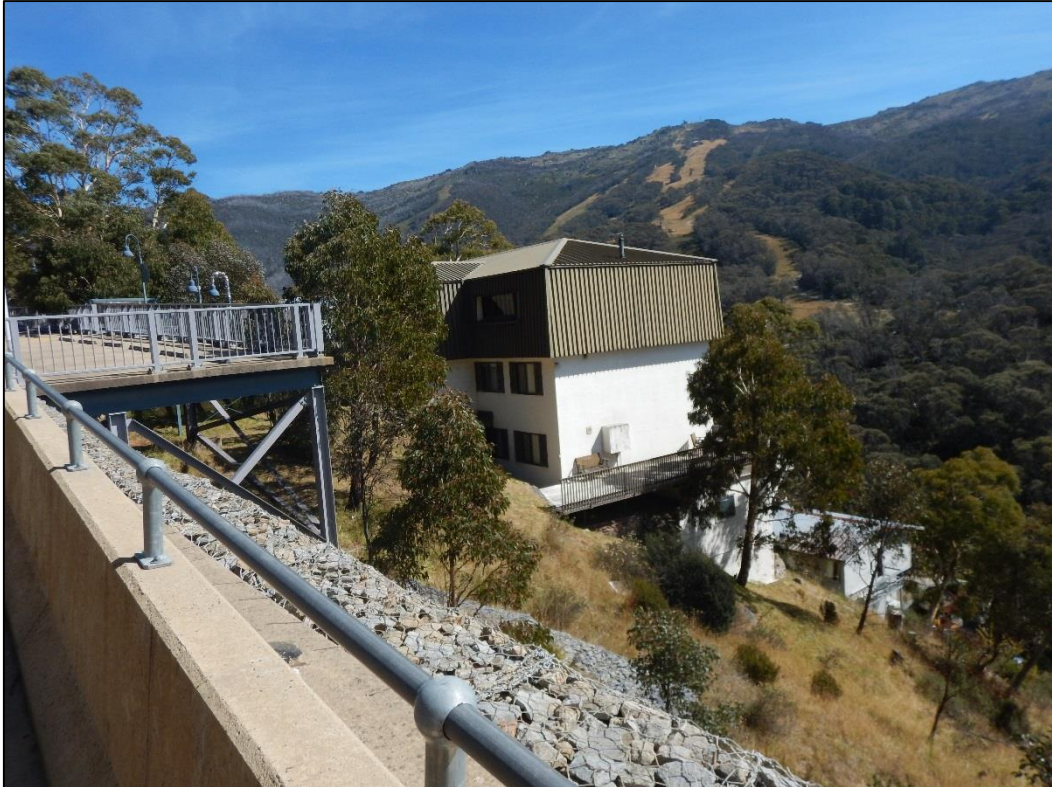
- The Lodge is located towards the toe of a moderately to steeply sloping north facing hillside, which grades between about 27° and 35°, as shown in the photograph below.

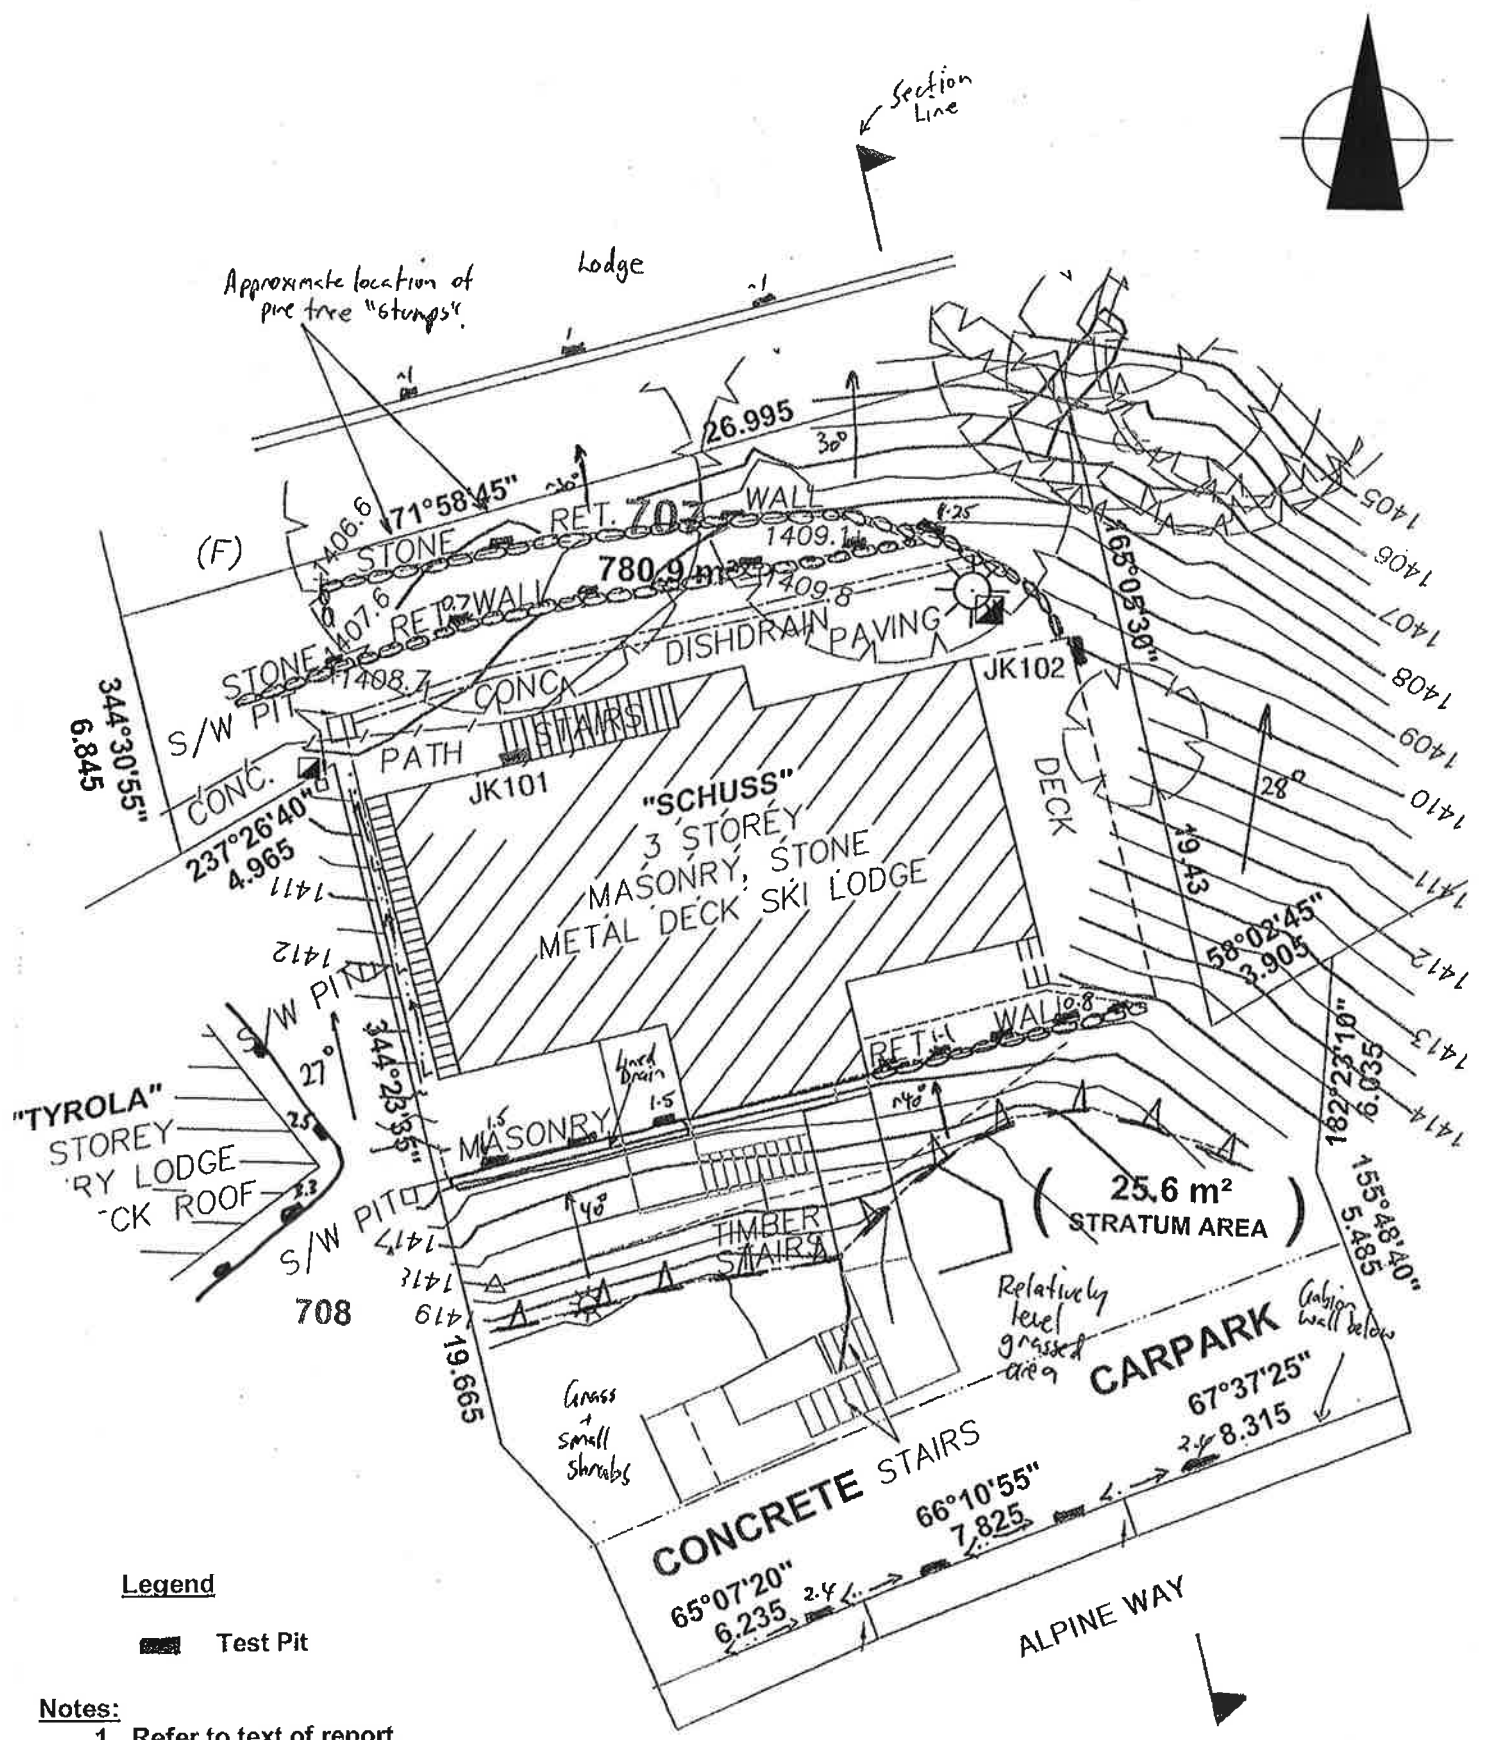
Report No. 28265RH Figure No. 1

- Figure 1 shows the position of the Lodge relative to the Alpine Way, which ran along the southern boundary. The Alpine Way had been constructed roughly along the hillside contours and is surfaced with asphaltic concrete (AC) which was observed to be in fair condition. Both the uphill and downhill sides of the Alpine Way directly opposite the Lodge were supported by gabion retaining walls, that appeared to be in relatively good condition. The uphill wall was about 4m high, whilst the downhill wall was about 2.4m high. At the time of our walkover inspection, groundwater seepage emanated just above the concrete footpath level along the Alpine Way through the gabion retaining walls directly opposite the Lodge, as well as through the PVC drainage pipe outlets at the base of the gabion walls.

- The area on the northern side of the Lodge was terraced. The terraced areas, which were either paved or covered with either grass or mulch, were supported by two low height mortared stone retaining walls, which were up to about 1.3m high. The retaining walls appeared to be in fair condition, based on a cursory inspection. However, the retaining wall at its eastern end contained a vertical and horizontal crack that was up to about 20mm wide.

- The pavers behind the aforementioned northern retaining wall, particularly over its eastern half, was uneven and had subsided in some areas by up to about 150mm. There were several small voids visible behind the wall near to where the subsidence had occurred. We infer that the subsidence and presence of voids are probably due to localised erosion of the backfill.

- The ground surface on the northern side the Lodge below the aforementioned retaining walls graded at about 30° down to the north to the neighbouring 'Gunyang' lodge and was mostly grass covered. Several pine tree stumps were located on the slope. There was also several medium to tall gum trees located at the eastern end of this area i.e. north-eastern corner of site, and some showed evidence of some downhill tilt or basal curvature, which could indicate some localised hillside creep.

- Several concrete lined dish drains were located around the perimeter of the Lodge. From our observations, it appeared that drainage from the 'drip lines' of the Lodge roof, discharged into the lined dish drains. The drains appeared to discharge into stormwater pits, though the outlet locations are unknown. The inlets of some stormwater pits were partially blocked with leaf litter. There was also erosion below the base of the western dish drain.

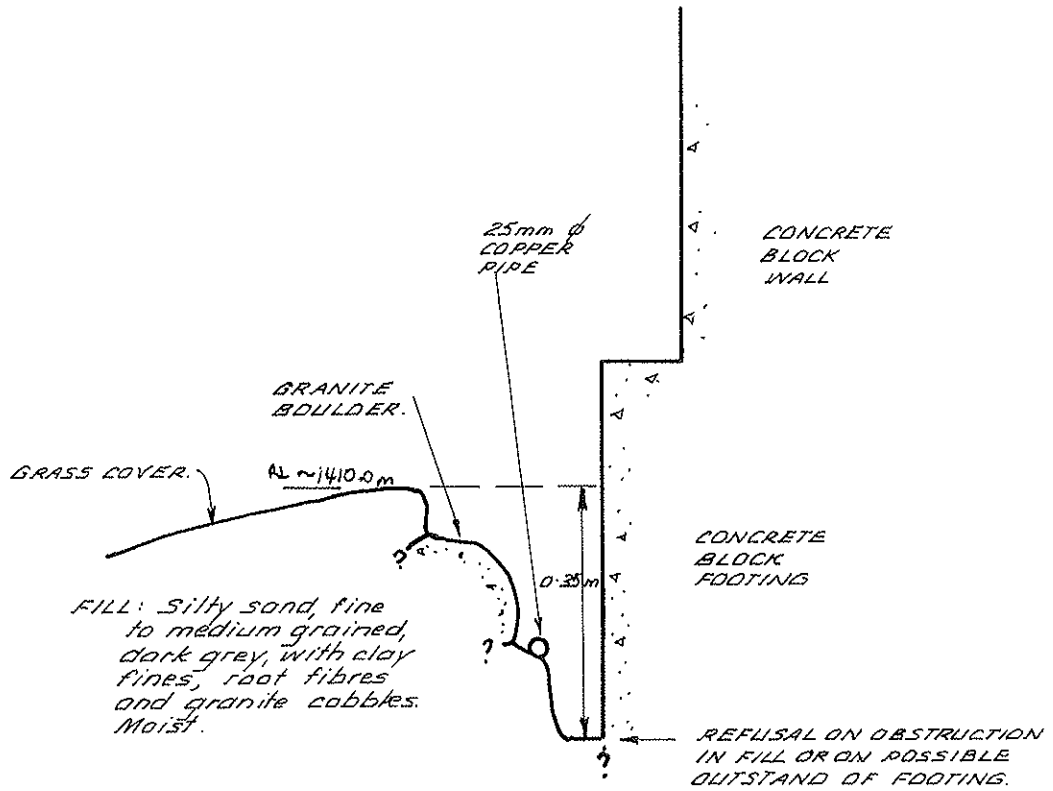
Figure No. 5

In the previous JK test pits, fill was encountered in JK102 down to a depth of at least 0.35m. Furthermore, ground surface levels have been raised along the rear (northern) side of the Lodge by up to about 1.3m where retaining walls were present. We therefore infer that fill is present to a depth of at least 1.3m below some parts of the subject site. We have no records that document the manner of placement, compaction specification and control of the fill. The pavers have also subsided which is indicative of the fill being poorly compacted. Hence, the fill is deemed not to be a 'controlled' fill as defined in Clause 1.8.13 of AS2870-2011 'Residential slabs and footings'. As the site is expected to be underlain by more than 0.4m of 'uncontrolled' fill, the site is Class 'P' in accordance with AS2870-2011.

BASE OF TEST PIT AT 0.35m

'DRY' ON COMPLETION.

BASE OF FOOTING NOT REVEALED, BUT IS FOUNDED AT LEAST 0.35m BELOW EXISTING SURFACE.
