Kosciuszko Thredbo Pty Ltd

**Proposed Merritts Gondola
Thredbo, NSW**

Geotechnical Assessment

Our ref: 4474-R1 Rev 1
22 August 2019

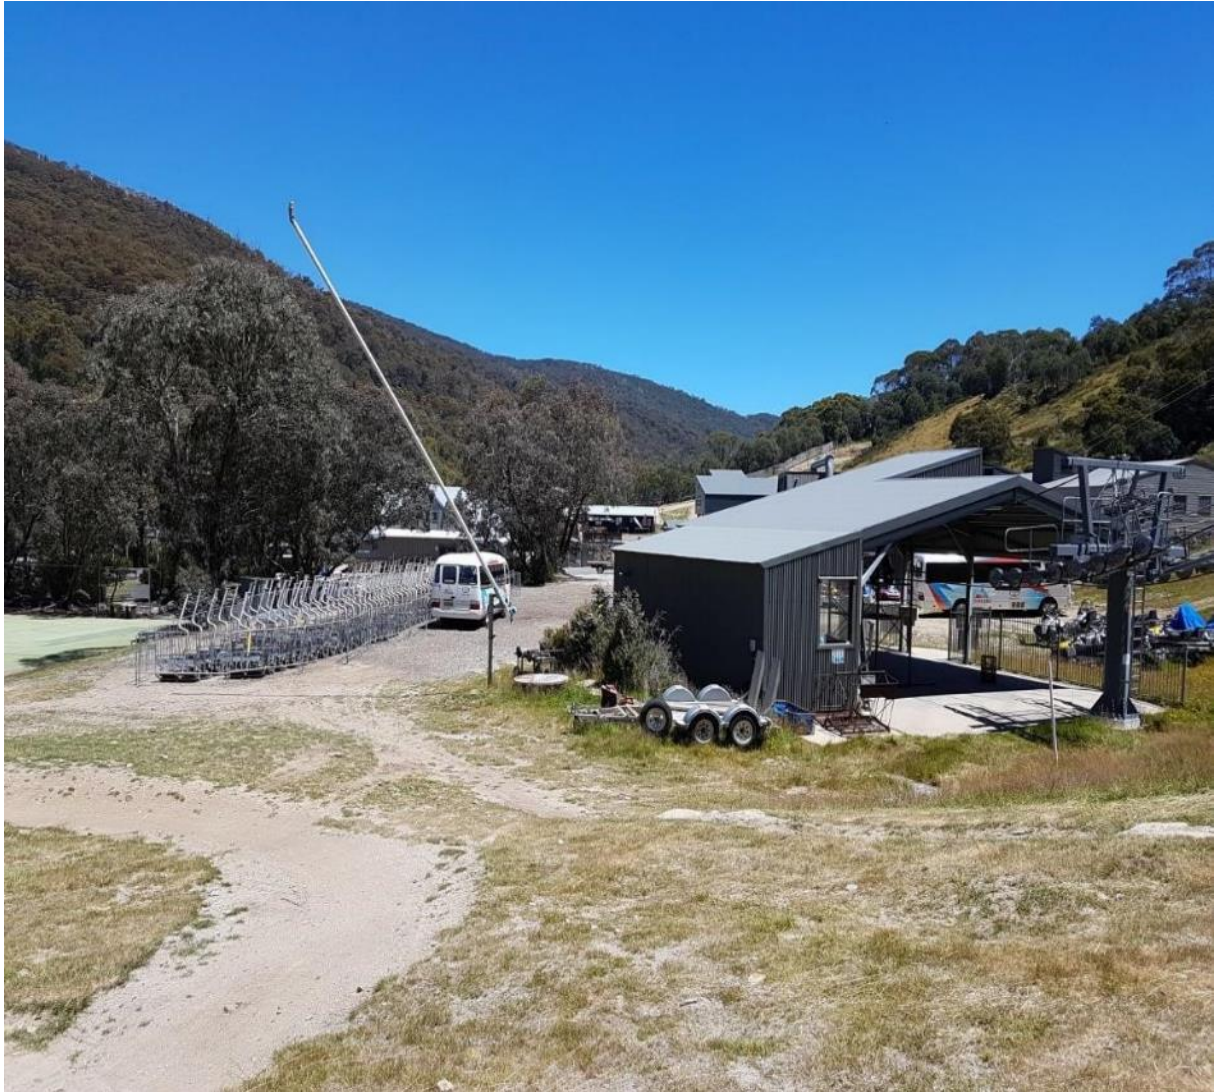
Plate 2 (source: JK)

To the east of the proposed Bottom Station and Towers 1 and 2 were several tennis courts. To the south and west of the proposed location were existing two storey sandstone block and metal panel buildings and single storey metal panel maintenance sheds. Refer to Plates 2 and 3.

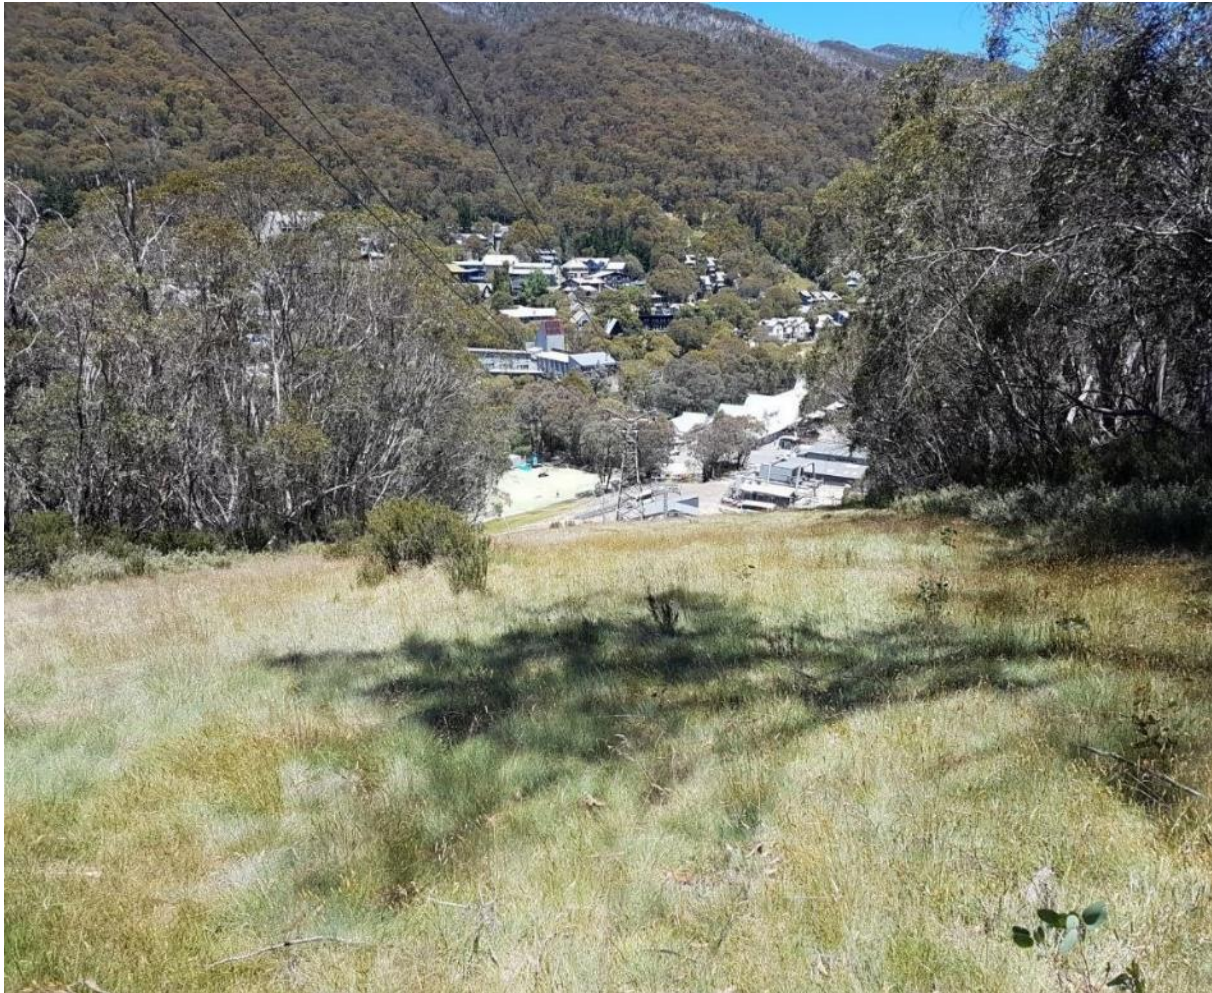
Plate 4 (source: JK)

The proposed Tower 3 location is situated towards the lower reaches of the hillside, which graded at approximately 16° down to the south. There was grass cover and sparse alpine vegetation on the ground surface, with scattered granite corestones nearby. Refer to Plate 4.

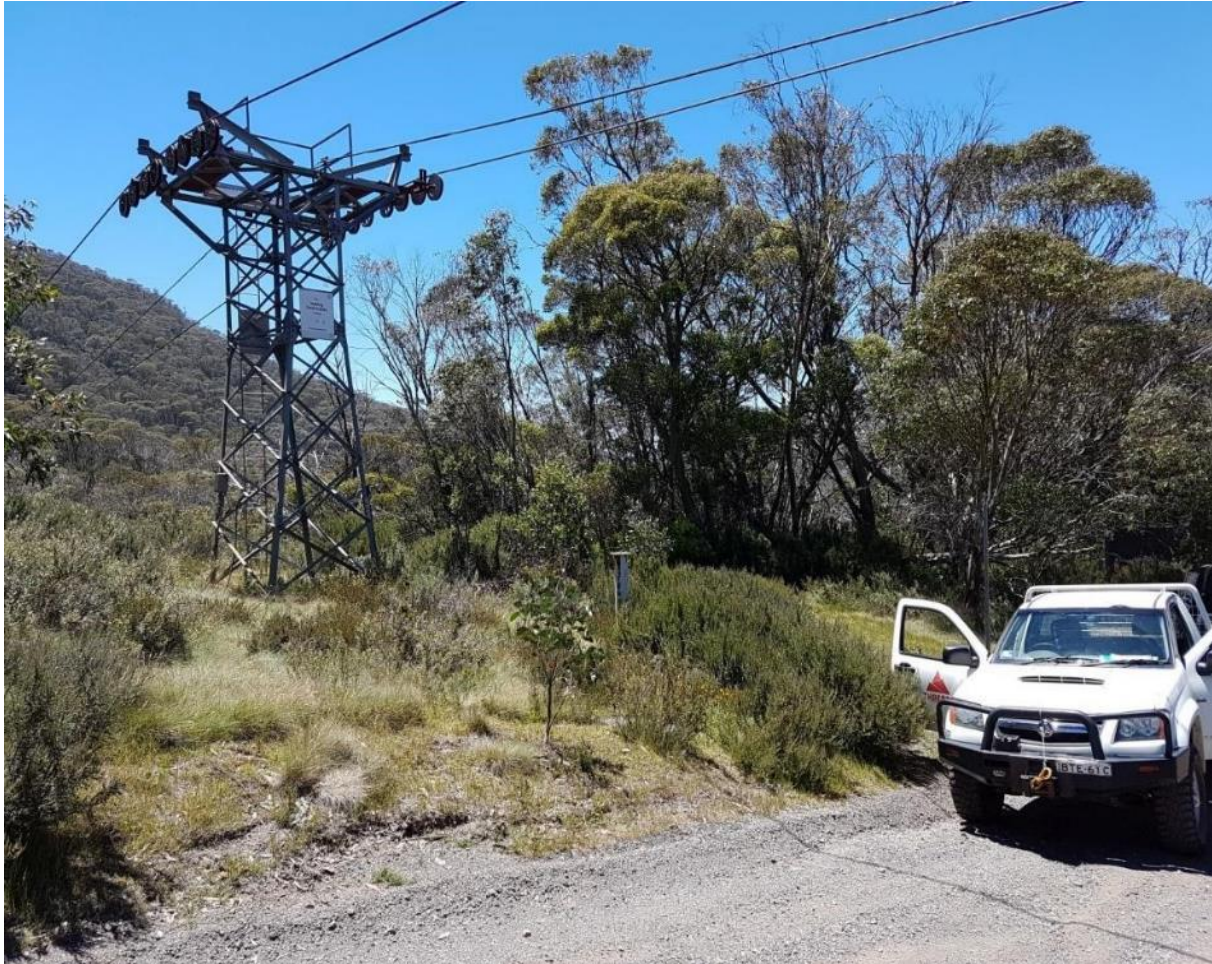
Plate 5 (source: JK)

The proposed Tower 4 location is situated at the crest of the lower reaches of a ridgeline, which is oriented approximately east-west. The northern and southern sides of the ridgeline graded at approximately 25° and 11°, respectively. The proposed Tower location is approximately 5m south of the existing chairlift tower and 5m north of a gravel access track. The ground surface was covered with alpine vegetation and a dense cover of medium sized trees were present to the east and west. Refer to Plate 5.

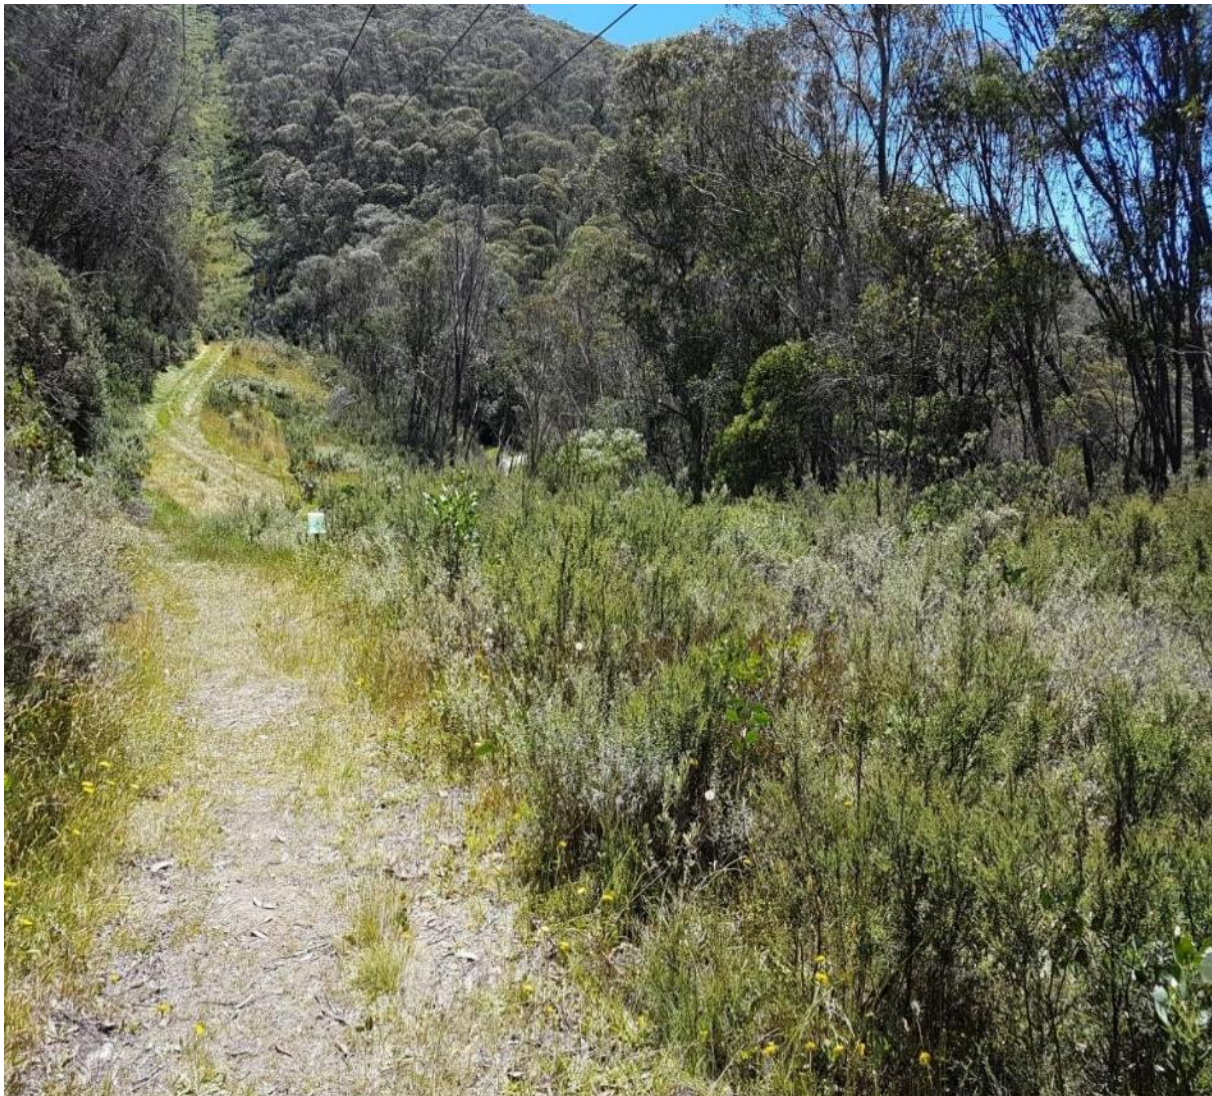
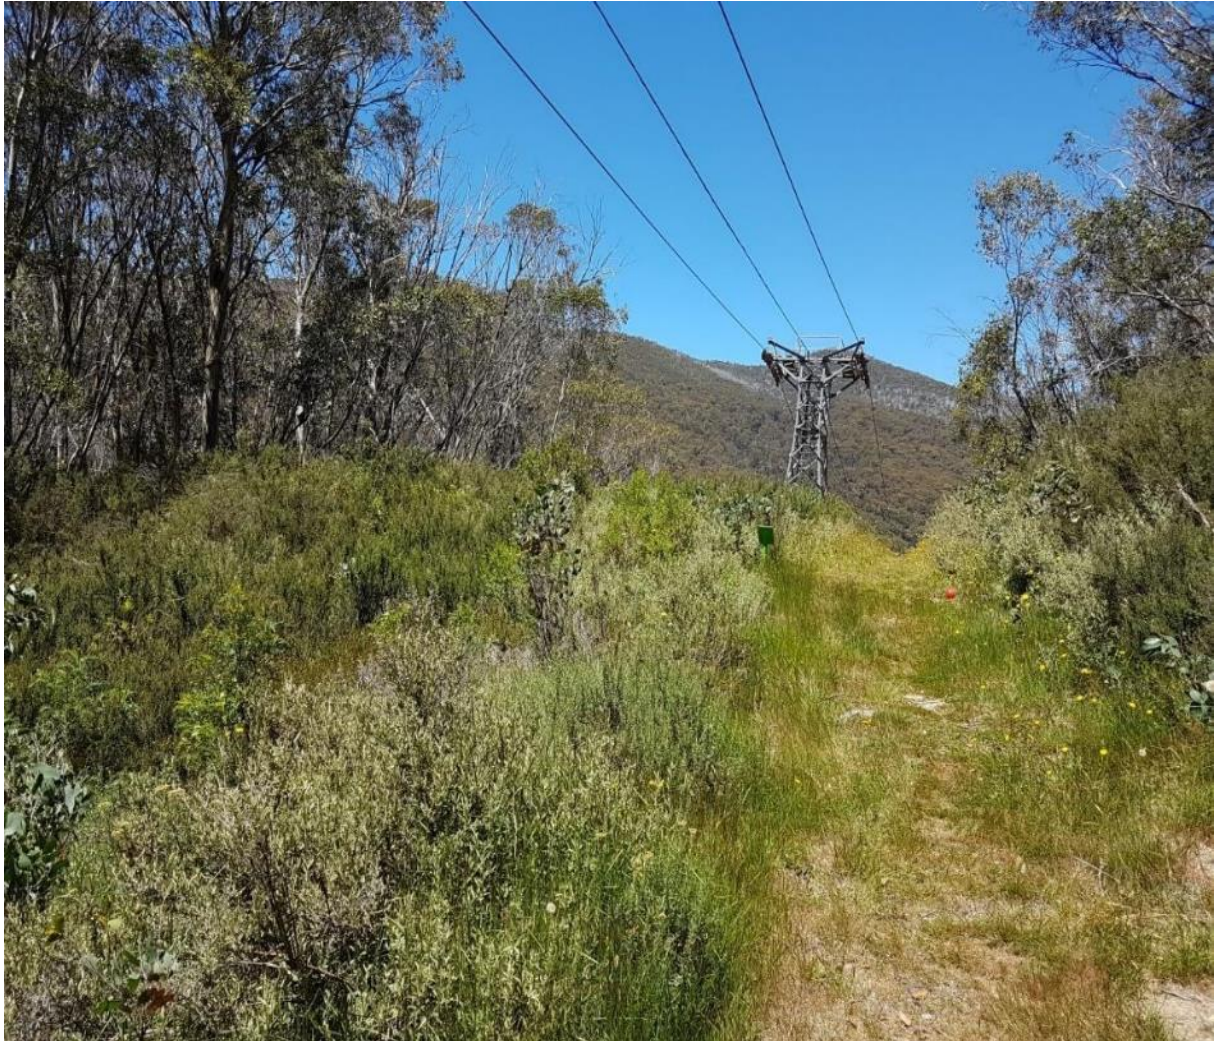
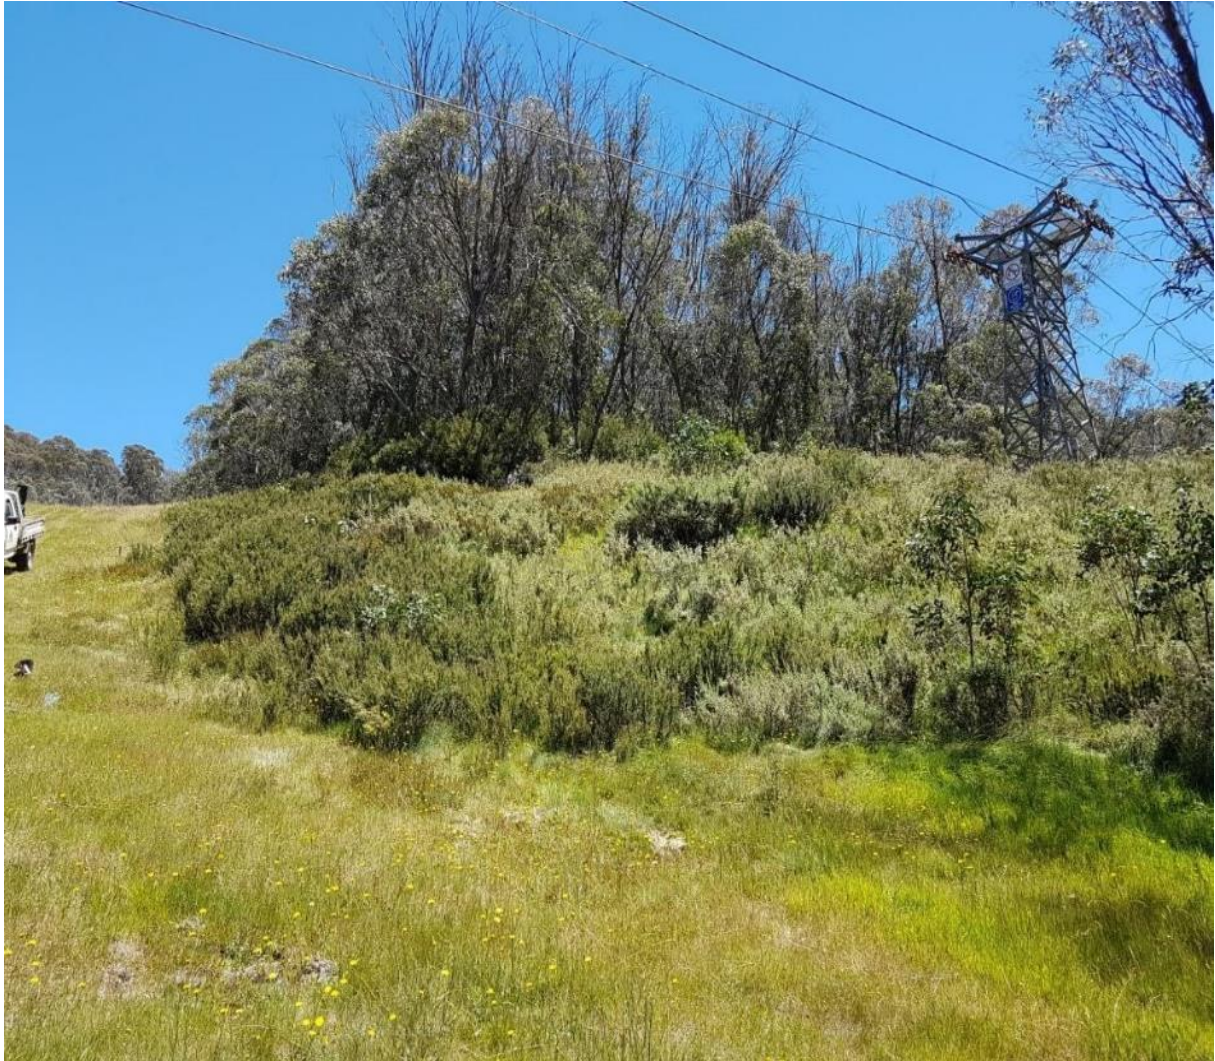
The attached Asset Figure 3 indicates the layout of the proposed Mid Station and Towers 6 and 7, overlaid on a contour plan with an option for proposed cutting and filling of up to about 6 m depth to form a benched area for the construction. Refer Plates 6, 7 and 8.

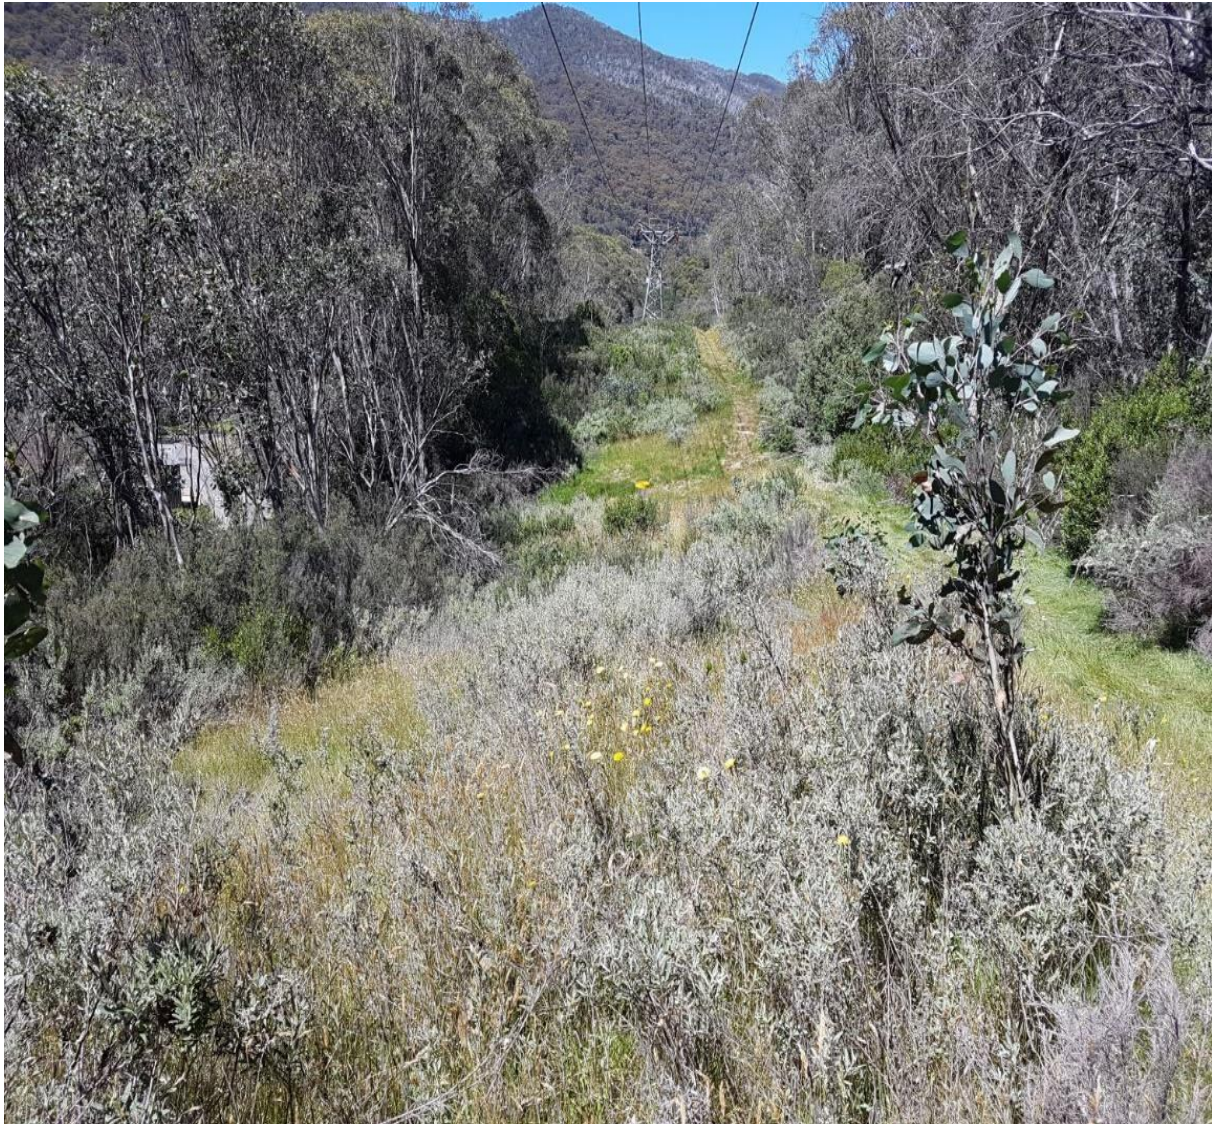
Plate 9 (source: JK)

The proposed Tower 8 location is situated towards the crest of a ridgeline. The area locally graded at approximately 13° down to the south-east. To the east of the proposed Tower location, the ground steepened to approximately 18° towards a creek, which extended north-south. A thin layer of topsoil and alpine vegetation were present over the surface of granite bedrock at the proposed Tower location. Refer to Plate 9.

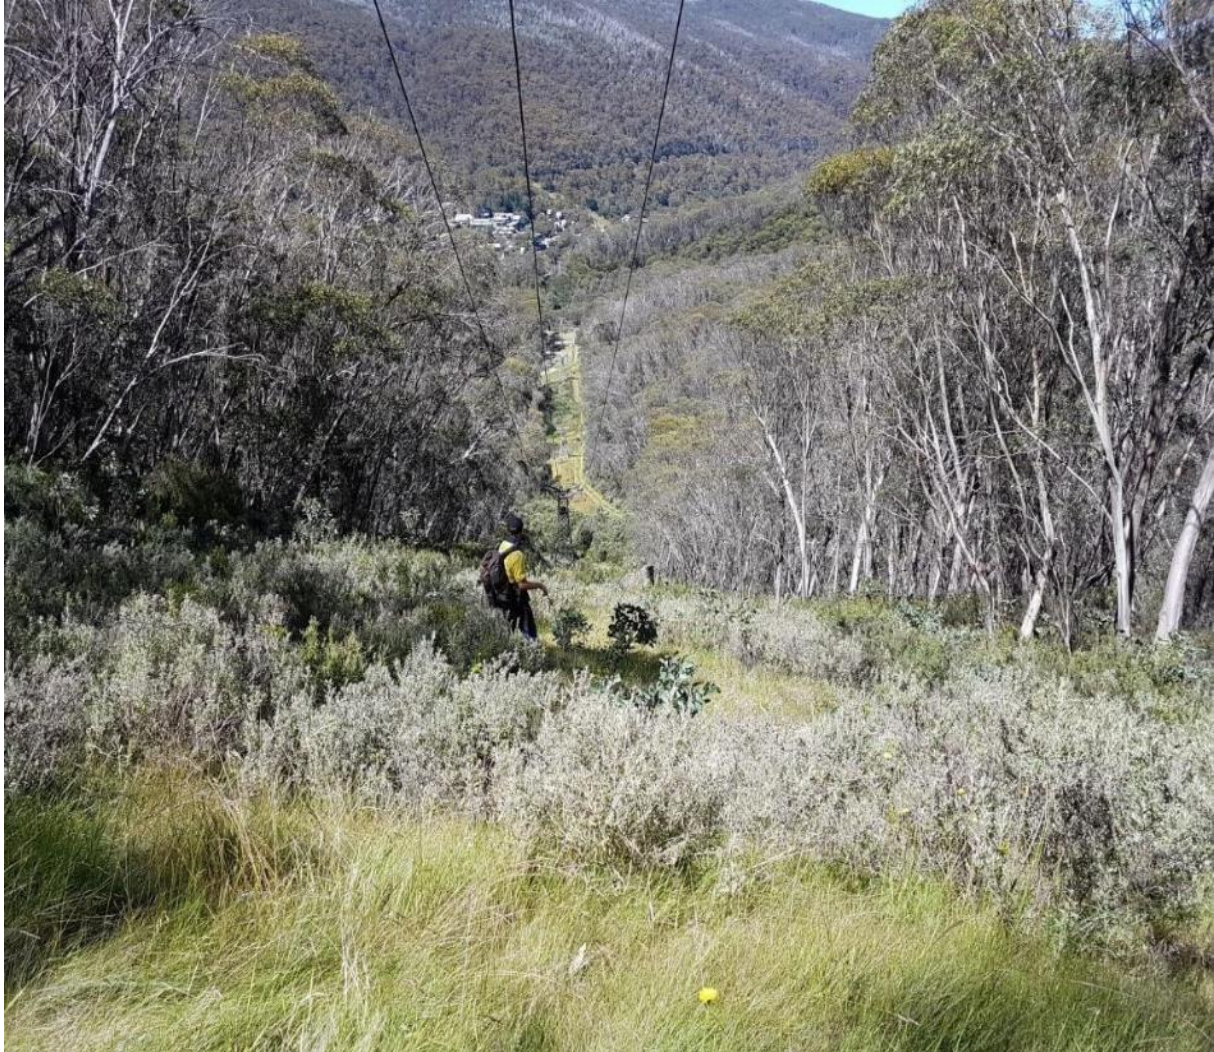
Plate 10 (source: JK)

The proposed Tower 9 location is situated towards the lower reaches of the upper hillside slope, which graded at approximately 22°. There were several granite corestones and granite bedrock outcrops present nearby. A thin layer of topsoil and alpine vegetation were present over the surface of granite bedrock at the proposed Tower location. Refer to Plate 10.

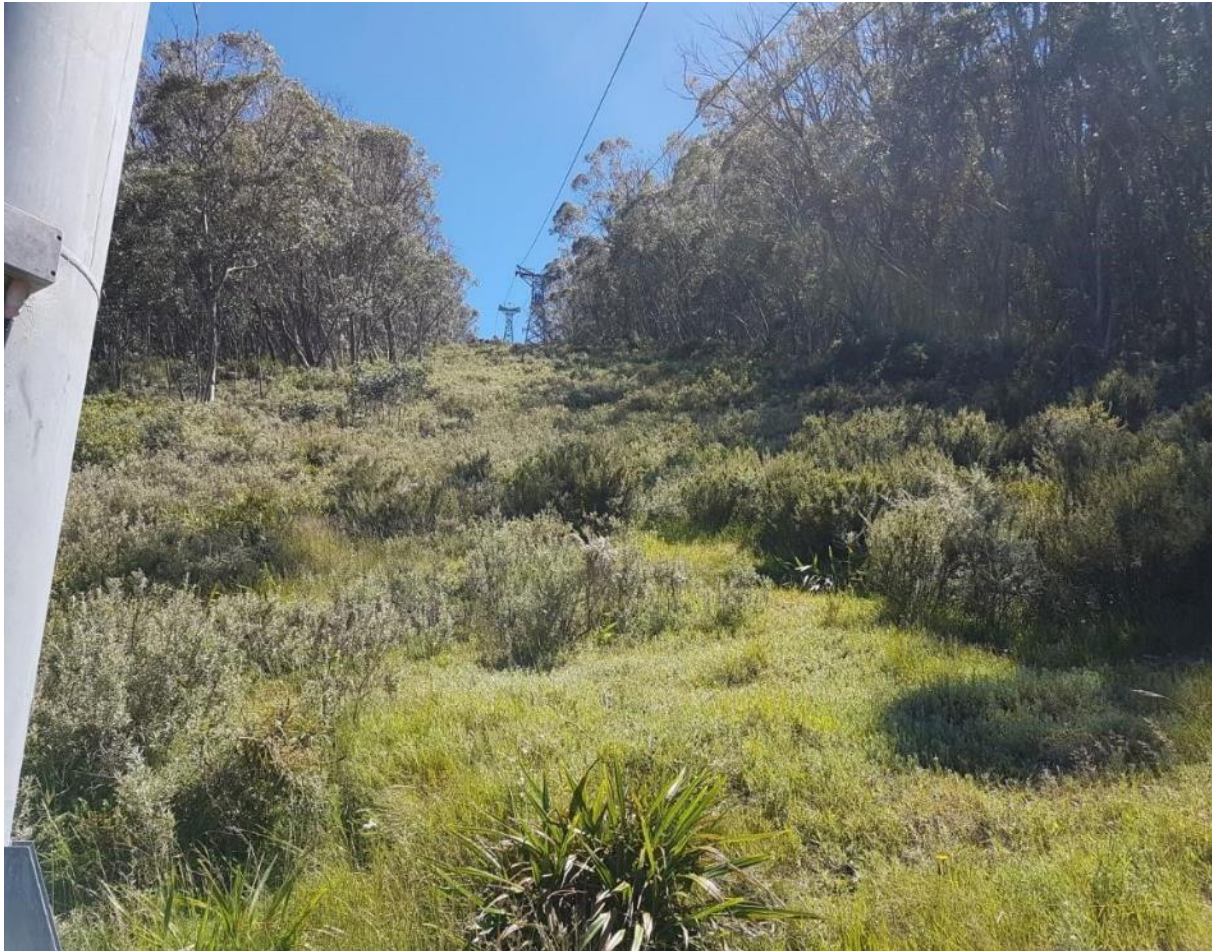
Plate 11 (source: JK)

The proposed Tower 10 location is situated approximately mid-slope on the hillside, which graded at approximately 23°. The proposed tower is located just up slope of the 'Gun Barrel' crossover. There was dense alpine vegetation and grass cover on the ground surface, with scattered granite bedrock outcrops nearby. Refer to Plate 11.

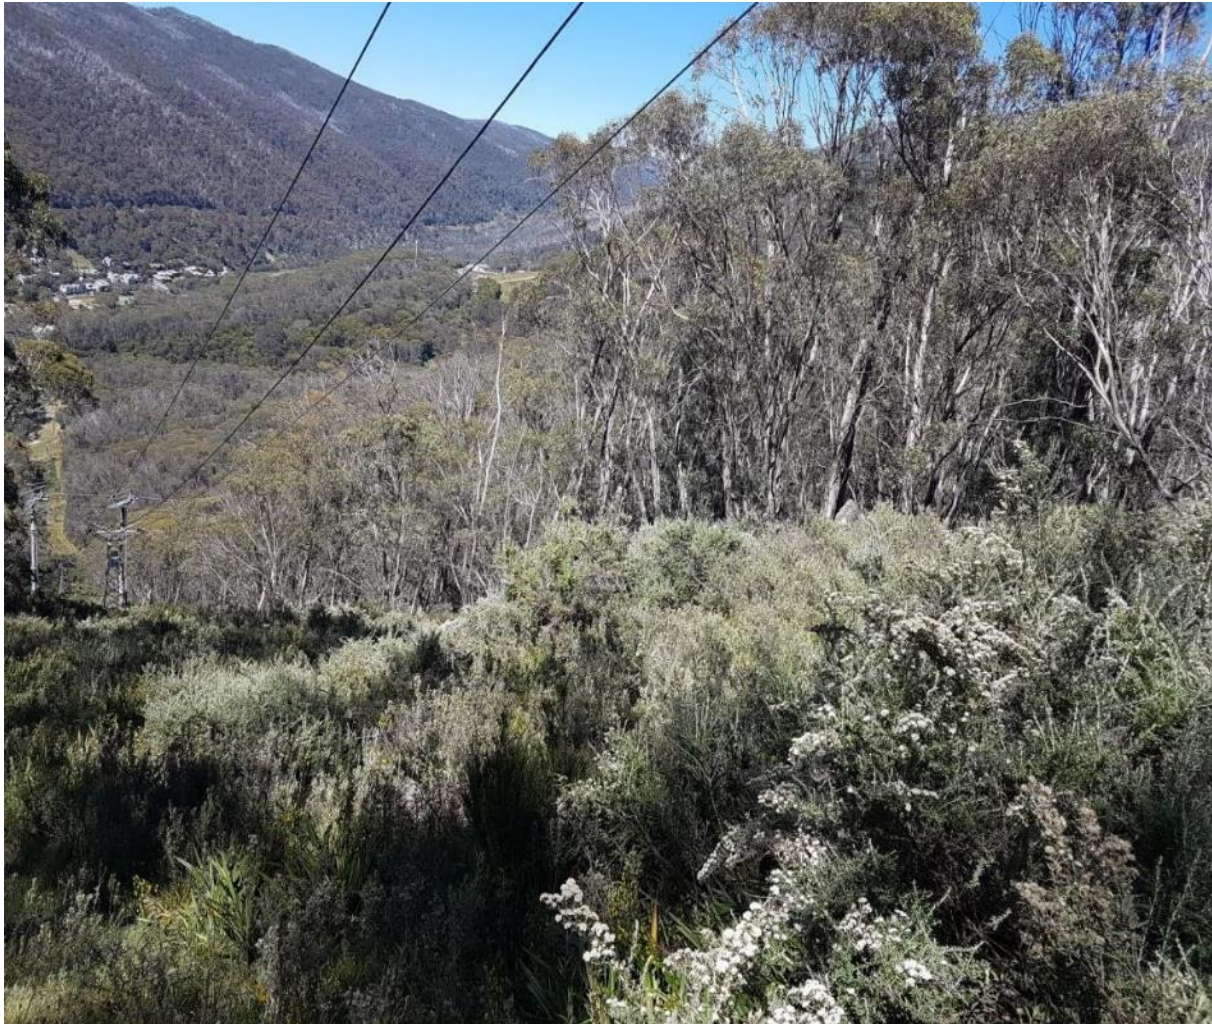
Plate 12 (source: JK)

The proposed Tower 11 location is situated partway down the upper reaches of the hillside, which graded at approximately 23°. Granite bedrock outcropped and corestones were present nearby. A thin layer of topsoil and alpine vegetation were present over the surface of granite bedrock at the proposed Tower location. Refer to Plate 12.

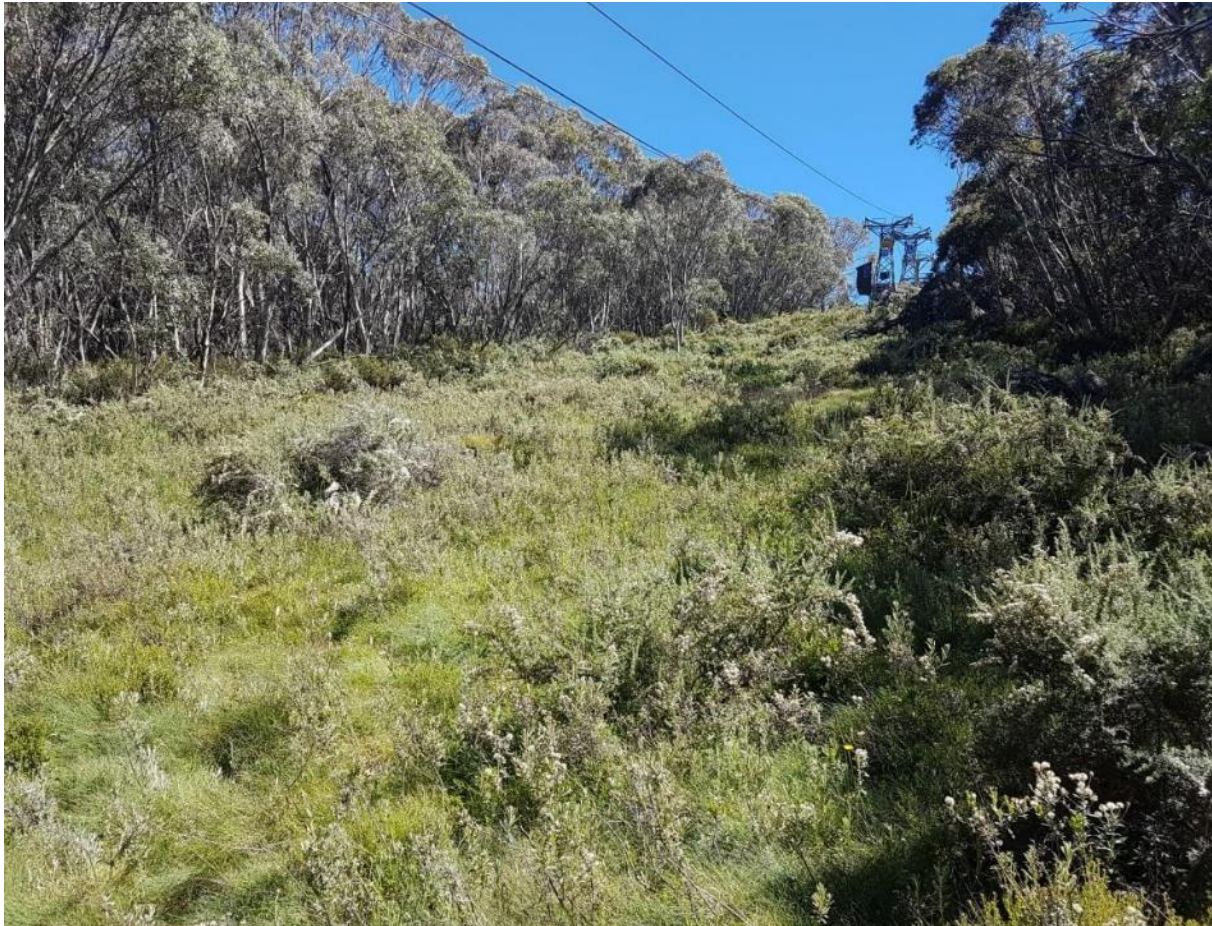
Plate 13 (source: JK)

The proposed Tower 12 location is situated towards the upper reaches of the hillside, which grades at approximately 17°. There were several granite corestones and granite bedrock outcrops present nearby. A thin layer of topsoil and alpine vegetation were present over the surface of the granite bedrock at the proposed Tower location. Refer to Plate 13.

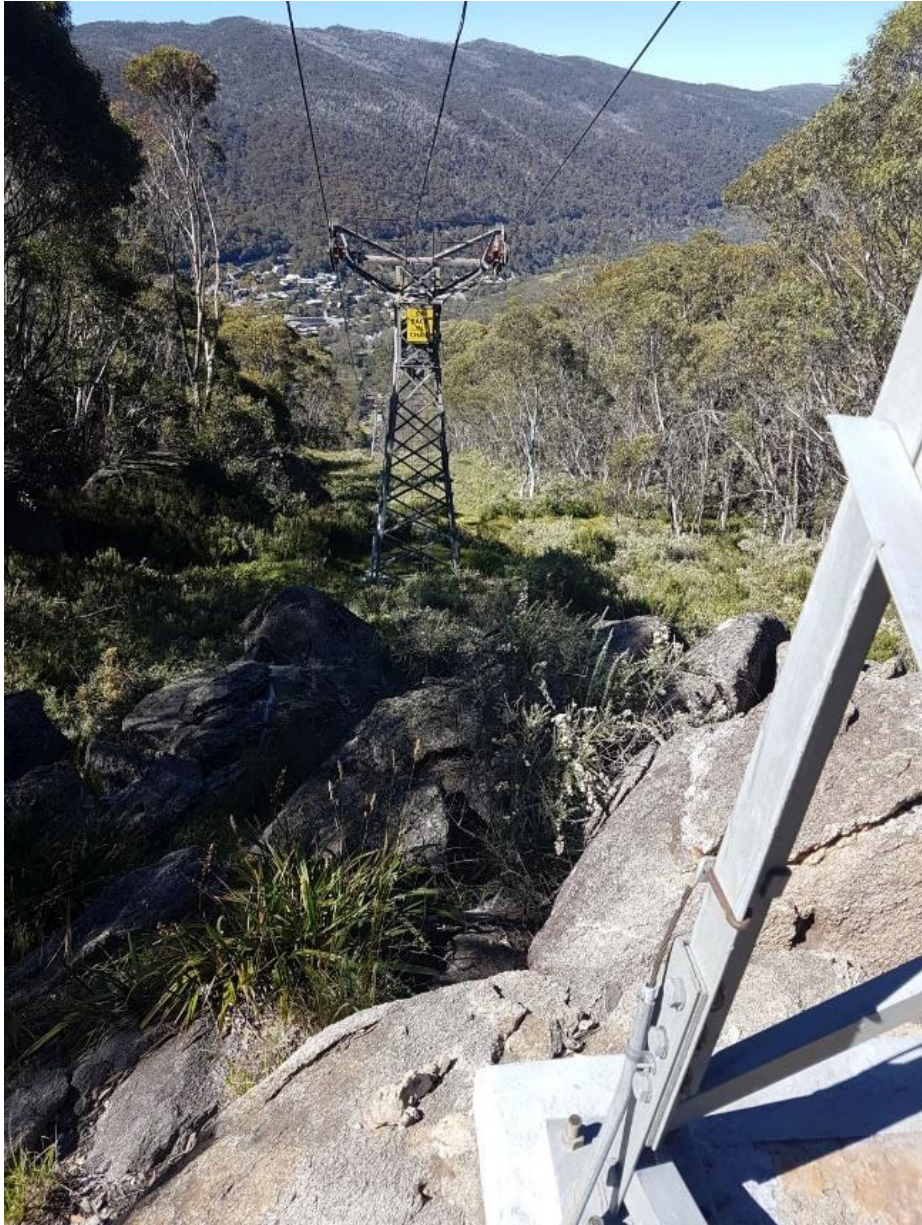
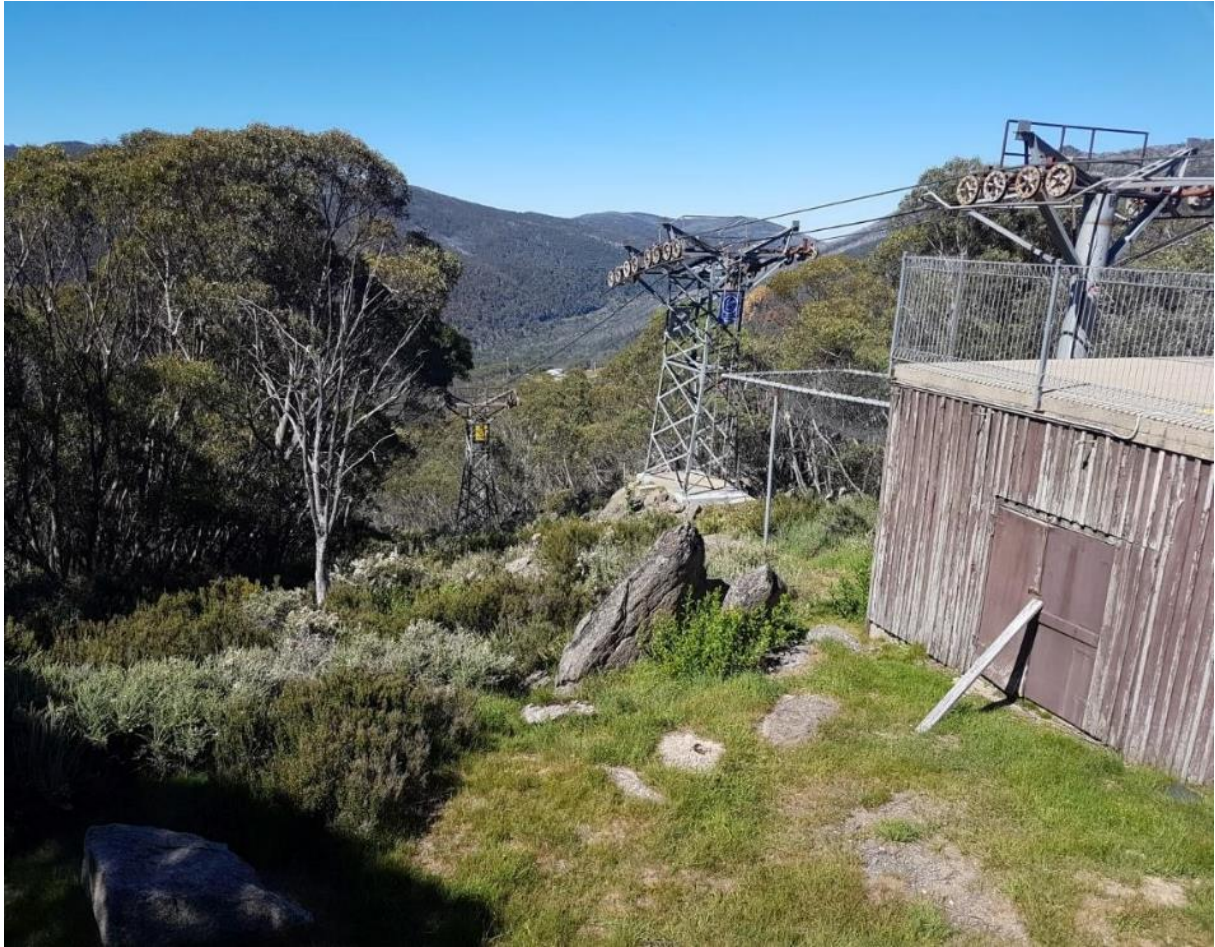
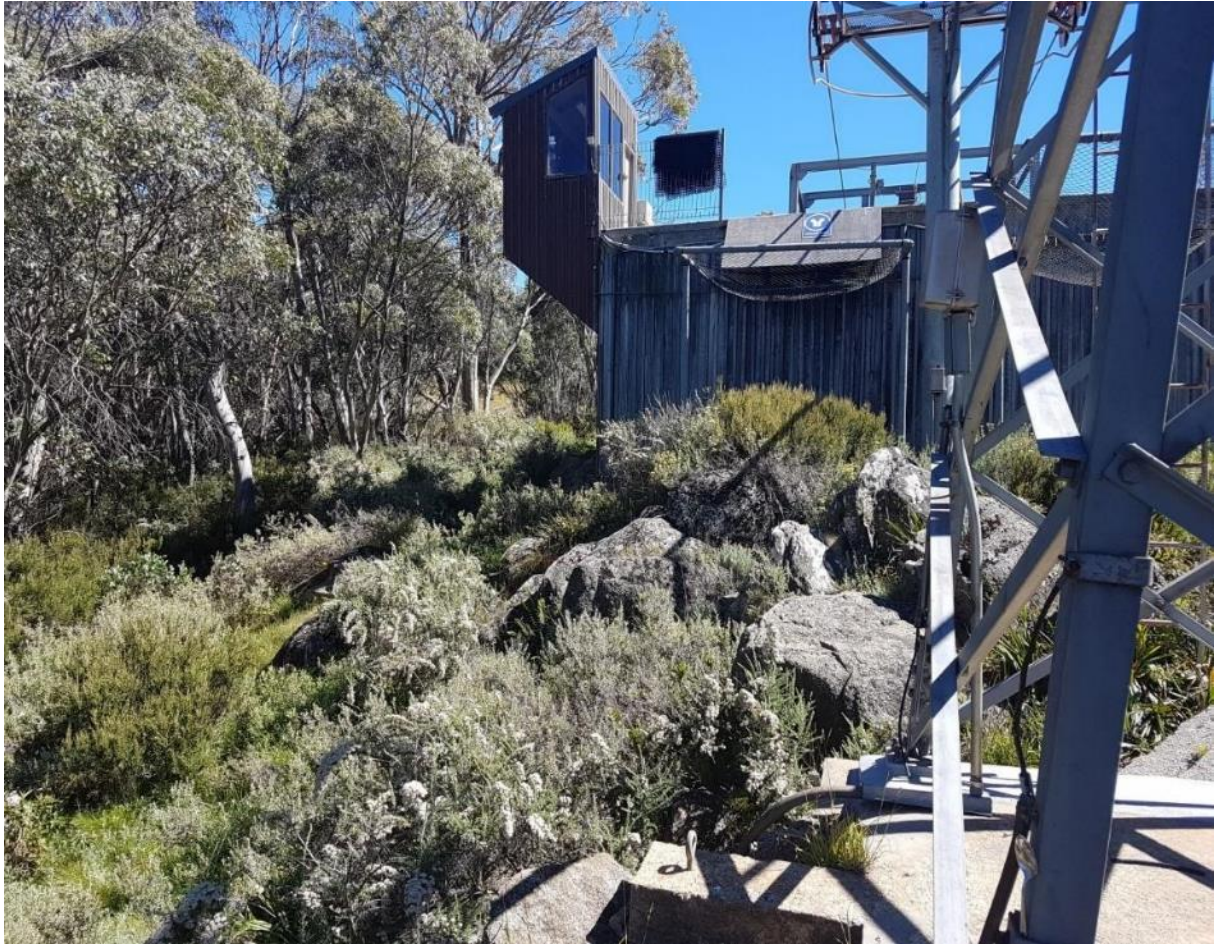
The location of the proposed Top Station and the adjacent proposed Tower 13 are located over, and just below, the southern end of the existing Top Station. The hillside just below its crest sloped down to the south south-west at approximately 17°. Granite bedrock outcropped and corestones were prevalent throughout this area. The ground surface was covered with grass and alpine vegetation. Refer to Plates 14 to 16.
