ISSUED FOR  
APPROVAL &  
CONSTRUCTION

# DETAILED RECTIFICATION PROCEDURE OF KANDAHAR LODGE SOUTHERN WALL TO REDUCE CONDENSATION

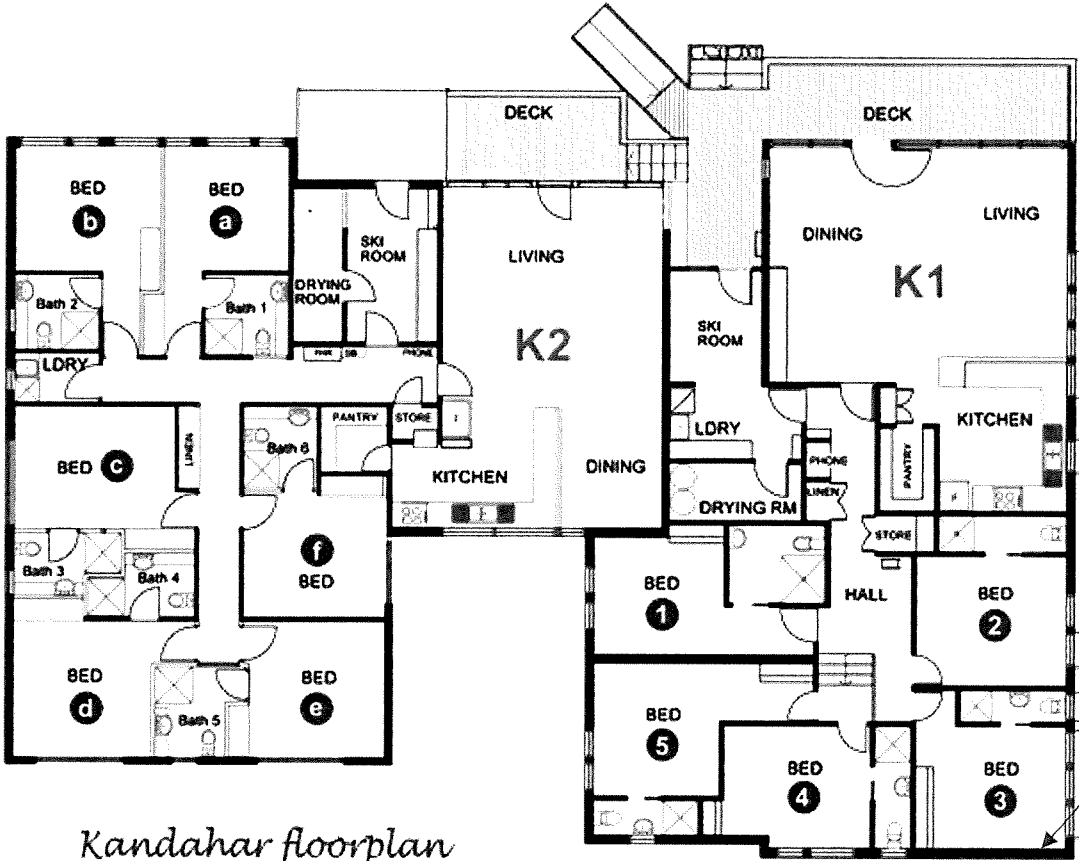
*Kandahar floorplan*

Internal wall to be repaired and improved to reduce condensation that occurs due to build up of snow behind the lodge. This is the only area that causes damp

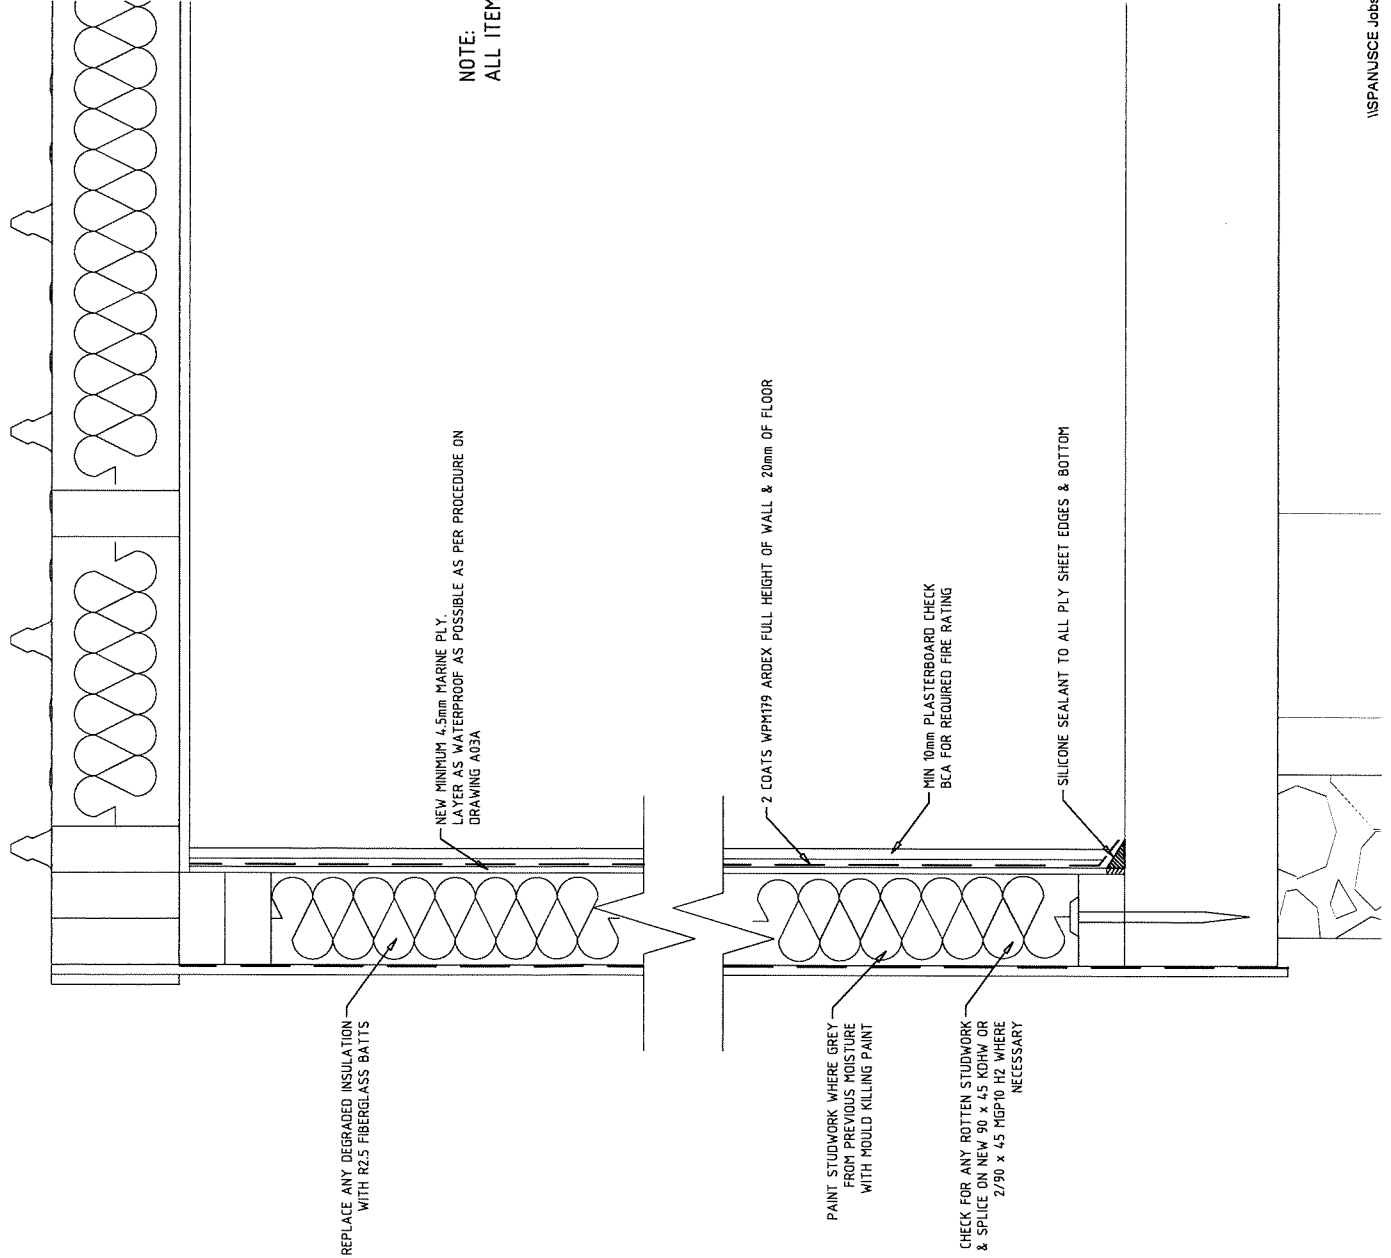
**SECTION  
1:5 @ A3**

1. The full height of the southern wall requires a layer that is as waterproof as possible on the inside face of the studwork to reduce the water vapour in the room getting into the wall cavity. This vapour in the cavity is currently condensing and dripping to the floor. The method consists of a minimum 4.5mm thick ply layer sealed and waterproofed and the internal plasterboard installed over the top.

2. Leave the external wall cladding on.
3. Remove the internal 13mm plasterboard for the full height of the wall.
4. Remove the insulation on the bottom of the wall up to where the studs are no longer stained grey from moisture in the past.

5. Replace any significant rotten timber studwork or bottom plate with new KDHW size to match existing or MGP10 H2 of the same depth but double the width of the existing HW. No rot at all was found on inspection on Monday 2nd December 2019, so it is unlikely this step is to be required, but should be checked.

6. Paint the bottom plate and any grey stained studwork with mould killing paint.
7. Determine where the joins in the minimum 4.5mm marine ply sheet will be (see 9 & 12 below) and install 90 x 45 MGP10 H2 nogs where required.

8. Re-install the batts and replace any that are damaged or wet with new R2.5.
9. Cut the ply sheets to ensure all vertical ply joints are at the center of a stud and horizontal joints at the center of each nog.

10. Install a 5mm triangle of mould resistant silicone sealant at the bottom wall plate / flooring intersection and a continuous bead approx. 15mm down from the top of the bottom plate. Sellys 'Wet Area Silicon' or similar.

11. Install two continuous beads of silicone approx. 15mm in from each side of the studs and nogs.
12. Install the first marine ply sheet on the inside face of the studwork. Attach to studs and nogs with #6 (3.5mm dia) x 25mm countersunk screws at 100mm c/c.

13. Install 4mm triangle of silicone at sheet edges down onto stud or nog.
14. Install next marine ply sheet as per first pushing the sheet flush (or nearly flush) to the edge of the first sheet so that the silicone is pushed up.

15. Tool silicone flush. This will act as a bond breaker for the WPM 179 (see below) so that it can stretch over these ply joints if they move.
16. Use the same procedure to install the remaining marine ply sheets.

17. Install a 4mm triangle of silicone at the base of the wall between ply and flooring. Again, this acts as a bond breaker.
18. Waterproof the erected inside face of the wall full height plus 25mm onto the floor with two coats of a flexible sealant such as 'Ardex WPM179' or 'Duram Azcothane', both available from CE Industries ph 62806010. Allow to dry.

19. Install new plasterboard over the inside face using screws in pre-drilled holes filled with silicone. The thickness of the wall plasterboard only needs to be 10mm for structural reasons, however, the required thickness for fire rating needs to be checked by a Building Certifier or Architect to the NCC/BCA.
