# Proposed Alterations & Additions Chimney's Ridge, Diggings Terrace, Thredbo NSW

## Geotechnical Assessment

Our ref: 5919-G1  
21 February 2020

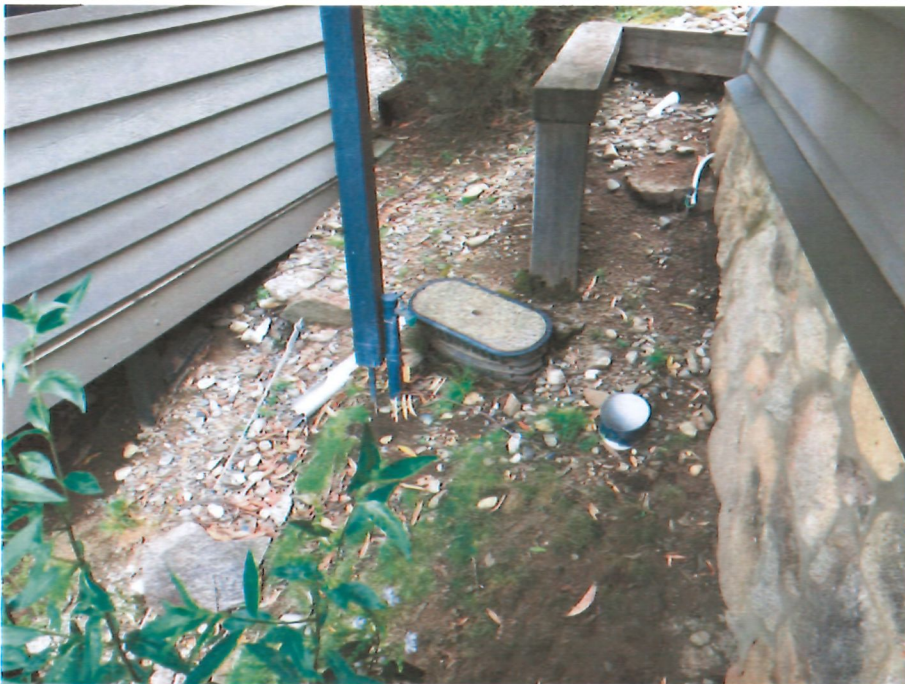
**Photo 1**  
Between the two lodges, east side. Note comms (?) cover.

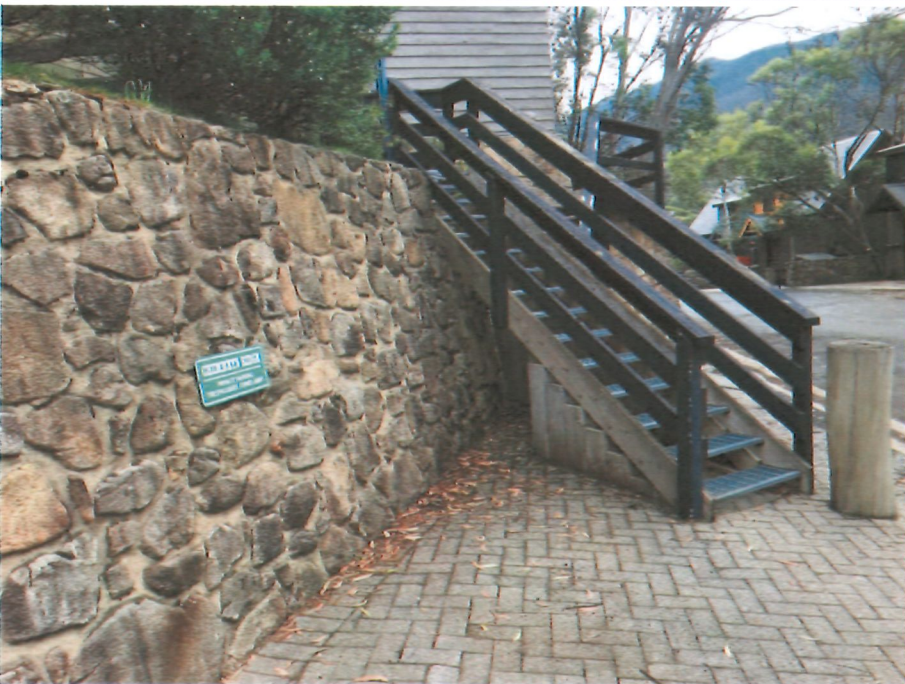
At the time of the investigation, the site was occupied by the main lodge. An existing timber and steel staircase zigzags down to street level. The lower flight of stairs is showing signs of deterioration. At the back of the parking area the site is supported by a masonry retaining wall that is in visually good condition.

**Photo 2**  
General street view of Flight 1 and retaining wall

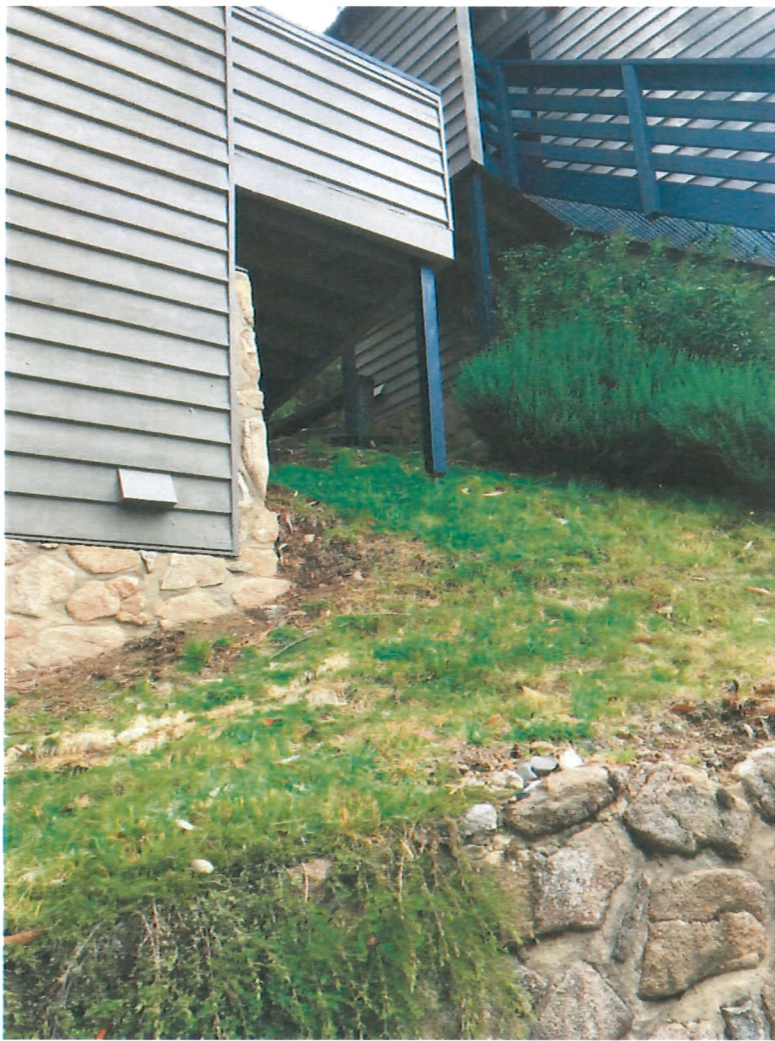
**Photo 3**  
Slope below gap  
between the two  
lodges.
