## APPENDIX A

### PHOTOS

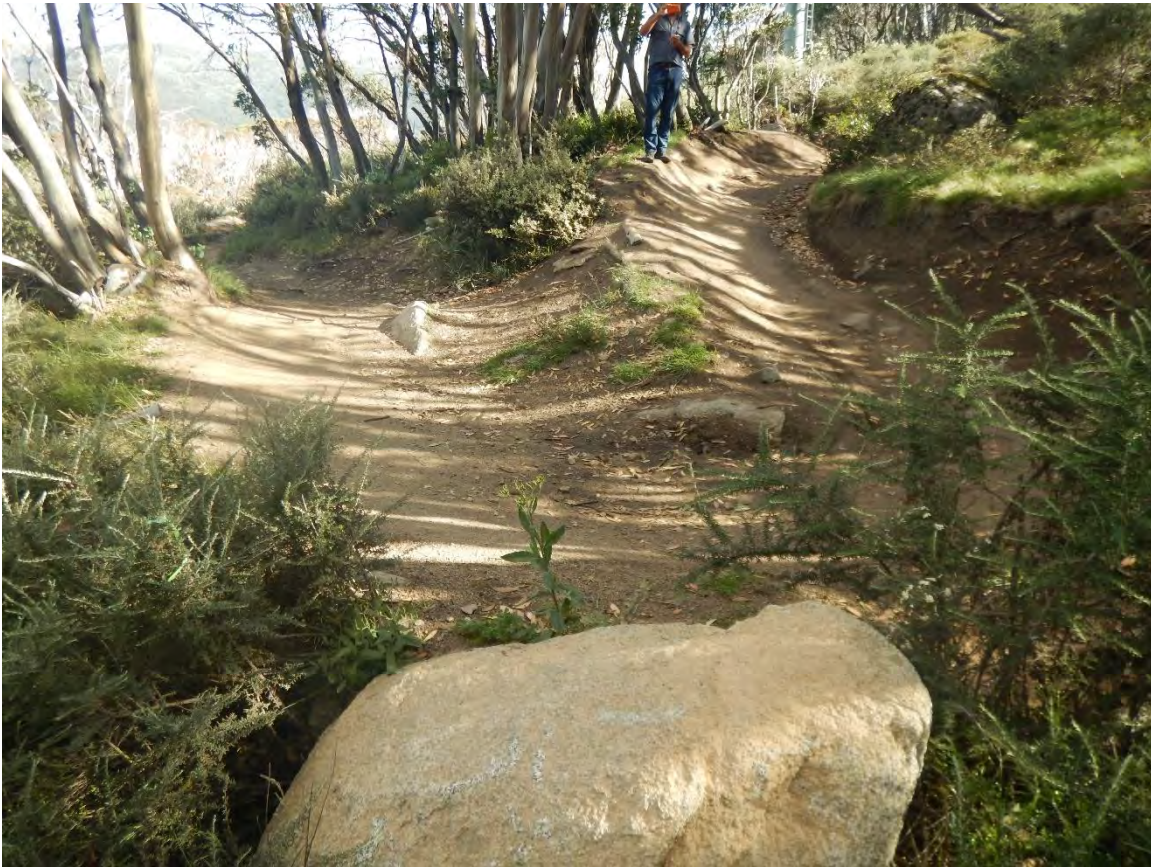
Figure 1: Section 1 – Existing corner which is too tight and technical and is to be re-aligned and rehabilitated

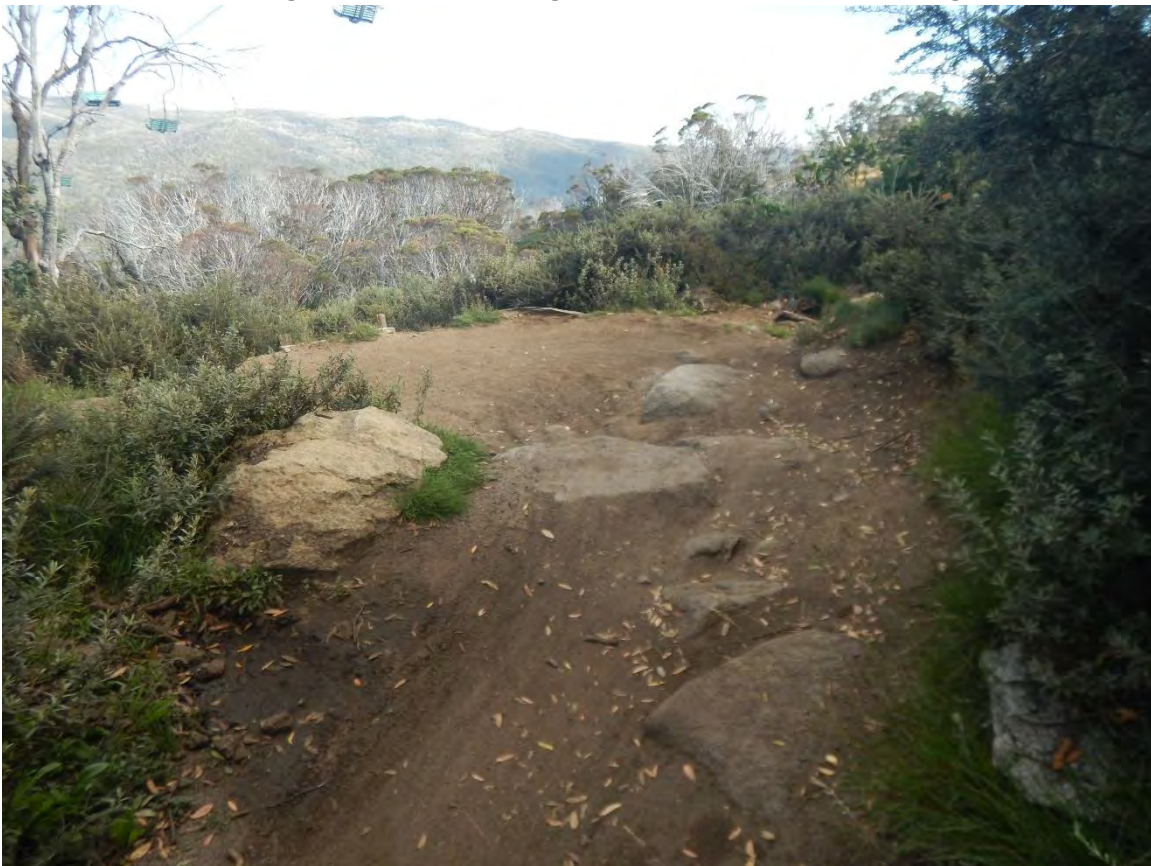
Figure 2: : Section 1 – Existing corner which is too tight and technical and is to be re-aligned and rehabilitated

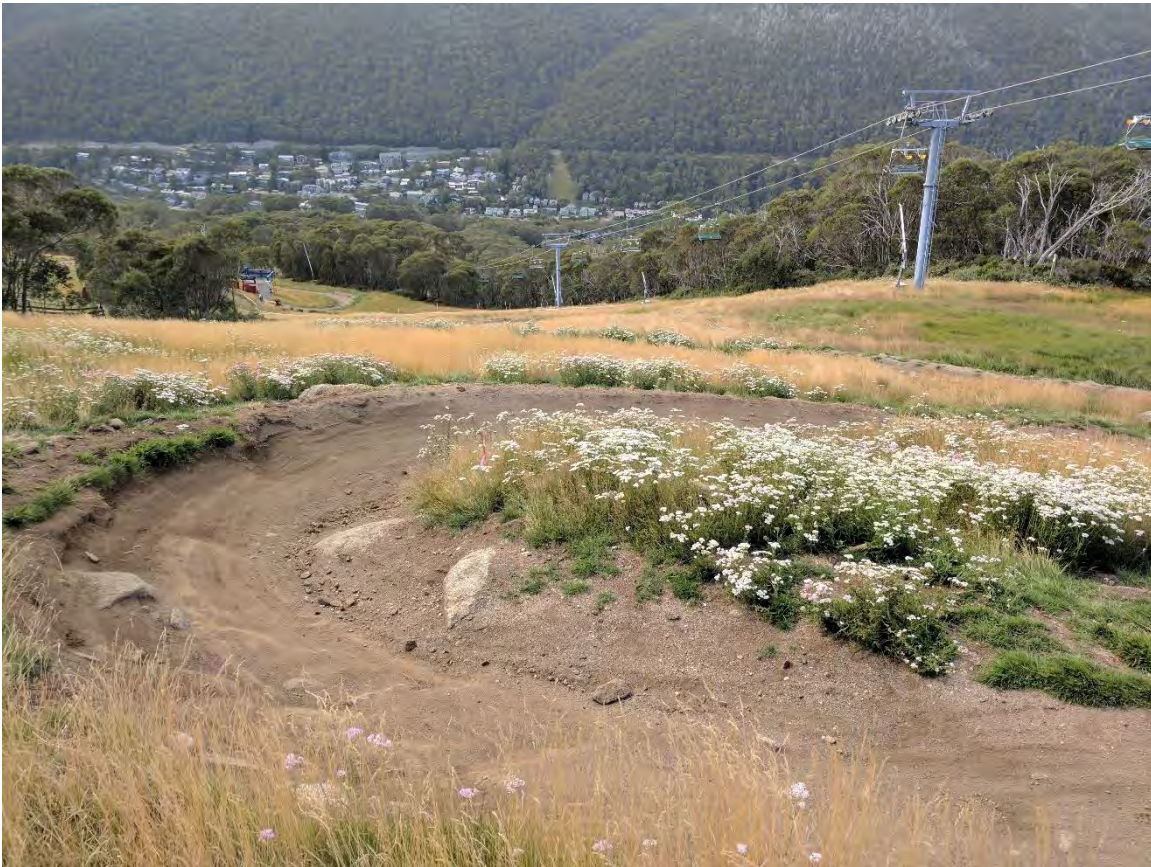
**Figure 3: Section 2 - Existing corners and berms to be re-located off the ski run**

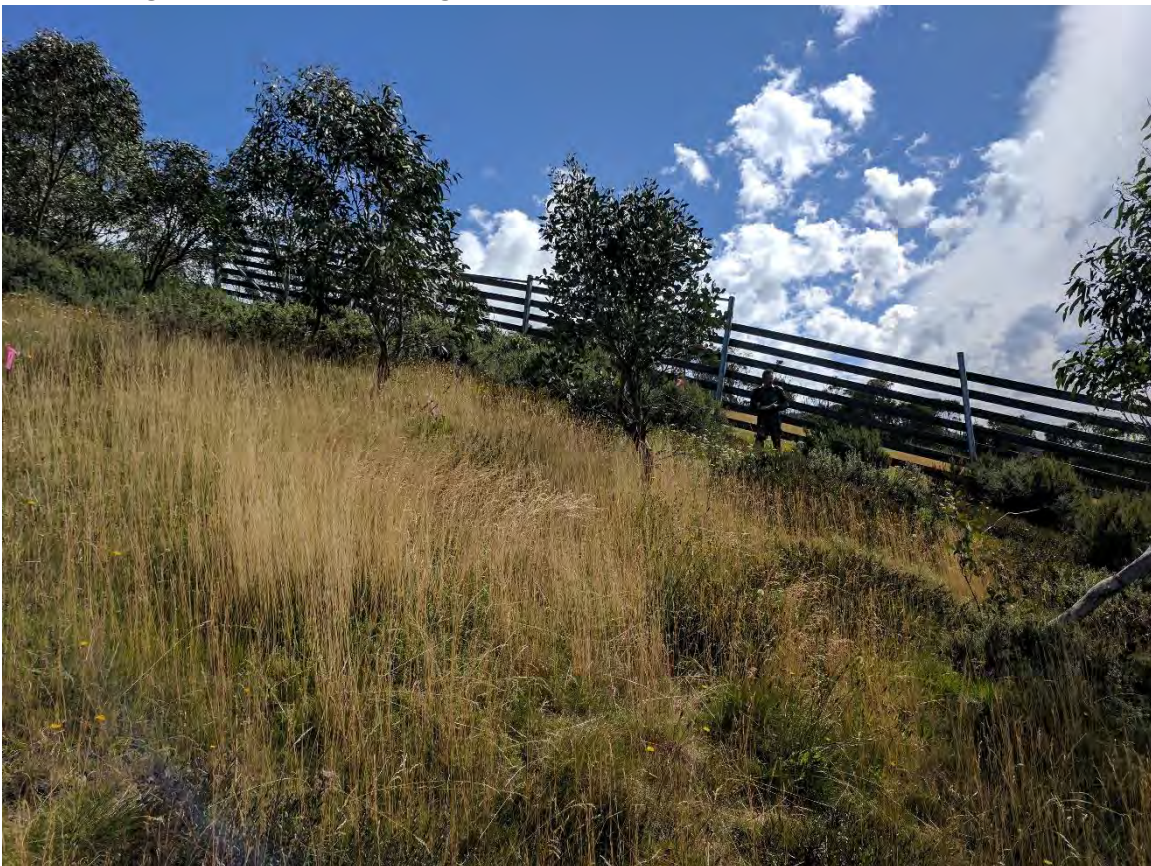
**Figure 4: Section 2 - Corners to be re-aligned into the existing planted tree island on the side of the ski run**

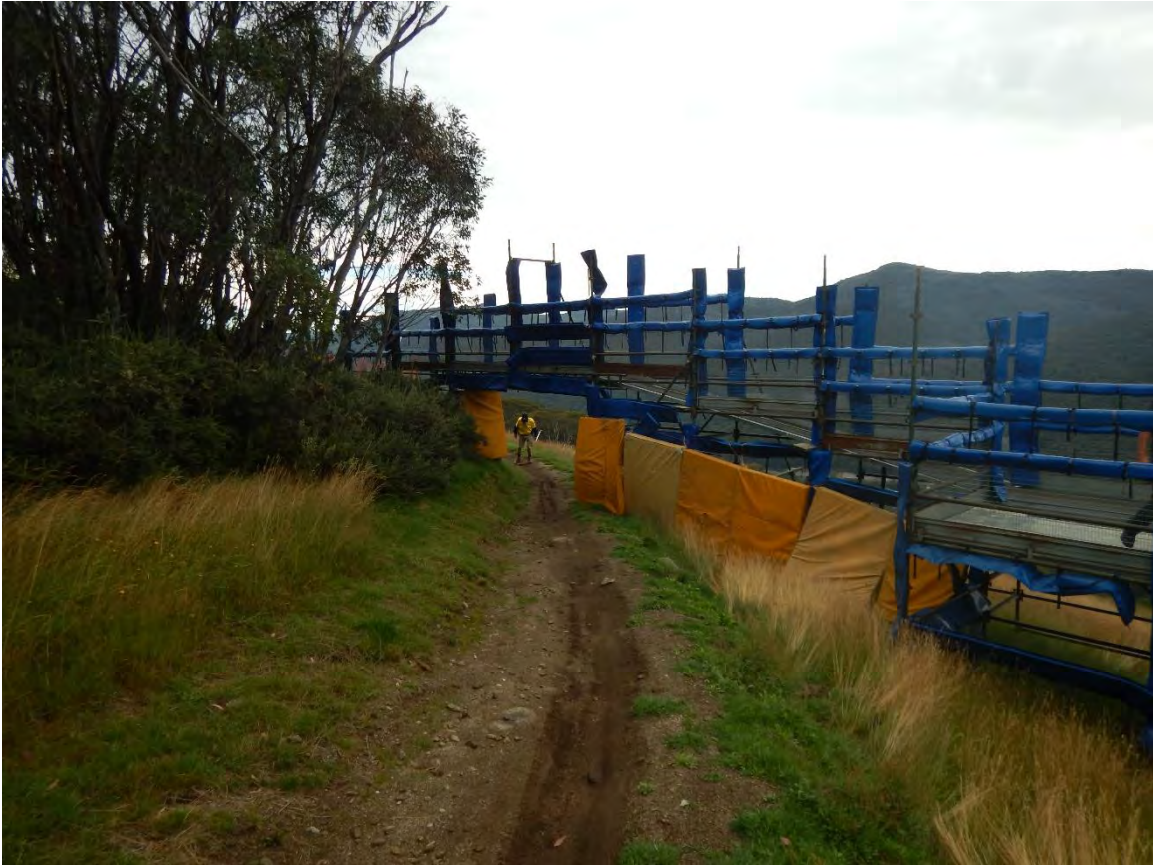
**Figure 5: Section 3 - Existing temporary scaffold overpass to be replaced with a permanent structure within the tree island adjacent**

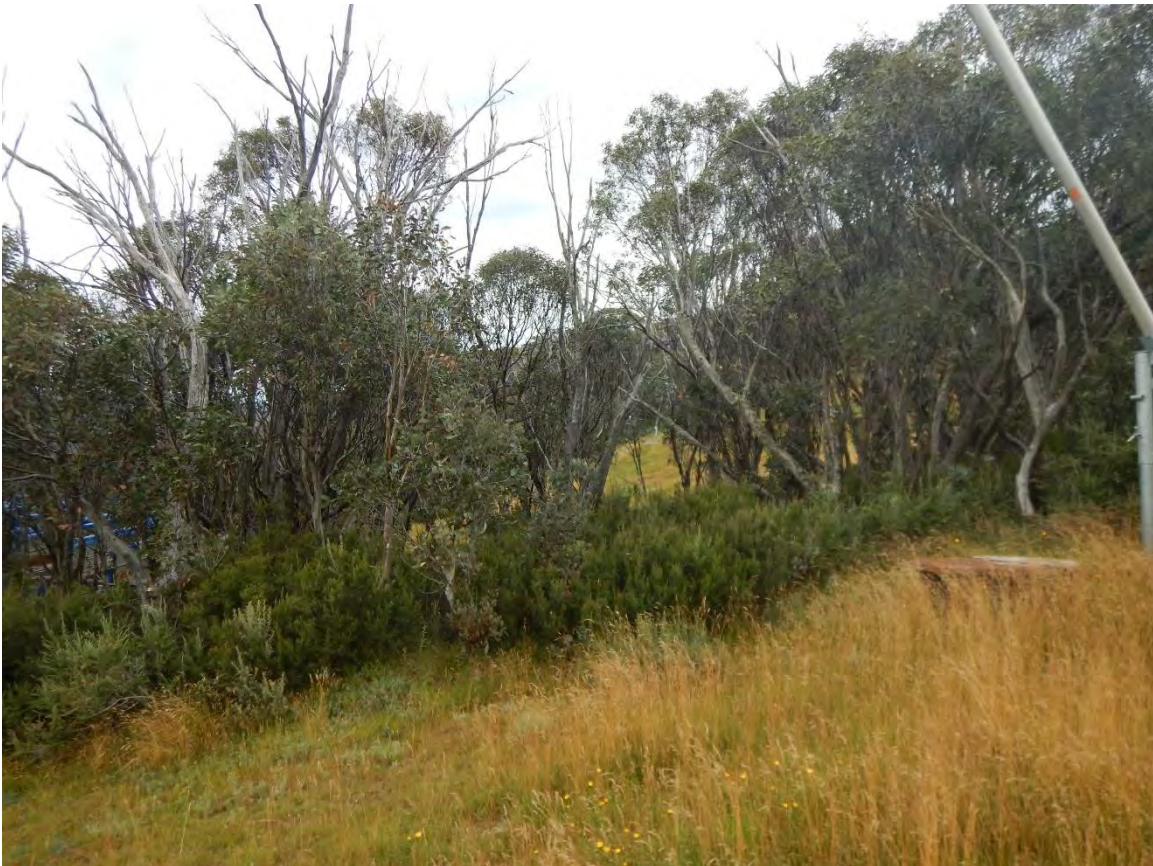
**Figure 6: Section 3 - Location of the permanent overpass structure within the tree island**

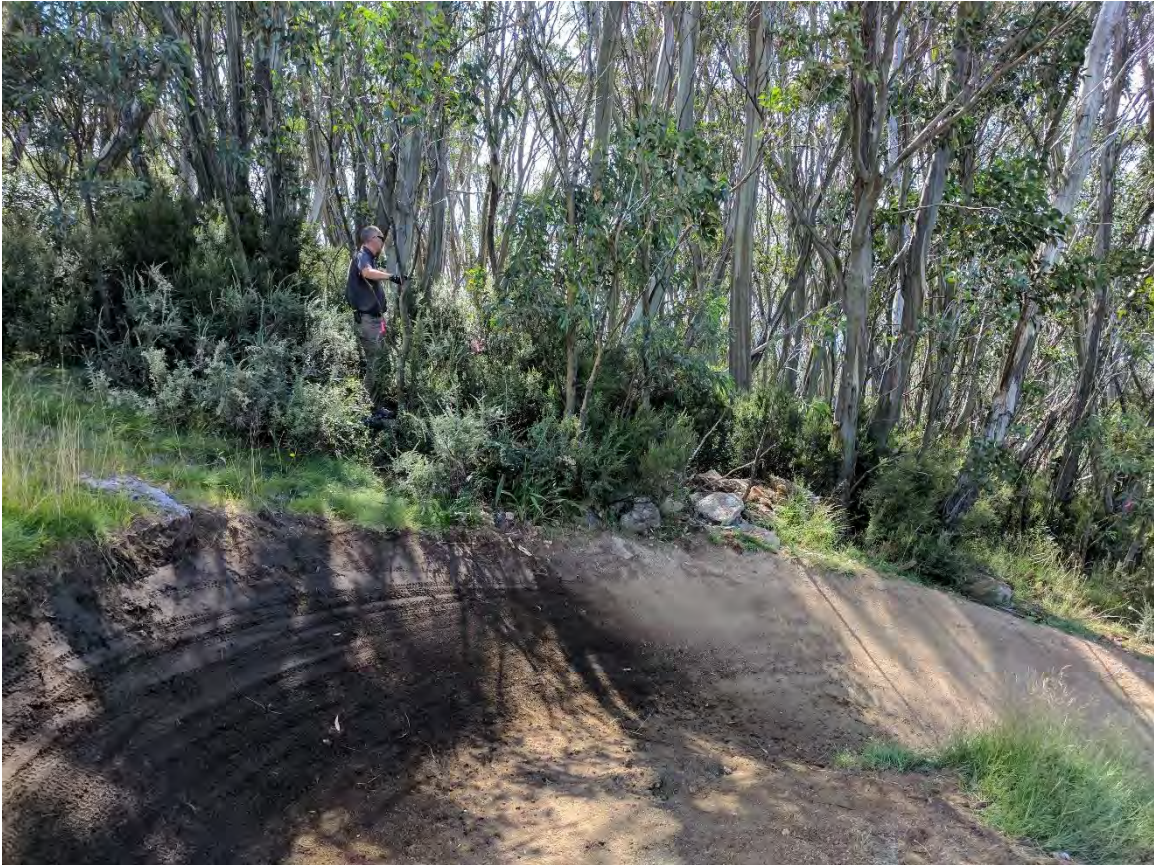
**Figure 7: Section 4 – Relocate the corner into the vegetation on the side of the ski run**

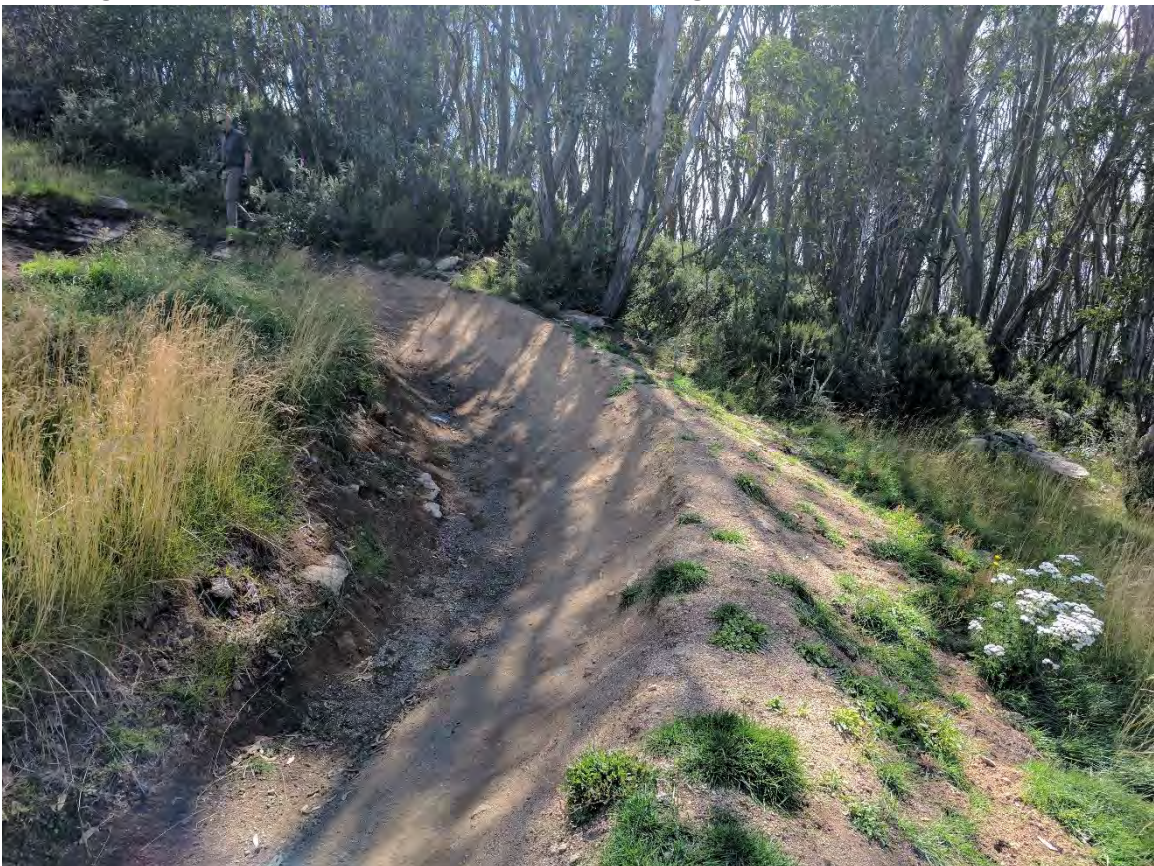
**Figure 8: Section 4 – Relocation of the corner will allow for this berm to be located off the ski slope**

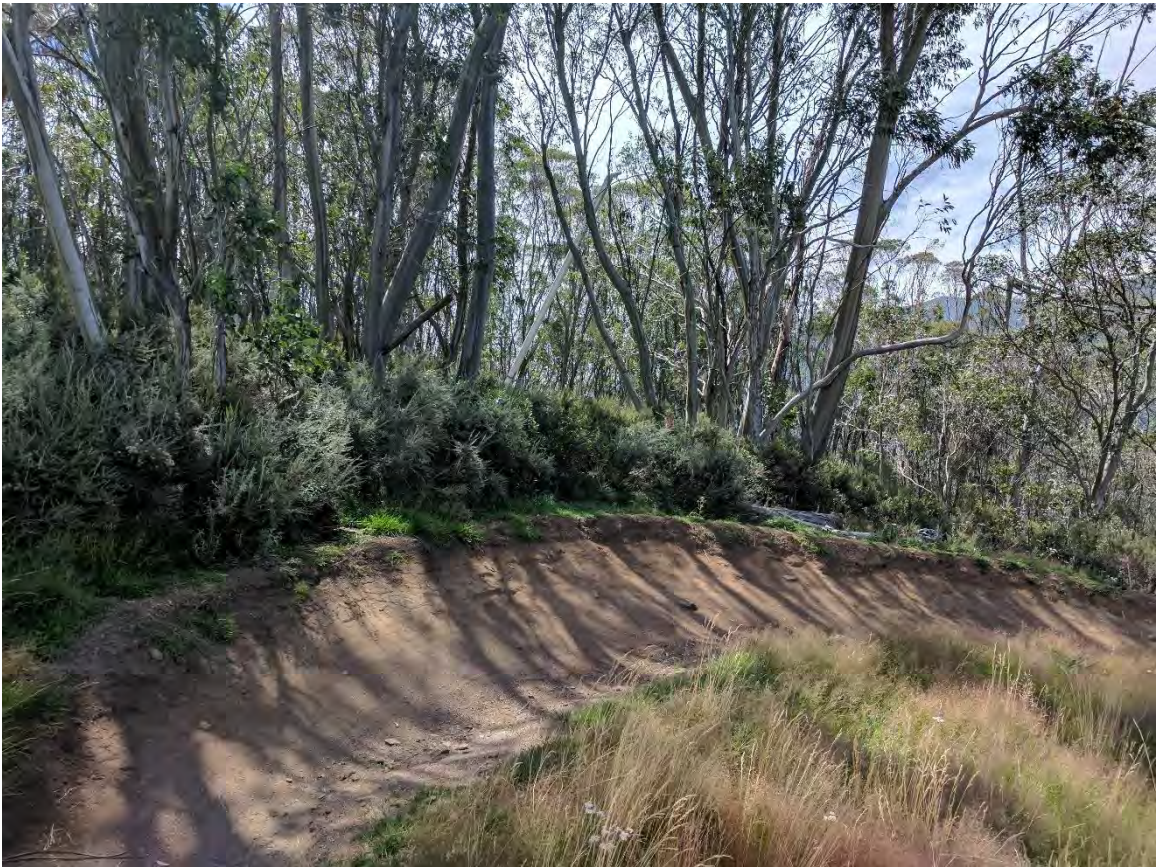
**Figure 9: Section 5 - Relocate the corner into the vegetation on the side of the ski run**

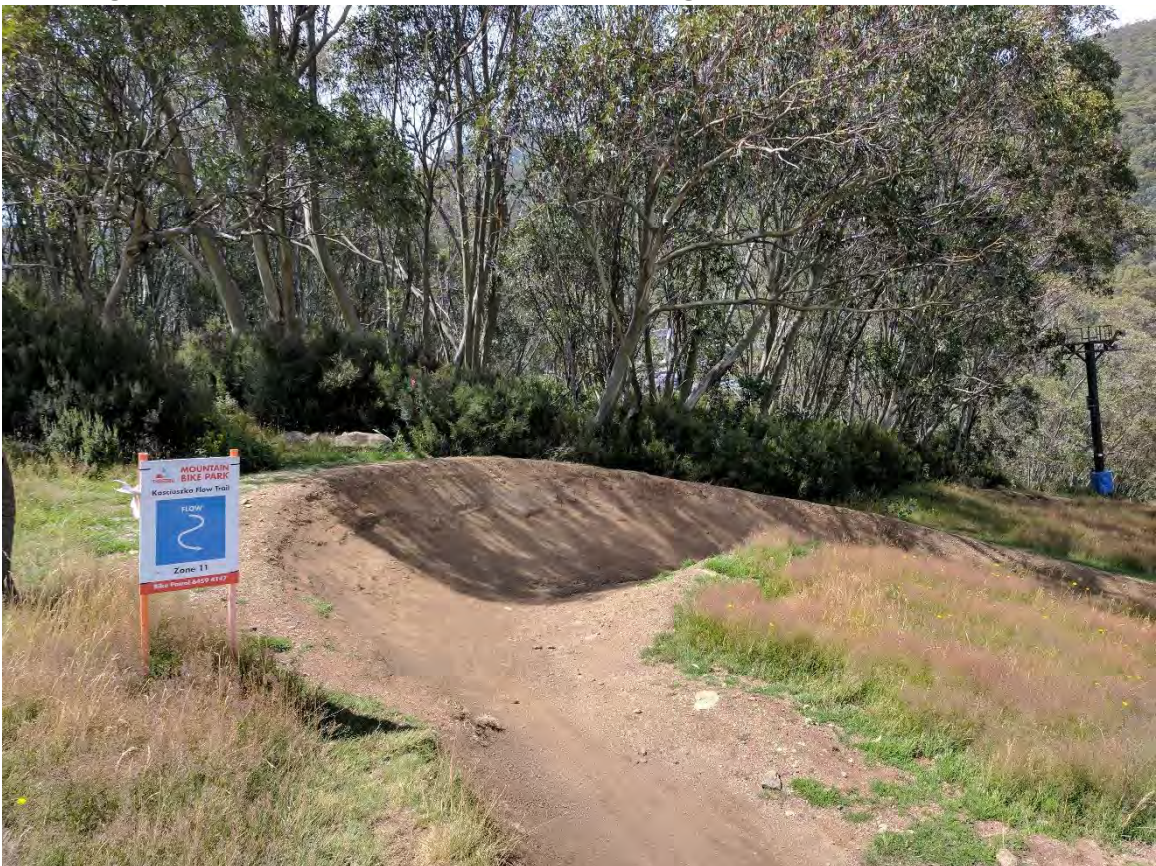
**Figure 10: Section 6 - Relocate the corner into the vegetation on the side of the ski run**

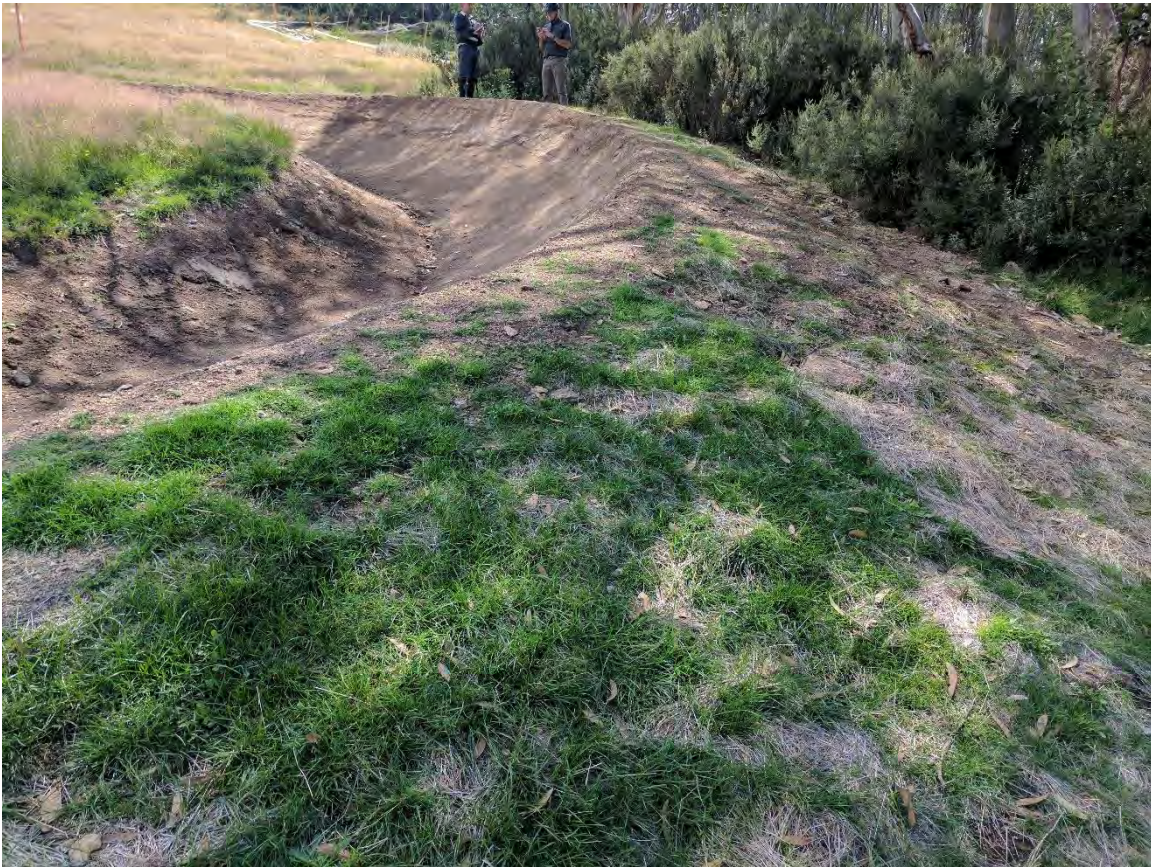
**Figure 11: Section 6 - Relocation of the corner will allow for this berm to be located off the ski slope**

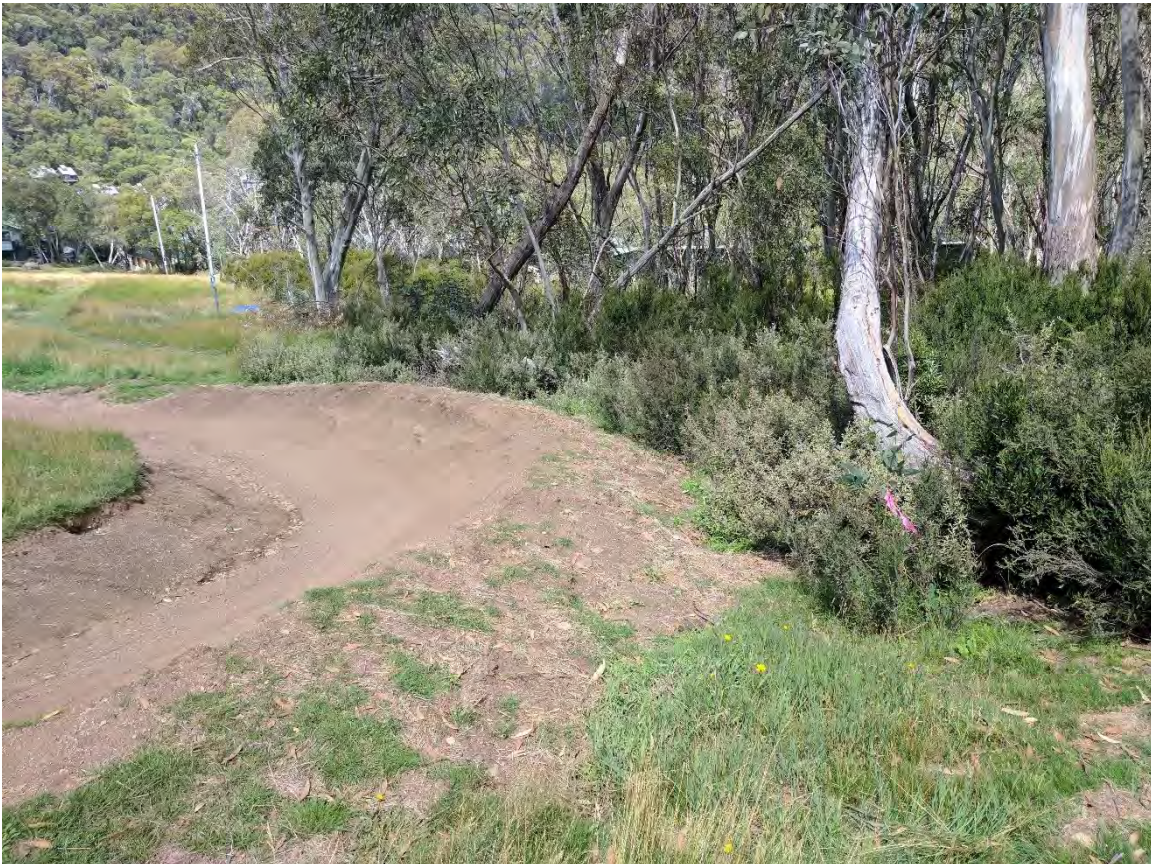
**Figure 12: Section 7- Relocate corner and berm off the ski slope into the vegetation on the side of the ski run**

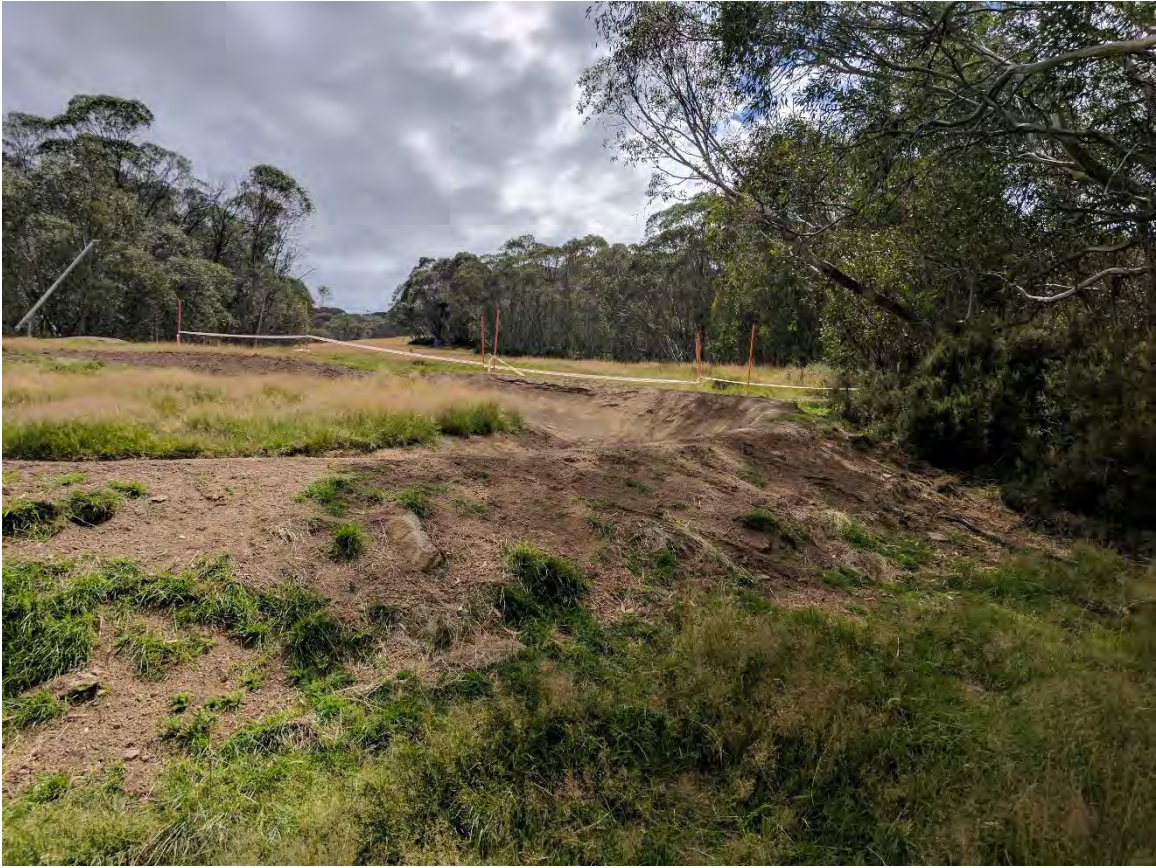
**Figure 13: Section 8 - Relocate corner and berm off the ski slope into the vegetation on the side of the ski run**
