This is a Bush Fire Protection Assessment for the proposed construction works on 'Athol Lodge' 7 Diggings Terrace, Thredbo NSW

ltem	Details			
Project	Bush Fire Protection Assessment, Proposed Alterations & Additions, 'Athol Lodge' 7 Diggings Terrace, Thredbo NSW 2627			
Version Number	First Edition			
File Located	fire_reportREV2.docx			
Date Last Saved	October 2013			
Author	Libby Pugh			
Review by	Nick Wilson			
Approved by	Andrew Fairfield-Smith Director

Bush Fire Protection Assessment Proposed Alterations Athol Lodge, Thredbo

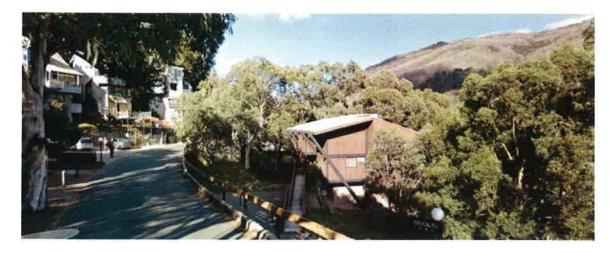
Substantial woodlands are located in a North-Westerly direction, down-slope, from the lodge, refer to Figure 4. Yet because this is outside the required Asset Protection Zone, more than 140m away, this vegetation is not considered to be a concern. This vegetation is also managed by National Parks and requires a sustainable environmental approach. Athol Lodge is surrounded wholy by National Park's land and management of this flora will be the main responsibility of National Parks. There is

**Figure 4** North-West view from Diggings Terrace displaying predominant vegetation located outside the Asset Protection Zone (Athol Lodge located to left of image).

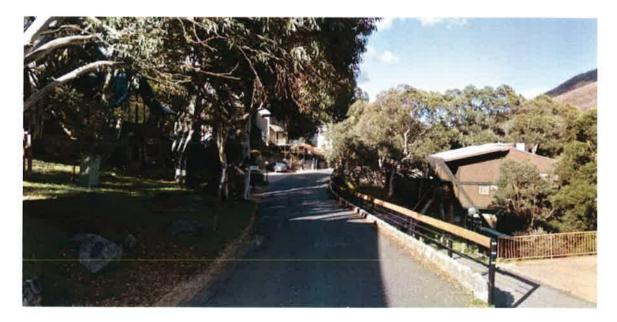
Figure 5 North-West view from Diggings Terrace showing Athol Lodge to the left of image.

There is a fire hydrant outlet located on the North East corner of the site, Refer to Figure 5

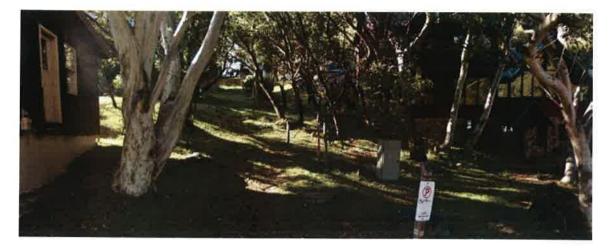
**Figure 6** South view from Diggings Terrace, showing woodland located approximately 8m upslope. Athol Lodge located to the right of image.

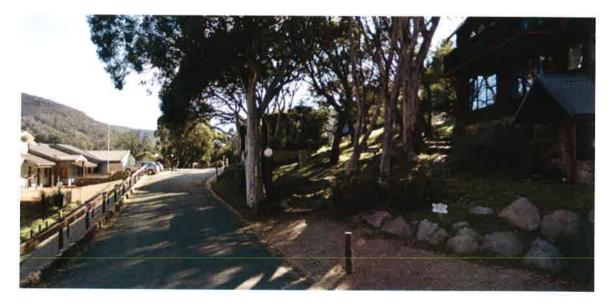
Figure 7 Eastern view from Diggings Terrace.

Within this APZ path there are a number of existing lodges, and vegetation conditions are alike to the North and South directions.

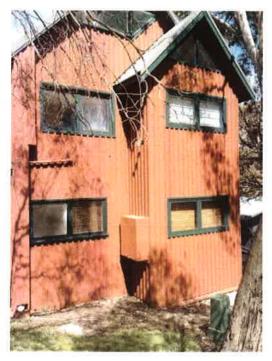
**Figure 8** Western elevation displaying the Electrical Switchboard.

Electricity to the dwelling is sourced through underground services, and the electrical sub-board is located within the existing buildings mess room / locker room. The main switchboard is located on the west elevation of the existing lodge. Refer to Figure 8 and Services Plan at end of this report.

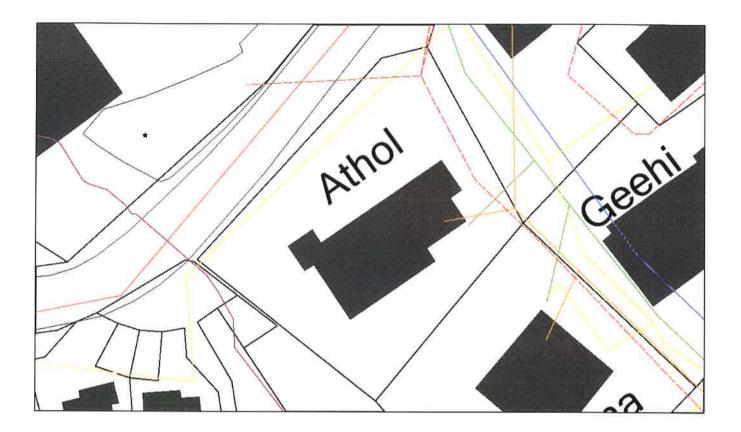
# **Athol Services**

NB. Due to the age of many of the services in the village these drawings represent their location to the best of our knowledge and we would recommend any excavation be done by hand.
