# Geotechnical Policy – Kosciuszko Alpine Resorts Form 4 – Minimal Impact Certification

**ON**  
**GEOTECHNICAL ASSESSMENT**

**FOR**  
**PROPOSED ALTERATIONS AND ADDITIONS**

**AT**  
**HOUSE OF ULLR,**  
**MOWAMBA PLACE, THREDBO, NSW**

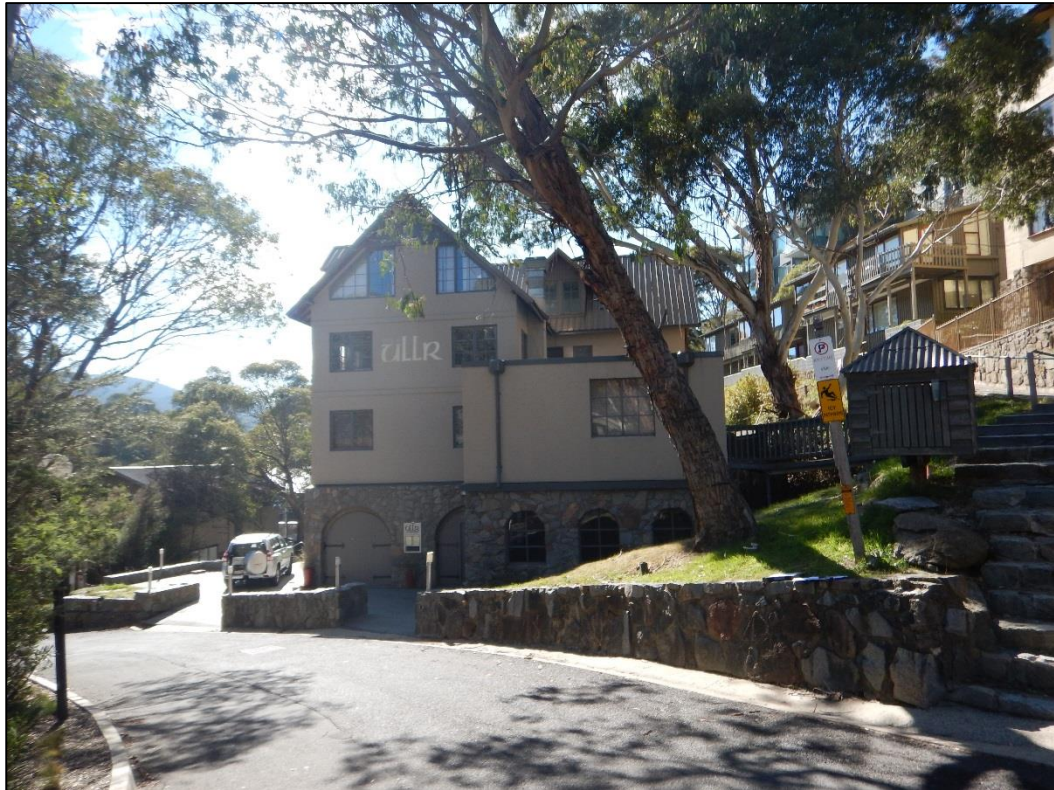
At the time of the fieldwork, the site was occupied by a two to four storey rendered concrete block and stone cladded building, which appeared to be in relatively good external condition based on a cursory inspection. Refer to Plate 1 below. The building appears to have been constructed on a platform formed by cut-to-fill earthworks. The area of cut was over the southern side of the building, whilst the area of fill was located to the north of the building. A granite boulder retaining wall supported the cut into the hillside on the southern side of the building to a maximum height of about 2.2m. A granite boulder and masonry retaining wall supported the northern and western

Plate 1: Western elevation of House of Ullr

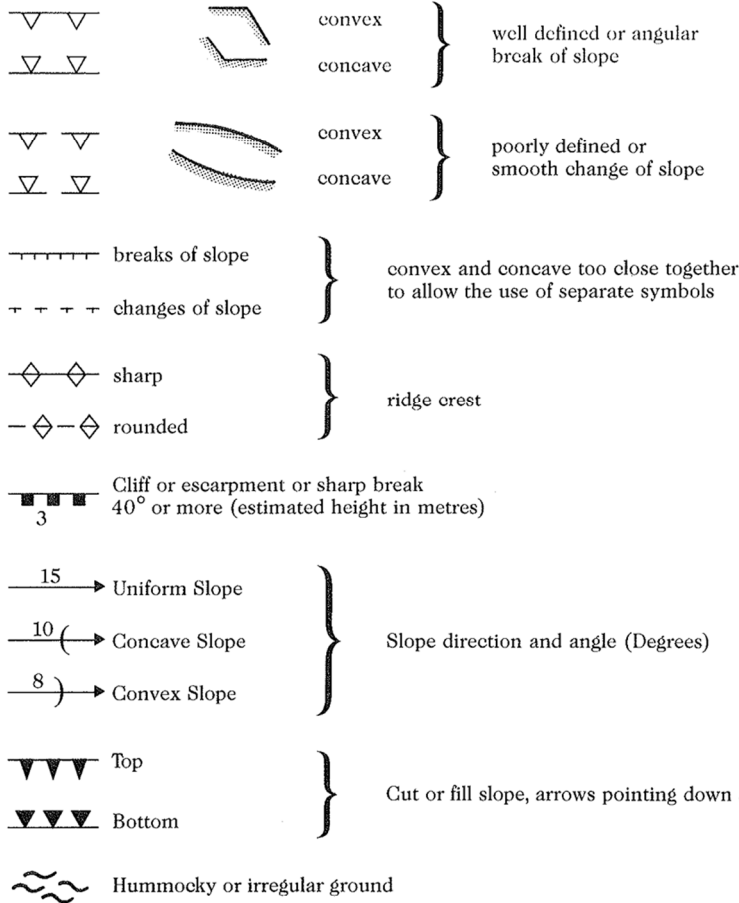
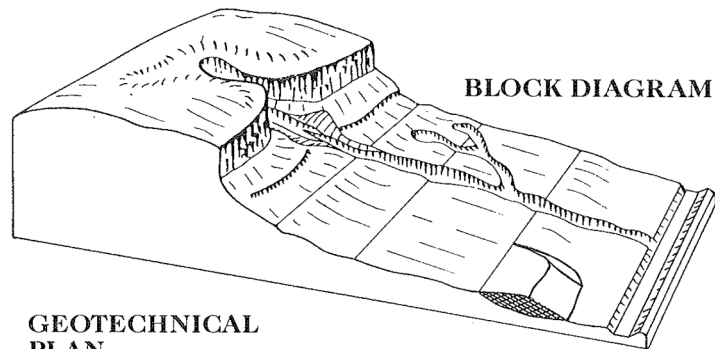
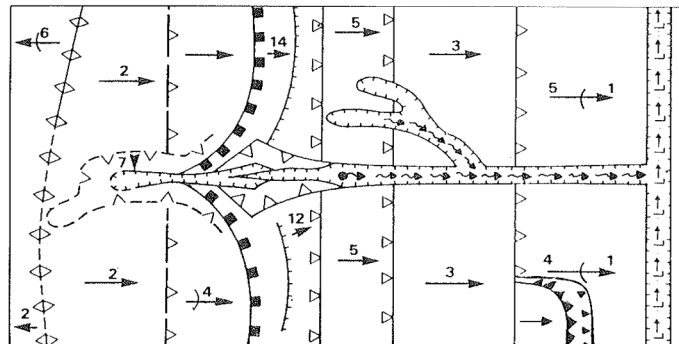
# GEOTECHNICAL MAPPING SYMBOLS

## EXAMPLE OF USE OF TOPOGRAPHIC SYMBOLS:

GEOTECHNICAL PLAN

Figure 2 presents details of the geotechnical mapping terms and symbols used in Figure 1. The slope angles in Section 3.1 were measured by hand held clinometer and hence are only approximate. We note that should any of the geotechnical features referred to below in Section 3.1 be critical to the proposed alterations and additions, we recommend they be located more accurately using instrument survey techniques.
