ATTACHMENT B

Ref/Job No: 15NAR_3373

RE: Trail 12 Alternate Alignment Inspection – DA 6751 Stage 1B MTB - Thredbo Alpine Resort

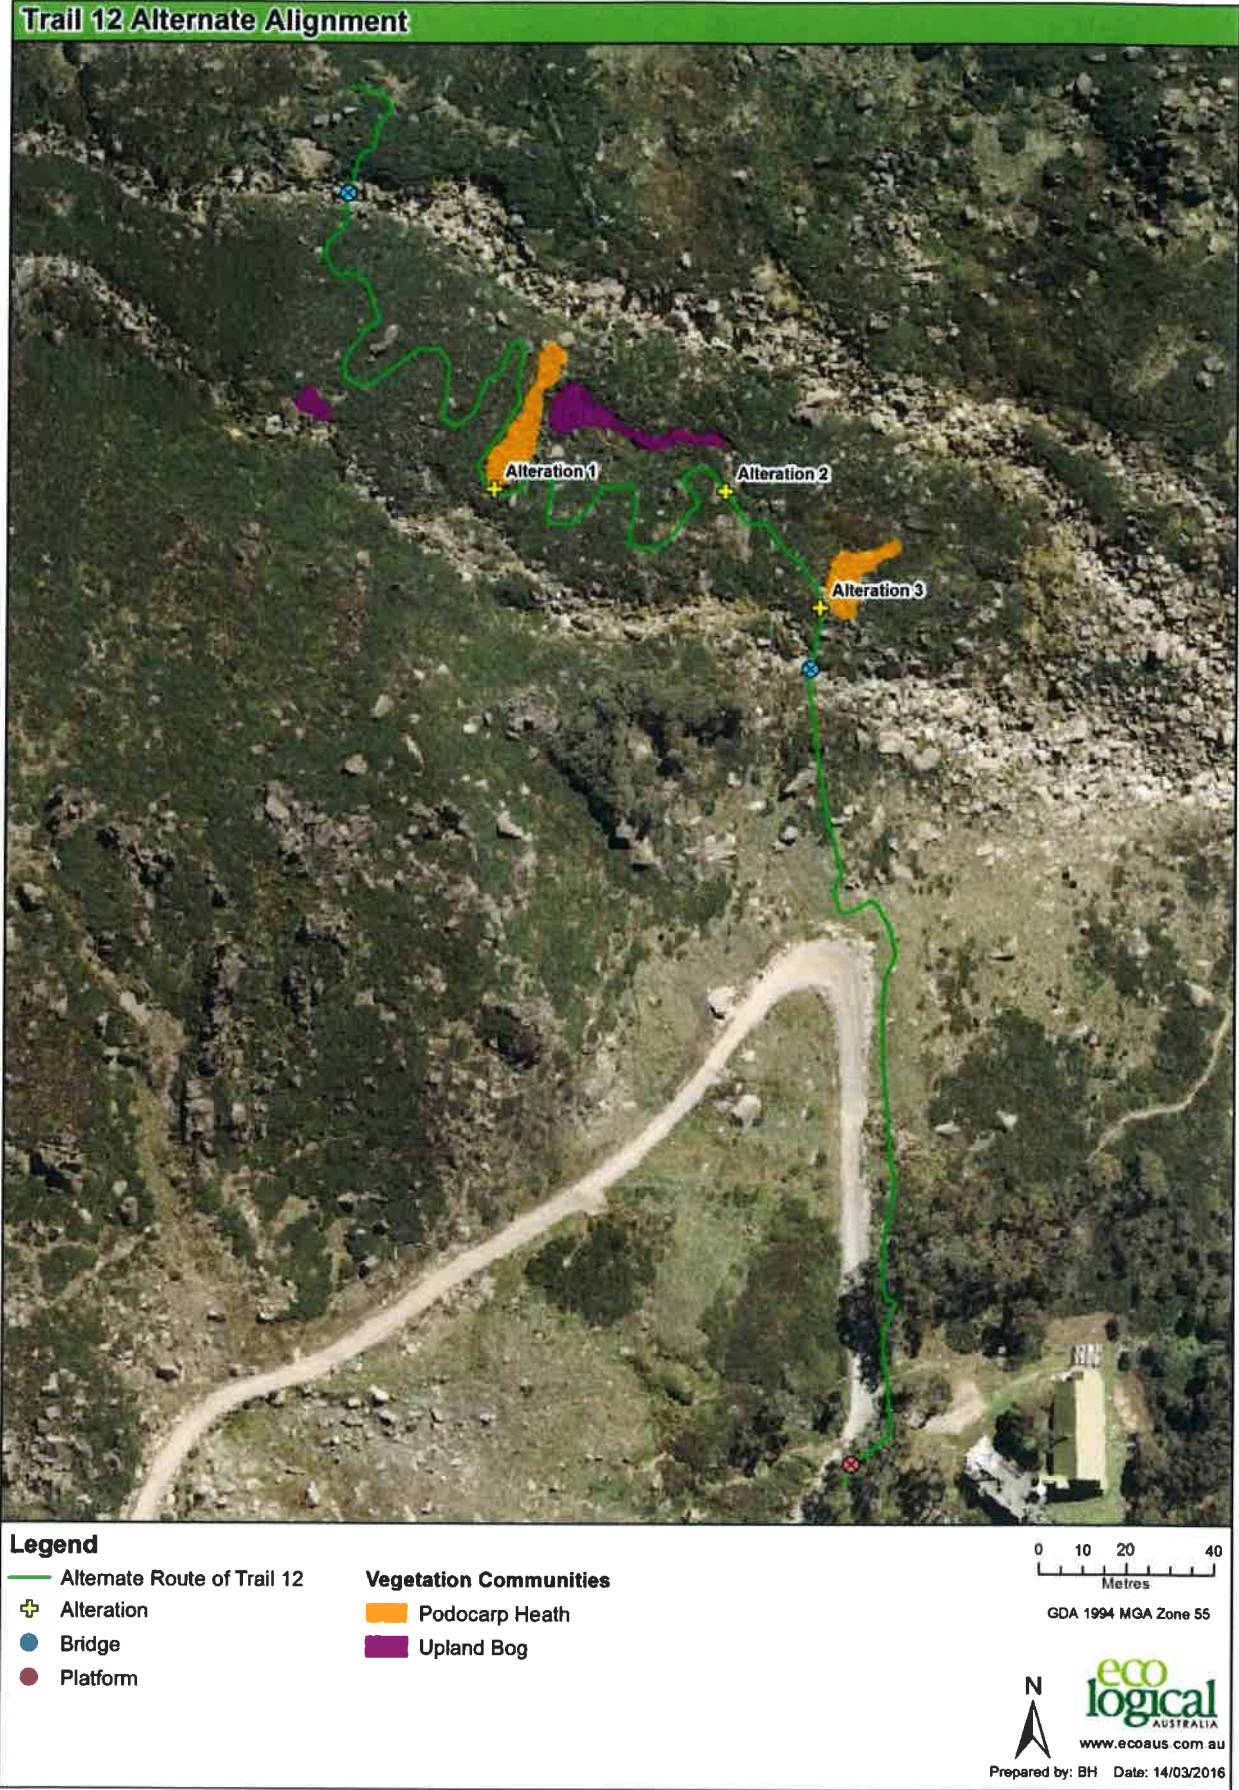
Figure 1: Trail 12 alternate alignment.

As requested I have completed an inspection of the proposed alternate alignment of Trail 12, as flagged by DirtArt and identified in **Figure 1**. The inspection was undertaken on 8 March 2016 over a period of approximately four hours. The results of the inspection are presented below.

The alignment does not impact on any Upland Bog, although there are small areas of Upland Bog near the alignment in two locations, as shown in **Figure 1**. There are a couple of plants of *Richea continentis* where the alignment is in the batter to the Summer Road adjacent to the Snow Gums restaurant, as shown in **Photo 4**. These plants are not considered to be of any conservation significance given that the vegetation within the proposed alignment is highly disturbed in that area. The Summer Road traverses the toe of a patch of Upland Bog in this area, as shown in **Photo 5**, and the parts above the road remain in good condition. The Upland Bog does not extend significantly below the Summer Road and the *Richea continentis* plants below the road are restricted to the edge of the road batter. The proposed alignment, whilst it will result in the removal of a couple of *Richea continentis* plants, will have less impacts on vegetation and fauna habitats than any alternative through this area.

Whilst there are two small areas of Podocarp Heath immediately adjacent to the alignment, as shown in **Figure 1** and **Photo 6**, recommended minor modifications to the alignment will ensure that the alignment will not impact directly upon this community.

- It is recommended that the alignment be modified slightly so that the alignment does not affect the areas of Podocarp Heath, as shown in **Photo 7** and **Photo 8** and **Figure 1** (Alterations 1 and 3).
- It is recommended that the alignment be modified slightly so that the alignment does is further from a minor watercourse, as shown in **Photo 9** and **Figure 1** (Alteration 2).

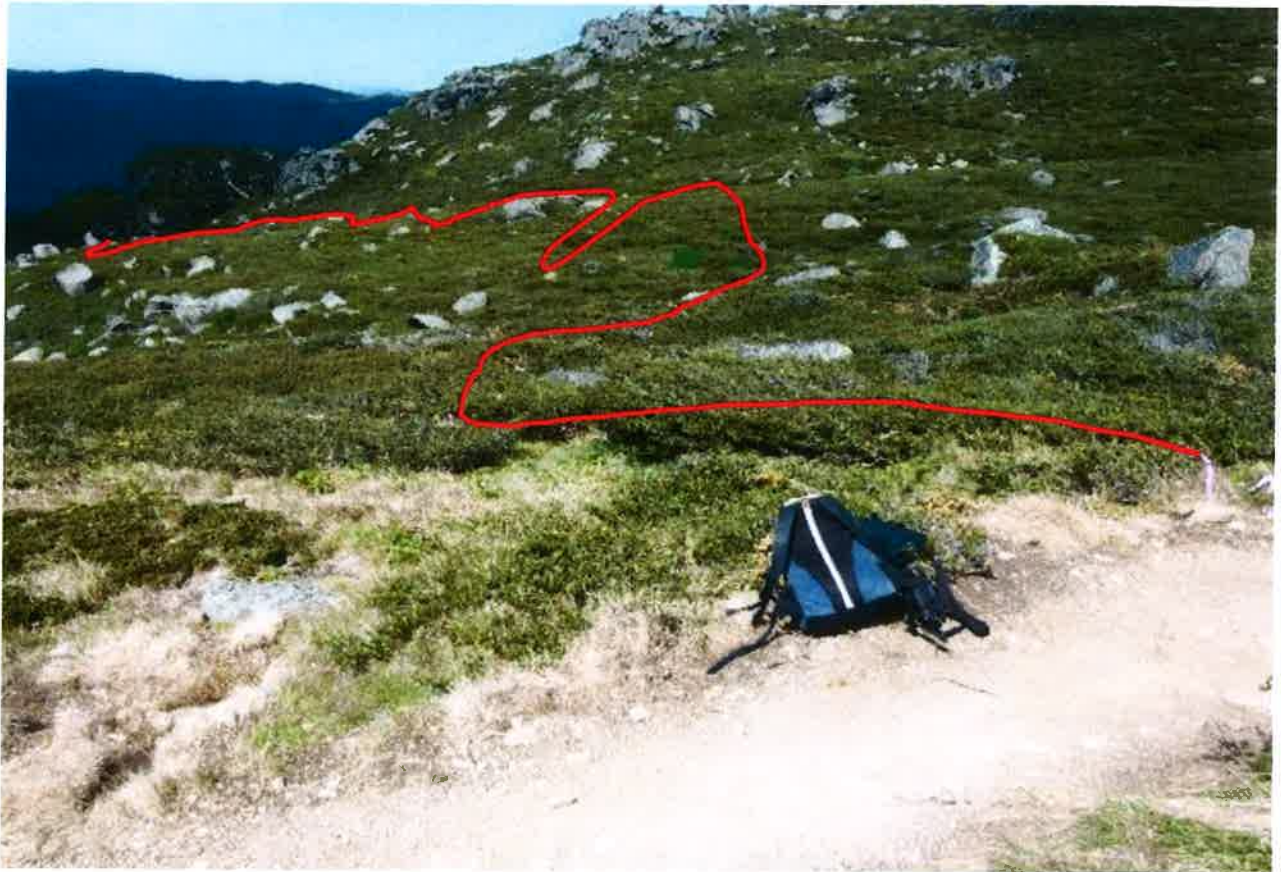
The impacts on vegetation communities are very similar to the approved trail alignment. The proposed trail alignment primarily traverses the Tall Alpine Heath without Eucalypts vegetation community, as shown in Photo 1. The Tall Alpine Heath without Eucalypts vegetation community is extensive in the area. Where the alignment traverses Merritts Creek there are narrow bands of Alpine Stream Complex, however the impact on this community will be negligible given that two bridges are proposed to span the creek. As with the approved trail, there is a small area of Snowpatch towards the lower end of the alignment as shown in **Photo 2**. The vegetation is highly disturbed and primarily exotic where the alignment is within the batter to the Summer Road, as shown in **Photo 3**.

Photo 1: The proposed alignment is almost entirely within Alpine Heath without Eucalypts.

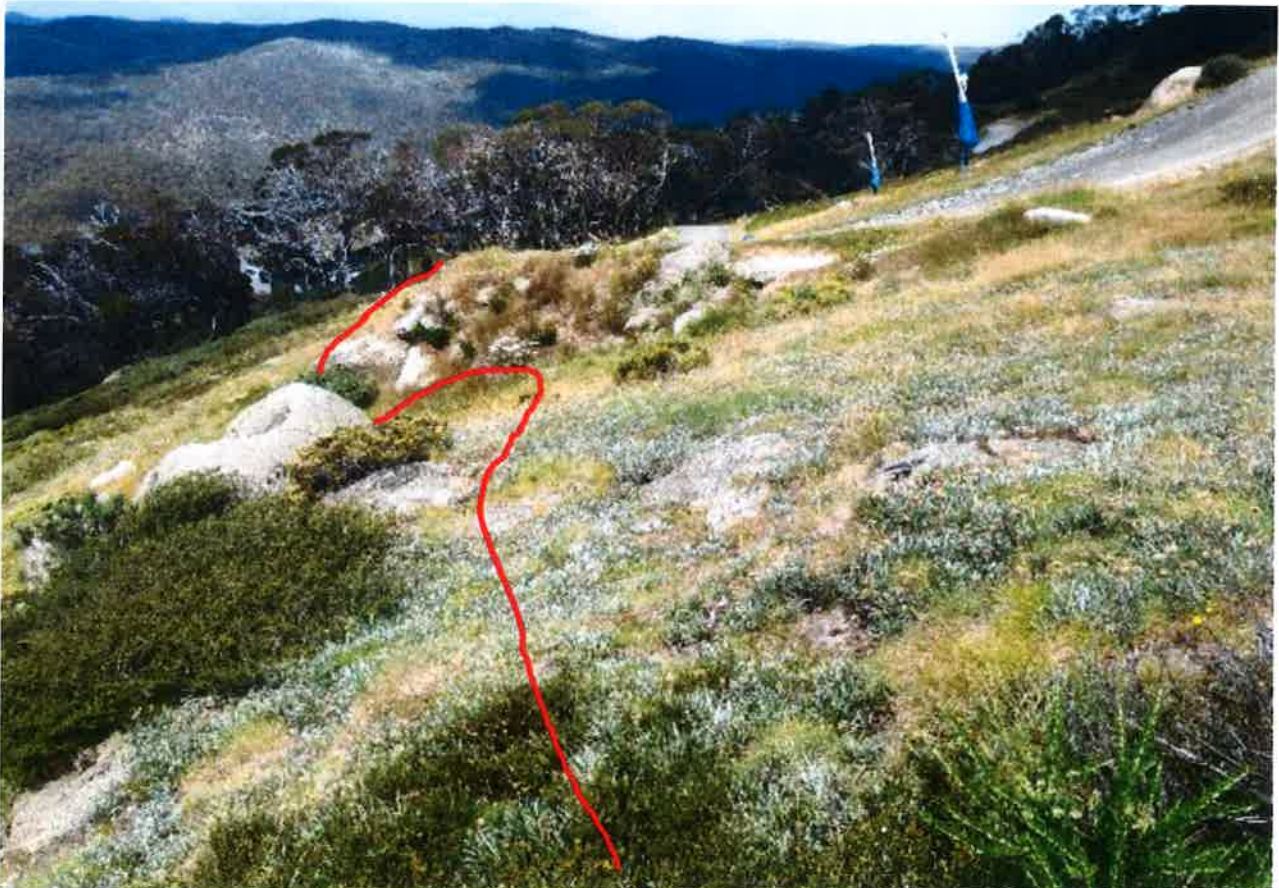
Photo 2: The proposed alignment traverses a small area of Snowpatch near the Summer Road.

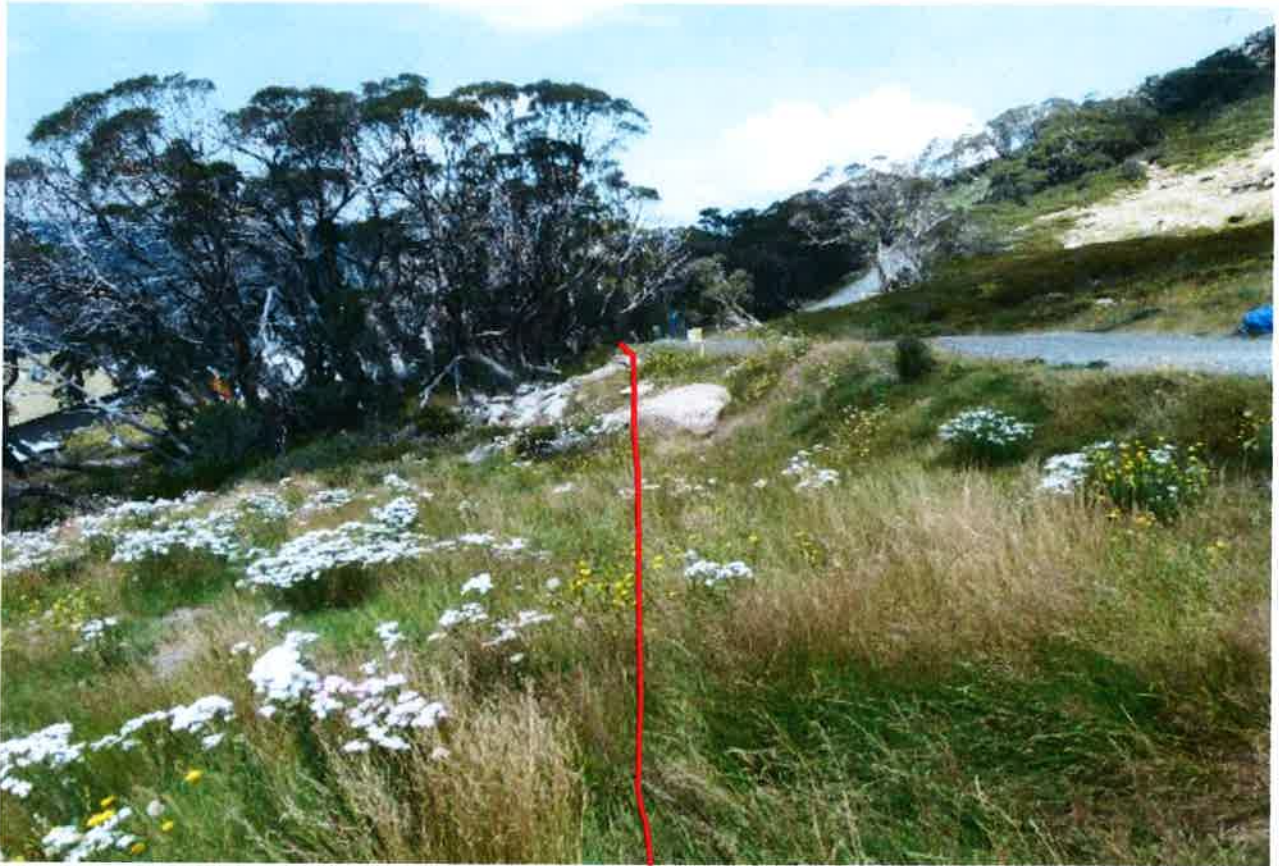
Photo 3: The lower parts of the proposed alignment traverse primarily exotic vegetation.

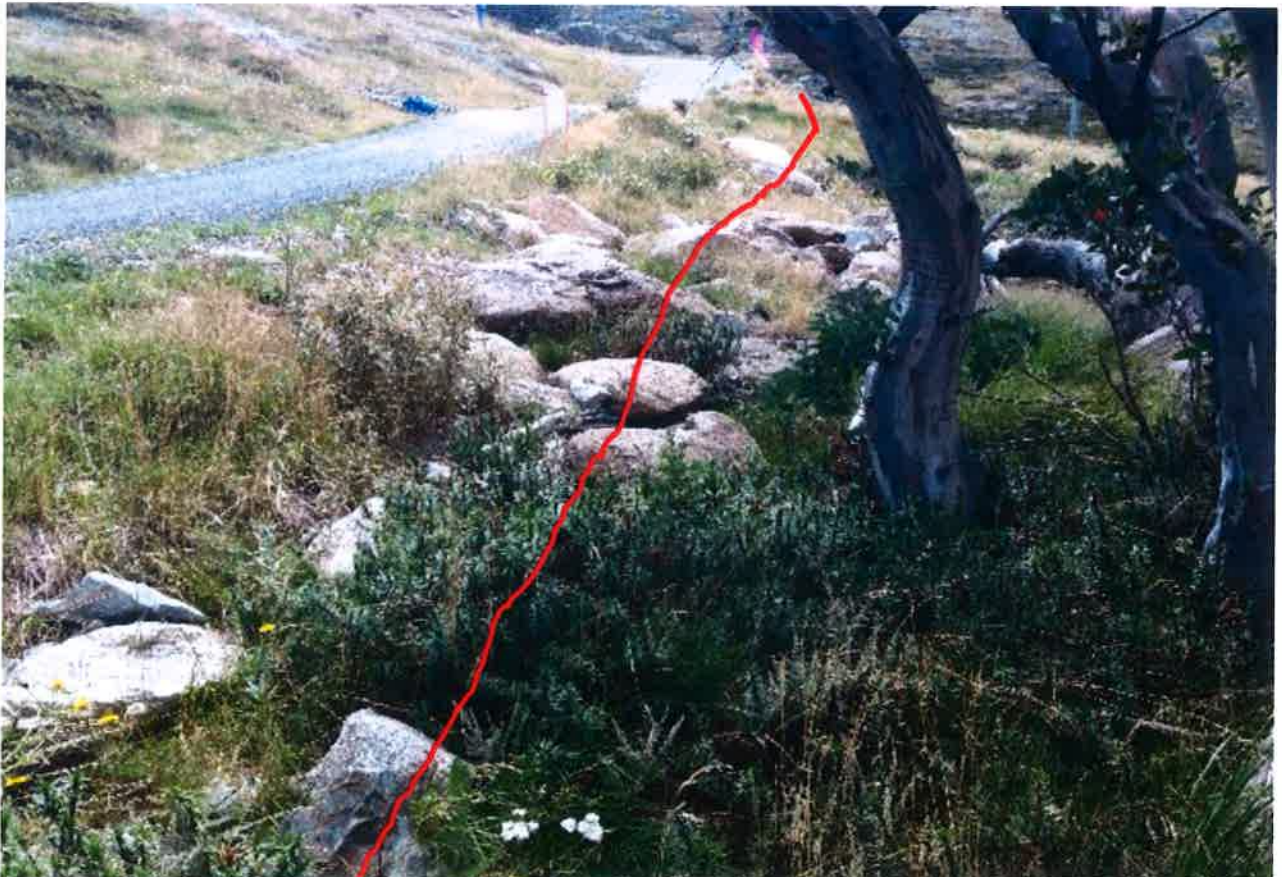
Photo 4: The proposed alignment will affect a few plants of *Richea continentis* growing on the batter to the Summer Road.

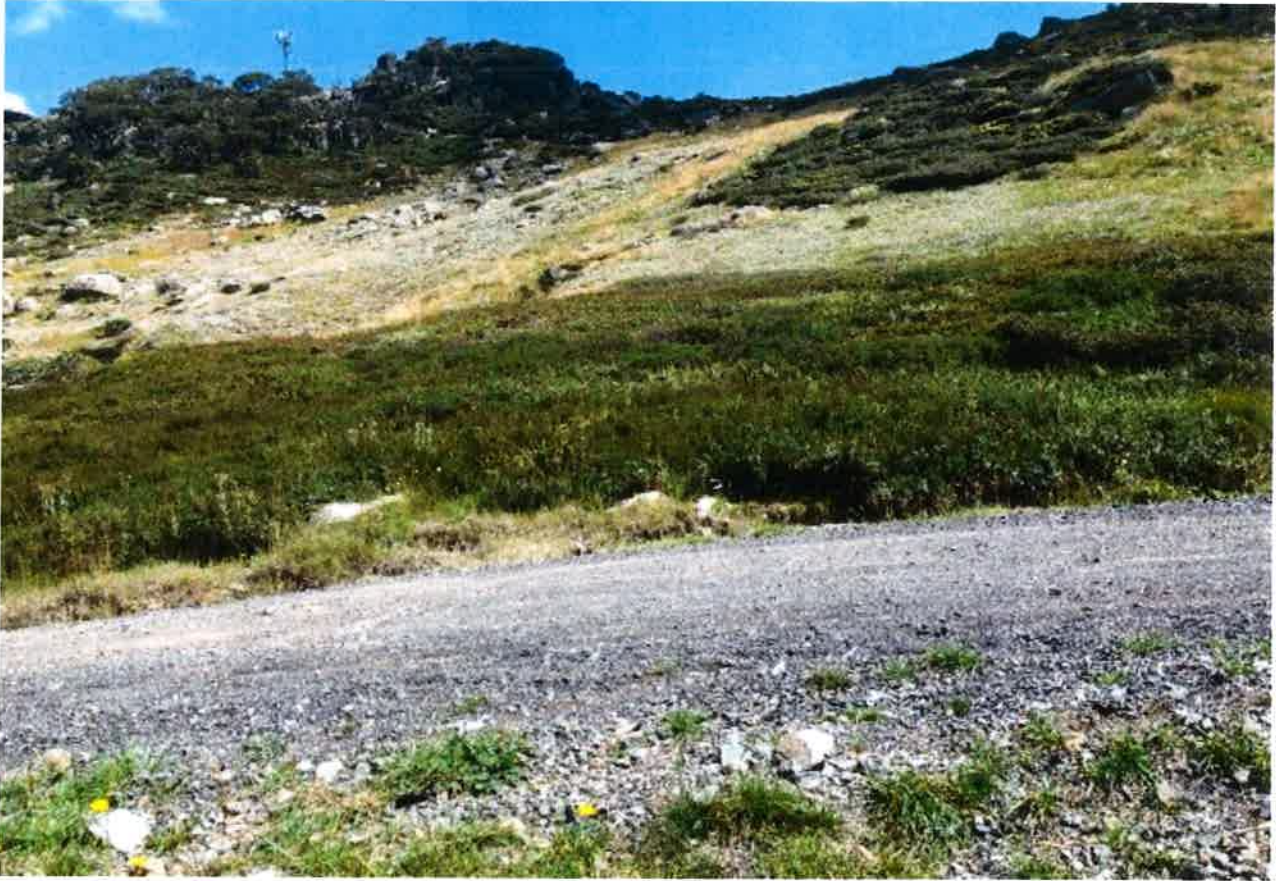
Photo 5: The Upland Bog above the Summer Road remains in excellent condition.

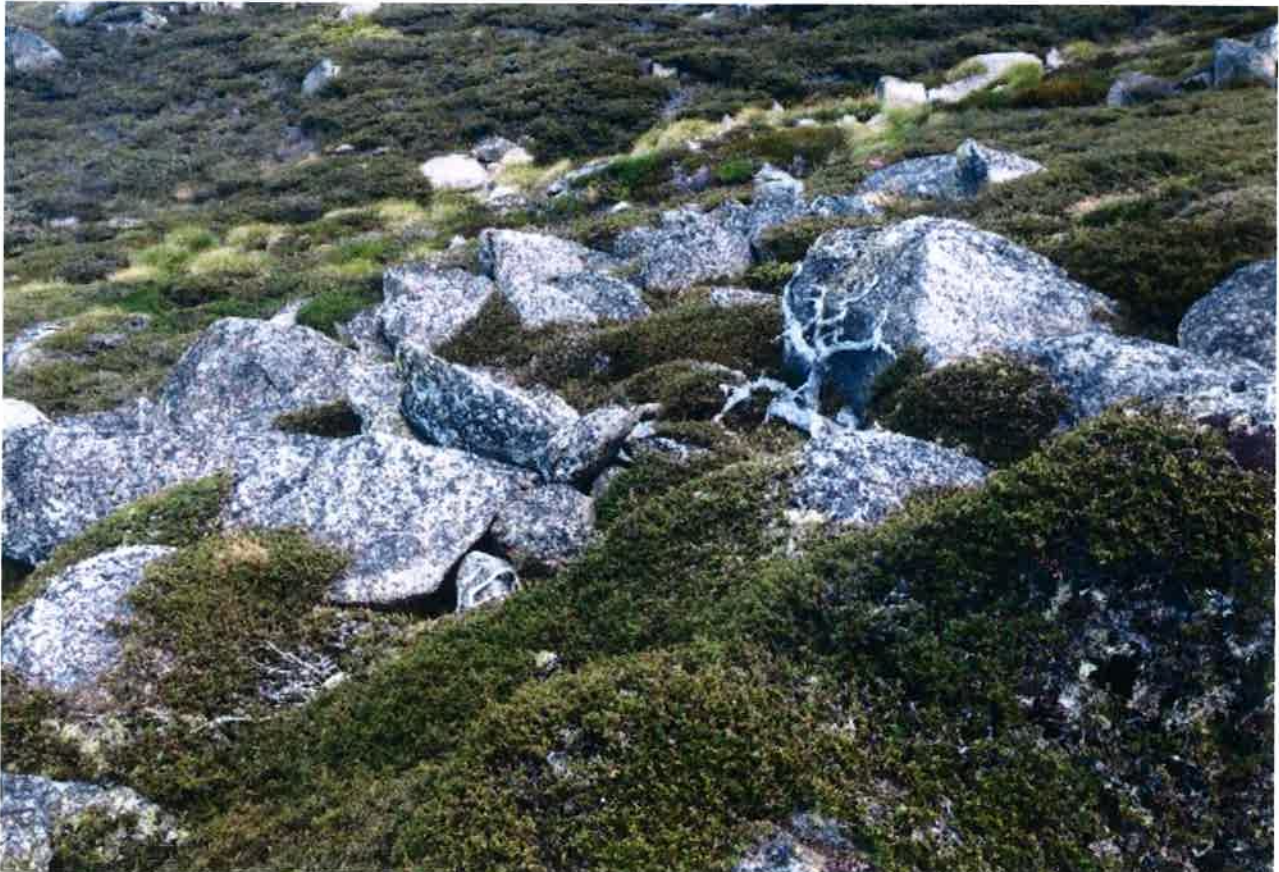
Photo 6: The proposed alignment will avoid direct impacts to the small patches of Podocarp Heath which occur in two locations adjacent to the alignment.

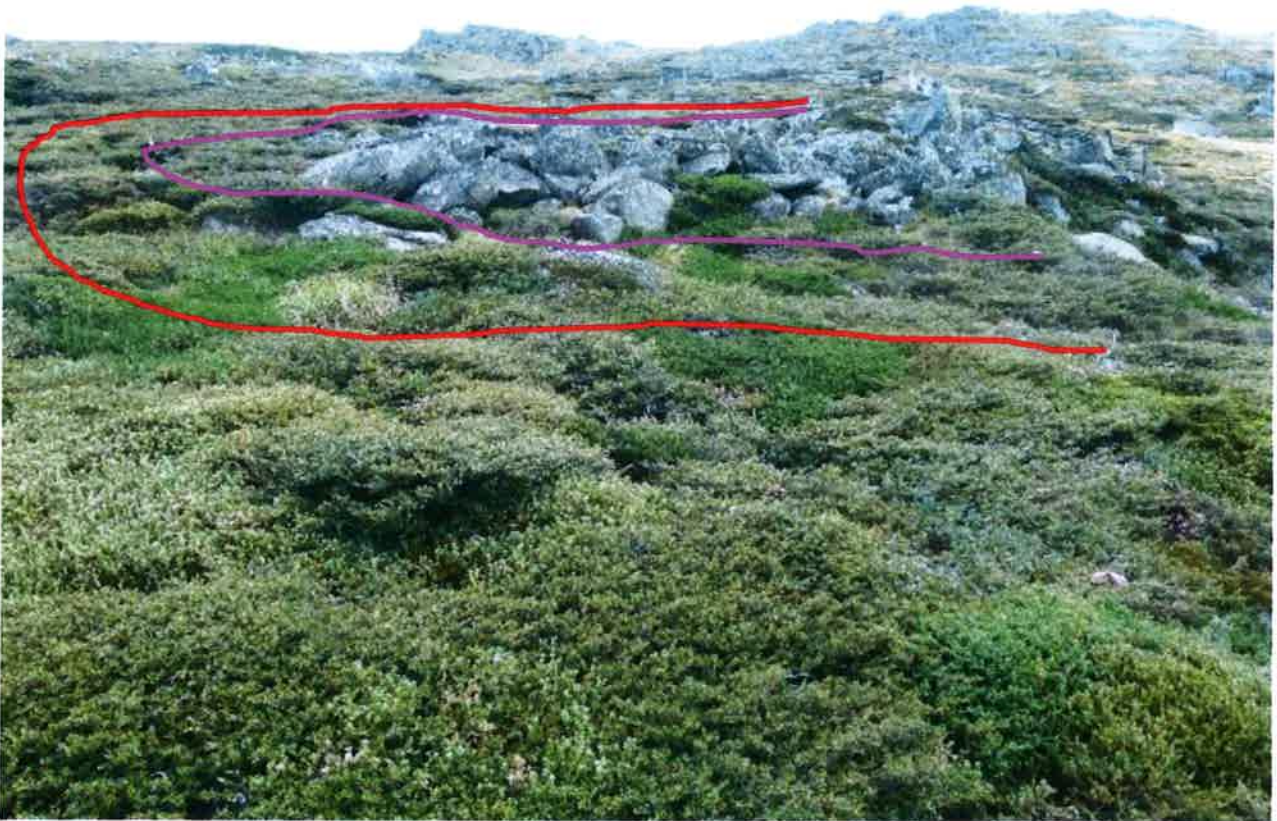
Photo 7: It is recommended that the alignment be modified slightly, along the lines of what is indicated by the red line, to further buffer the Podocarp Heath from the trail alignment (as indicated by the pink line).

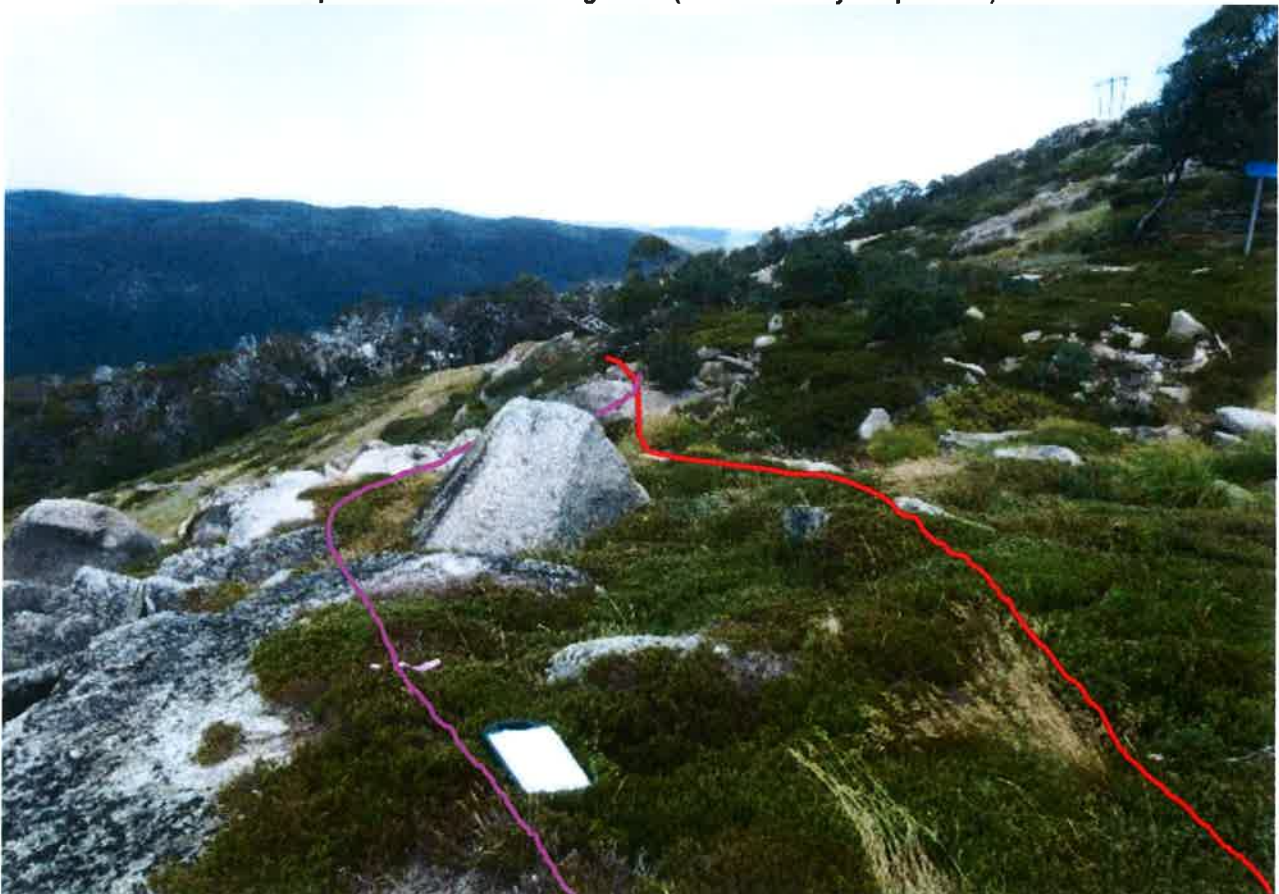
Photo 8: It is recommended that the alignment be modified slightly, along the lines of what is indicated by the red line, to further buffer the Podocarp Heath from the trail alignment (as indicated by the pink line).

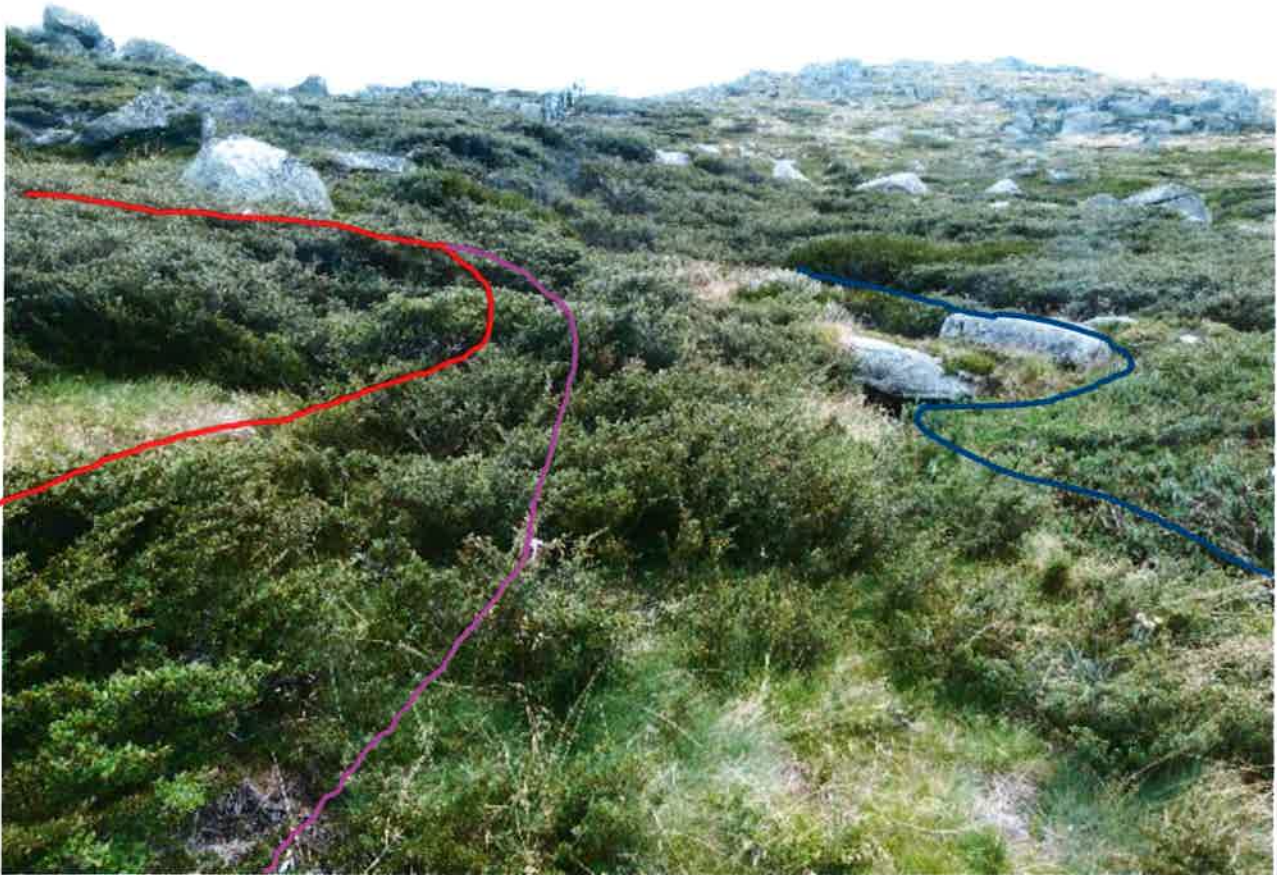
Photo 9: It is recommended that the alignment be modified slightly, along the lines of what is indicated by the red line, to further buffer the minor watercourse (blue line) from the trail alignment (as indicated by the pink line).
