Aboriginal Cultural Heritage Due Diligence Assessment

FRIDAY FLAT CARPARK PROPOSED EXTENSIONS

Report Prepared for Event Hospitality Pty Ltd

20th December 2018

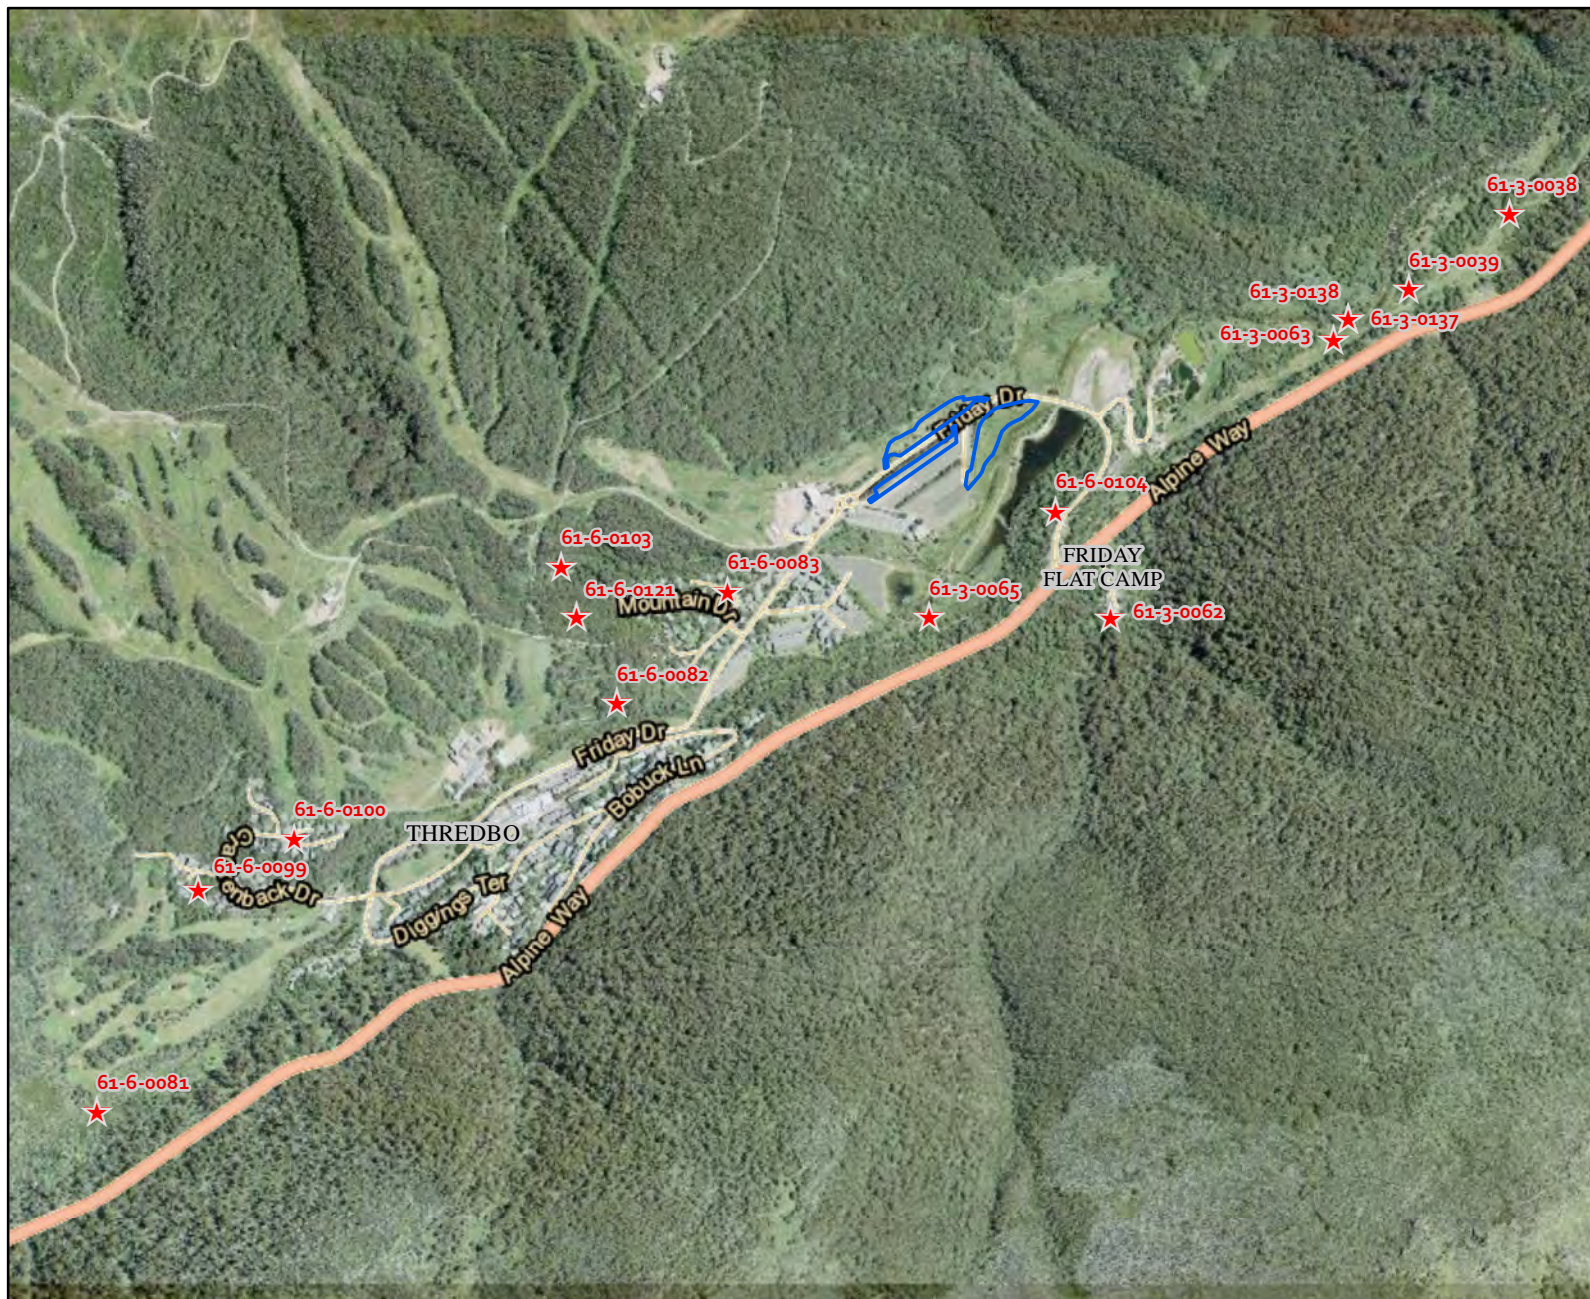
Figure 3: AHIMS

The majority of all sites located in the region consists of low density artefact scatters or isolated finds. The location of previously recorded sites is shown in Figure 3.

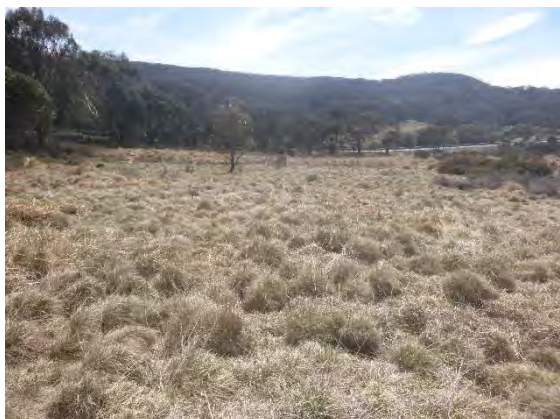
GSV over most of the study area was very low due to the high levels of vegetation and grass coverage. Exposures were present at low frequency across the project areas consisting of levelled areas, pedestrian walking trails and mountain bike trails. The conditions at the time of the site visit are shown in plate 1.

Plate 1: view north across Carpark 3 - low GSV with planted trees along road verge

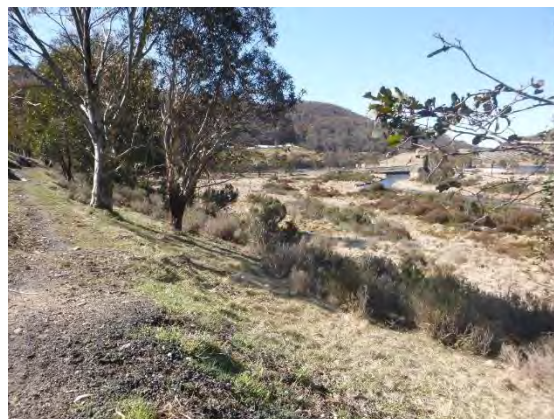
Plate 2: view north east along Thredbo River flats to carpark 3 location showing constructed bank to carpark

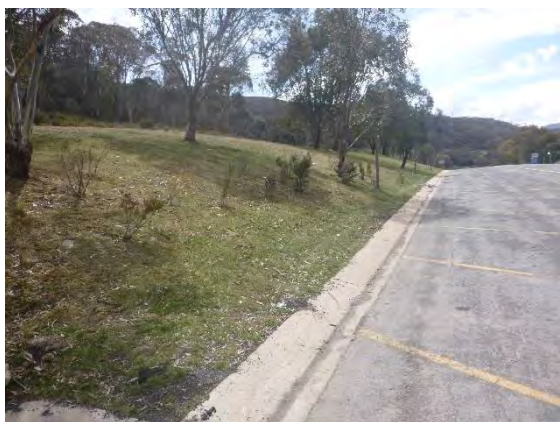
Plate 3: view east along Carpark 2 area

The degree of disturbance varied across the two car park areas (Carpark 2 and Carpark 3). Disturbance appeared to be high across the area of Carpark 2, located adjacent to the north of Friday Flat Drive. Disturbances were present in the form of prior vegetation and tree removal, construction of mountain bike and pedestrian trails and Friday Flat Drive. The landform appeared to have been shaped to provide level to gentle gradient access to walking trails and has been planted with grass and rows of trees along the verge of Friday Flat Drive. The excavation for the road access and the land shaping along the verges would have removed or deposited soils in this area removing archaeological potential for site retention. Blue metal and gravels are visible in several locations along the road verge on the slopes.

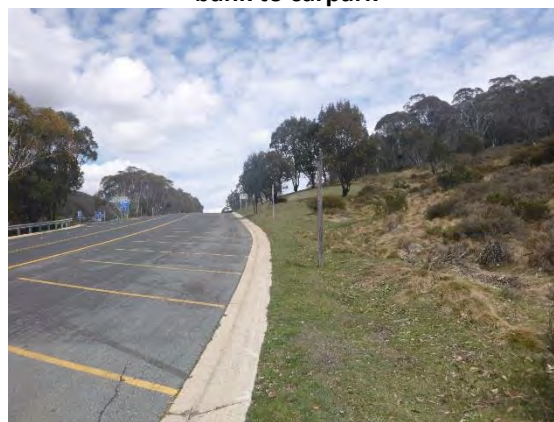
Plate 4: view west along carpark 2 area

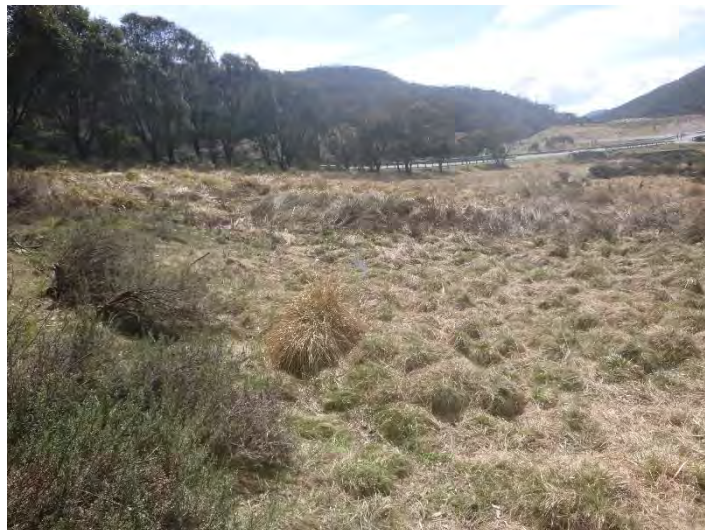
Disturbance appeared to be low across the river flats proposed for Carpark 3. The flats were wet and marshy on the day of field survey with clear water channels through the vegetation. Being low lying and just above the river line this area would be currently subject to flood events. The marshy conditions would not have been conducive to Aboriginal camping or gathering as sites are generally located in well drained, elevated contexts above water lines. This area is considered to hold low potential for any unrecorded heritage sites to be present in a subsurface context.

Plate 5: area of river flats showing standing water through grasses.
