**RE: PROPOSED NEW TELECOMMUNICATIONS FACILITY: OPTUS SITE S3176 – A (BLUE COW),
SKI TUBE TERMINAL, BLUE COW, NSW.**

Geotechnical Investigation:
TELSTRA SITE 41627
KOSCIUSZKO NTNL PARK BLUE COW -
Perisher Blue Cow Link Rd, Kosciuszko
National Park, NSW

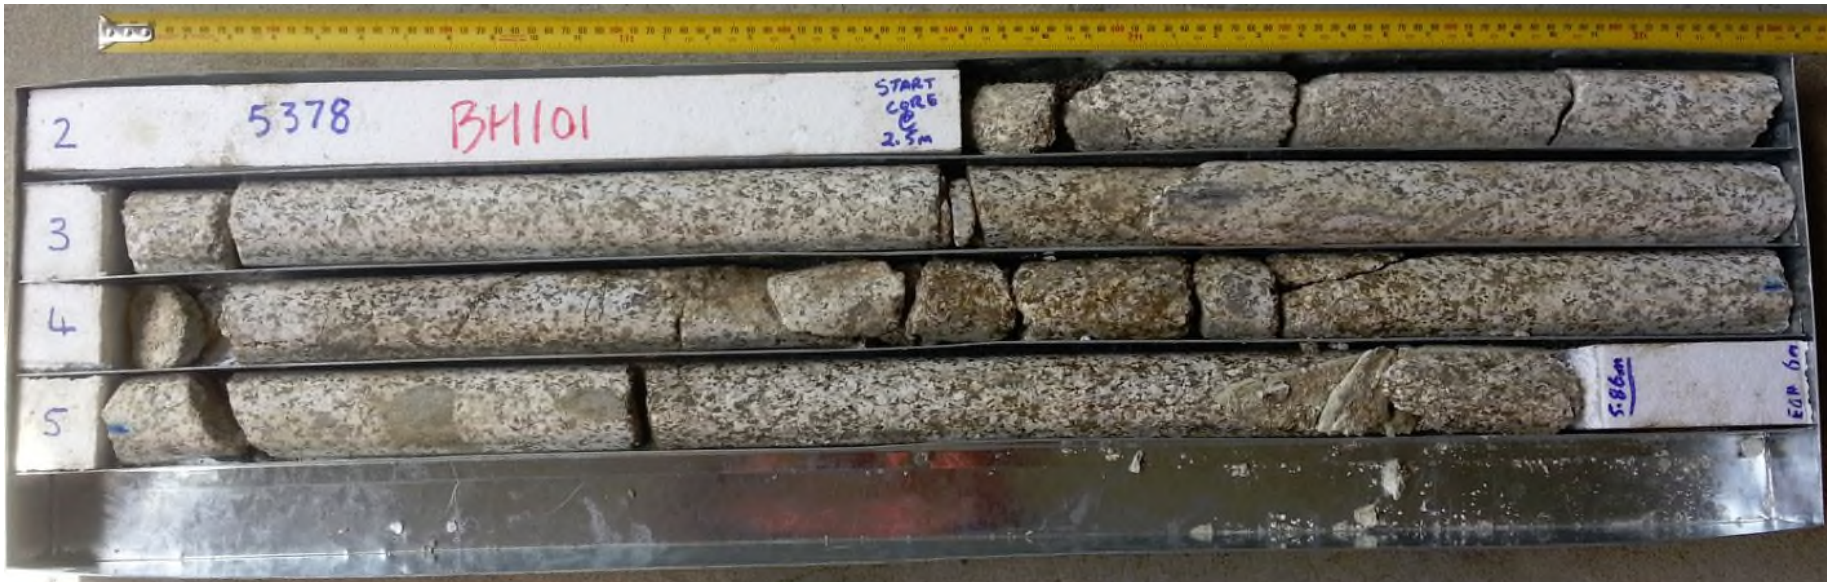
9 Attachment D – Rock Core Photo

MARTENS & ASSOCIATES P/L
 PROJECT: P1605378
 BOREHOLE: BH101 DEPTH: 2.50m – 6.00 m DATE: 02.11.2016

Martens & Associates Pty Ltd ABN 85 070 240 890		Environment Water Wastewater Geotechnical Civil Management	
Drawn:	SZ	PHOTO OF ROCK CORE TELSTRA SITE 41627 KOSCIUSZKO NTNL PARK BLUE COW Perisher Blue Cow Link Rd, Kosciuszko National Park, NSW	
Approved:	RE		
Date:	16.11.2016		
Scale:	NA		
		Drawing: FIGURE 1	
		File No: P160537818JR01V01

Test results and observations during rock coring indicate that the bedrock at BH101 consists of very low to low strength granite between 0.30 mBGL and 2.50 mBGL, and medium to high strength granite between approximately 2.50 and 6.00 mBGL. It should be considered that testing was carried out on relatively intact core samples. Engineering properties of the rock mass will be impacted by the presence of defects in the rock profile, including weathered zones.
