REPORT ON GEOTECHNICAL ASSESSMENT

PROPOSED NEW APARTMENTS

**30 DIGGINGS TERRACE, THREDBO
'BLACK BEAR INN'**

Project No.: 2019-121

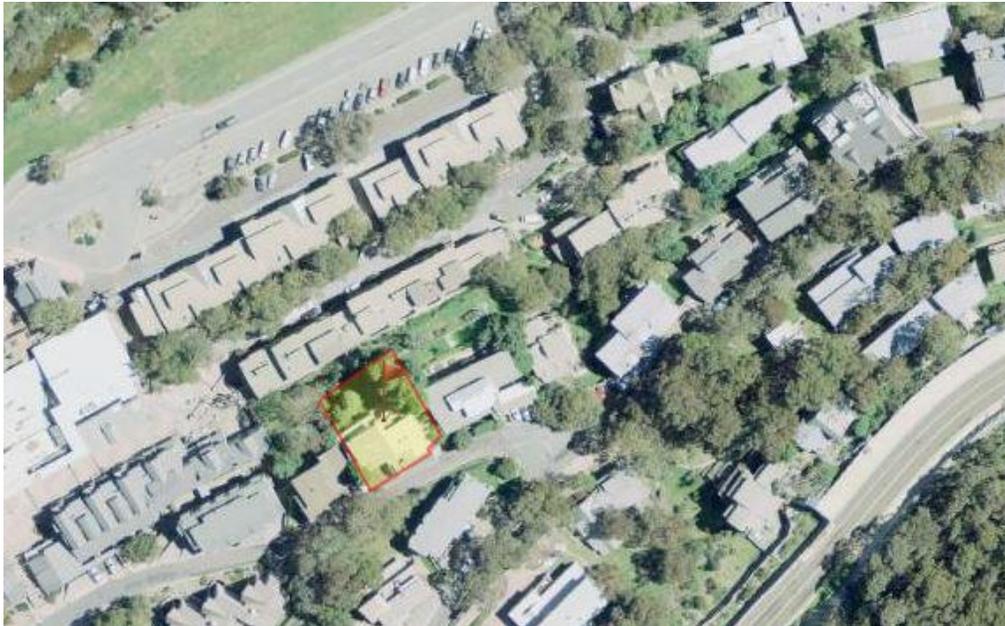
Photograph: 1 ó site and surrounding properties

An aerial photograph of the site and its surrounds is provided below, as sourced from NSW Government Six Map spatial data, as Photograph 1.

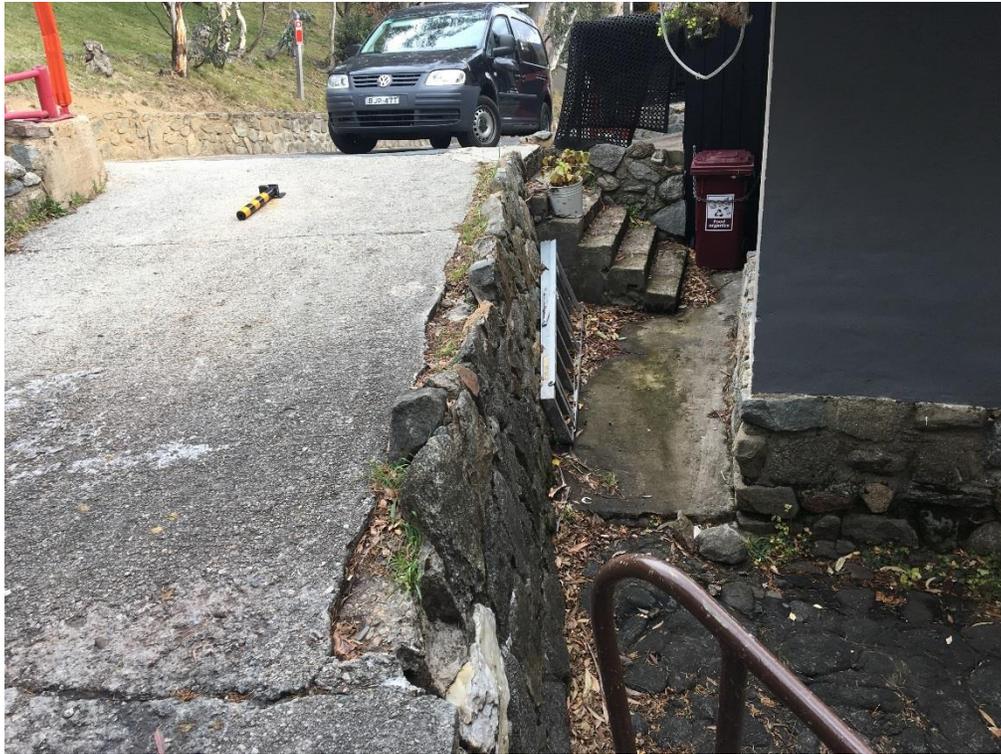
The neighbouring property to the east No. 5 -Candelight Lodgeø contains a three level masonry and timber development on the front half of the block located within approximately 1.0m off the eastern boundary of the site. A concrete driveway provides access to the south-west corner of this property at lower floor level, past the south-east corner of the site. This driveway is retained along the boundary by an approximately 1.5m high sloped rock retaining wall, see Photograph: 2. The building structure appears of similar age to the existing -Black Bear Innø building and appears formed above ground surface levels. There were no indications on external walls of any foundation/footing movement adjacent to the site.

Photograph: 2 – South-east corner of site showing neighbouring (No. 5) driveway and retention.

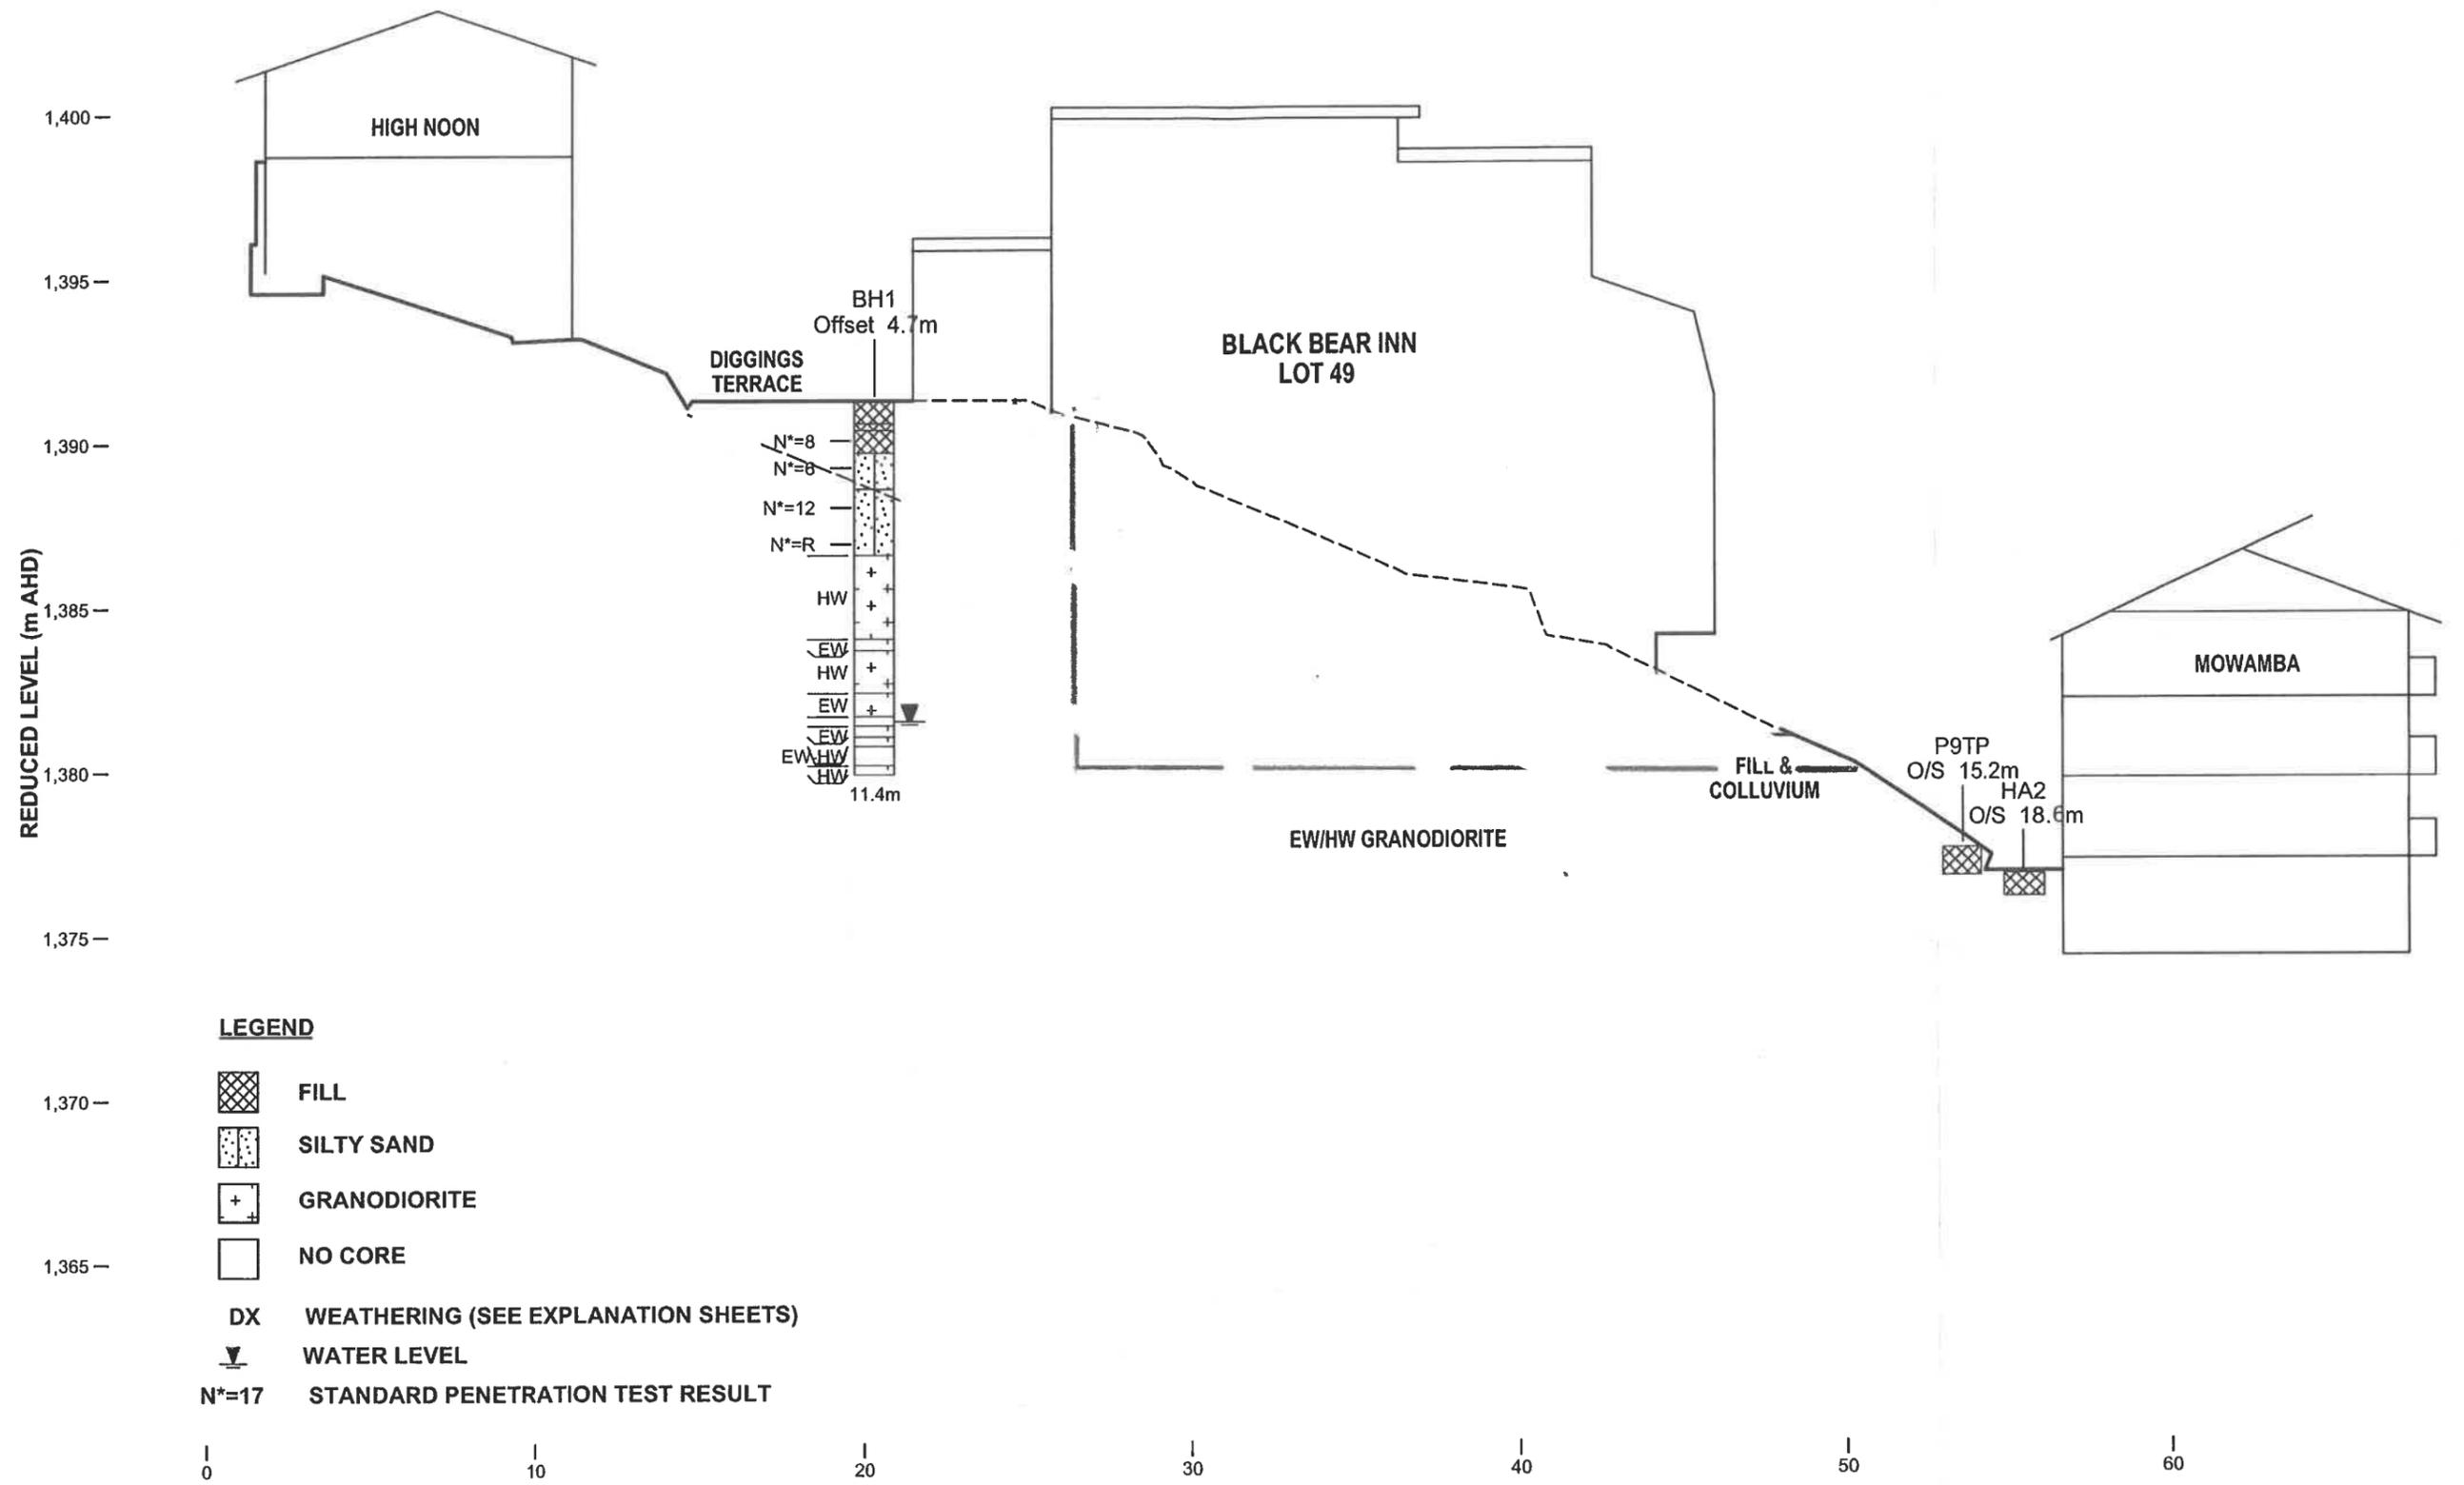
Appendix 2

A field investigation was undertaken by Coffey Geotechnics in June 2000 and comprised the drilling of two boreholes up to 4.40m depth at the front southern side of the existing lodge building. Another investigation was undertaken in June 2003 and comprised extension of the previous Borehole 1 to a total of 11.40m depth along with installation of a groundwater monitoring well/piezometer and measurement of water levels. A geological model/section showing identified geological conditions, as prepared by Coffey Geotechnics, with the proposed excavation outline is supplied in Appendix: 2.
