Project: Resort Operations Centre
213A Kings Cross Road, Kiandra NSW
Lot 36 DP 46316

DATE: NOVEMBER 2020
PREPARED FOR: SELWYN SNOW RESORT PTY LTD
PREPARED BY: COMPLETE TOWN PLANNING PTY LTD
REVISION: REV 02

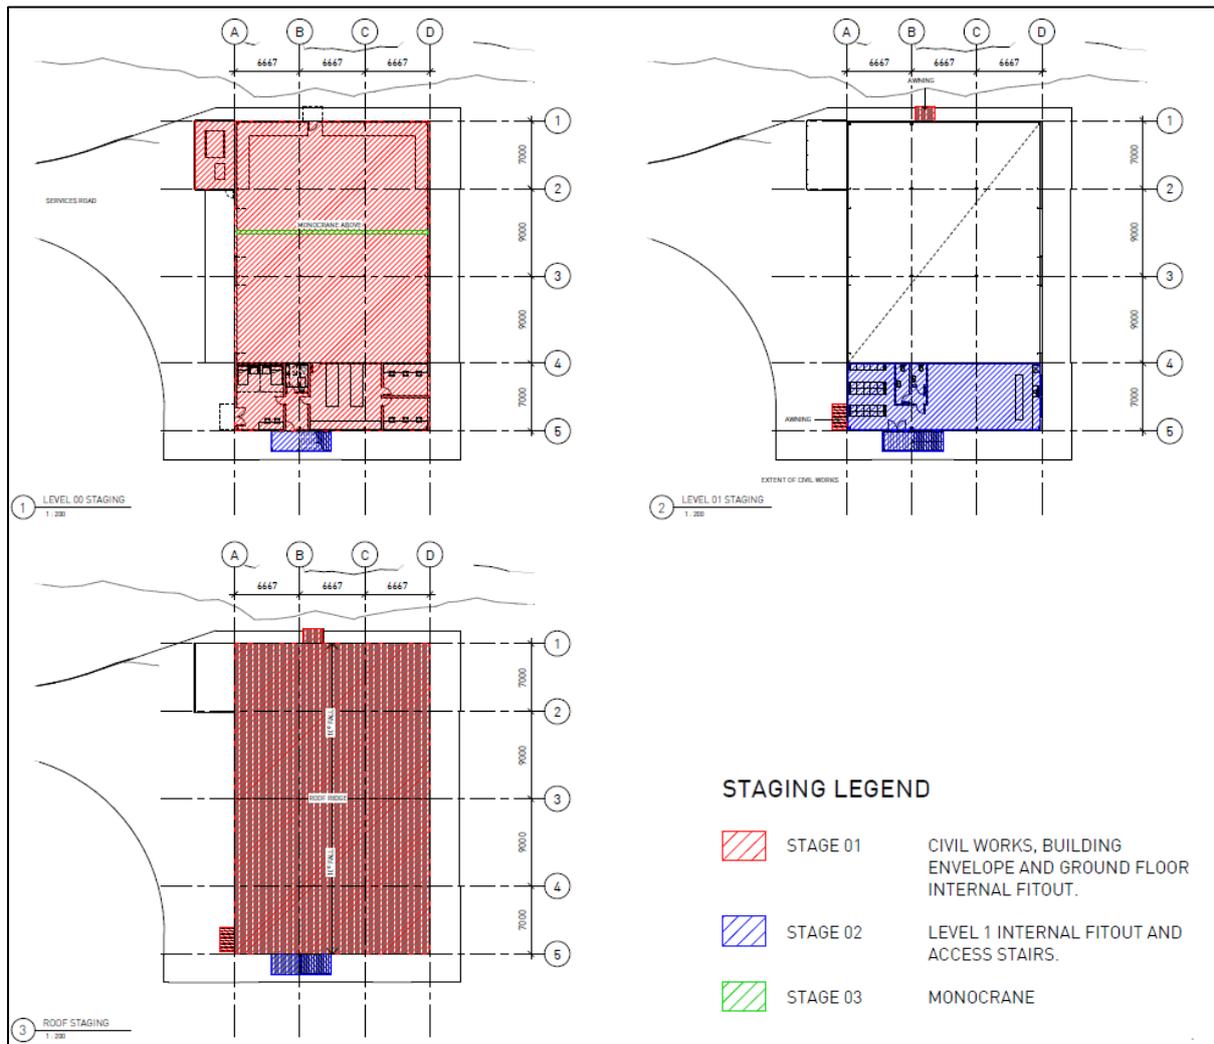
FIGURE 5 STAGING PLAN

It is proposed that construction of the Resort Operations Centre will be stage as per the below:

- Civil works, building envelope and ground floor internal fitout
- Level 1, internal fitout and access stairs
- Monocrane

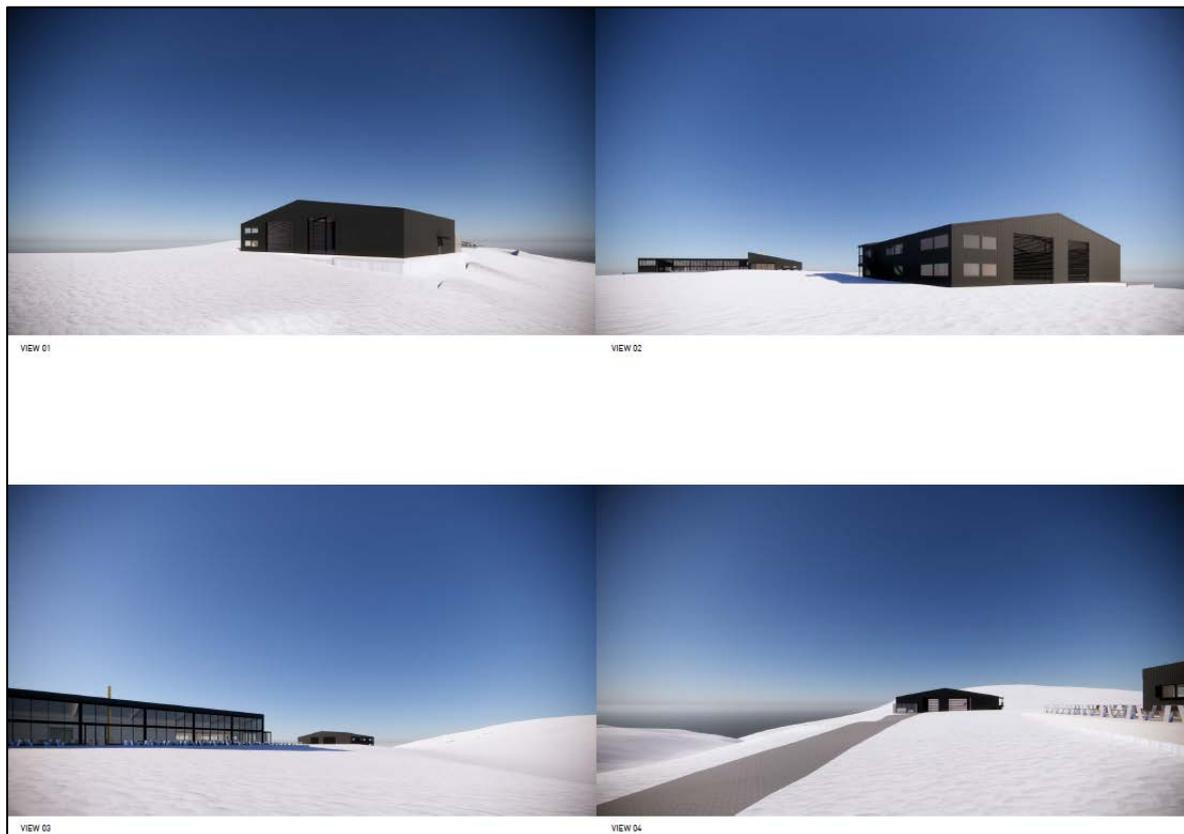
FIGURE 7 PROPOSED RESORT OPERATIONS CENTRE

The proposed Resort Operations Centre offers an articulated façade with a mix of materials and natural tones. This allows the structure to not only blend into the area but also complement the existing landscapes and development found within the Kosciuszko National Park and Snowy Mountains region. Likewise, the proposed building utilises steel construction with a natural monument tone that will not only blend into the natural environment but also complement the new built environment of the new Staff Accommodation dwellings and Visitors Centre.

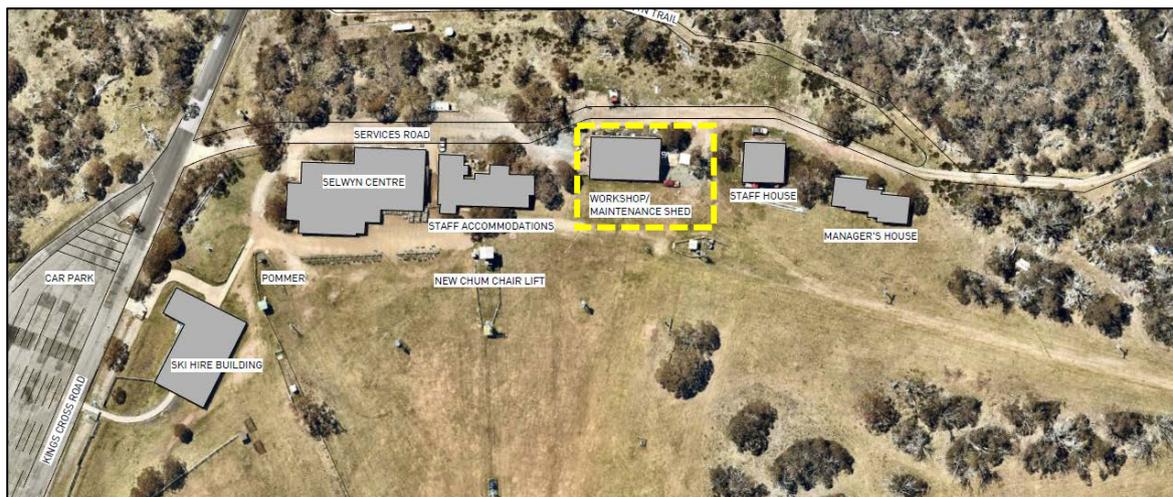
FIGURE 9 PREVIOUS BUILDING LOCATIONS

The new proposed Resort Operations Centre is to be located in a similar location to the previous building which allows for a level site with no existing vegetation. The proposed site also allows for minimum excavation as a flat site is already provided, reducing impacts to the environment.

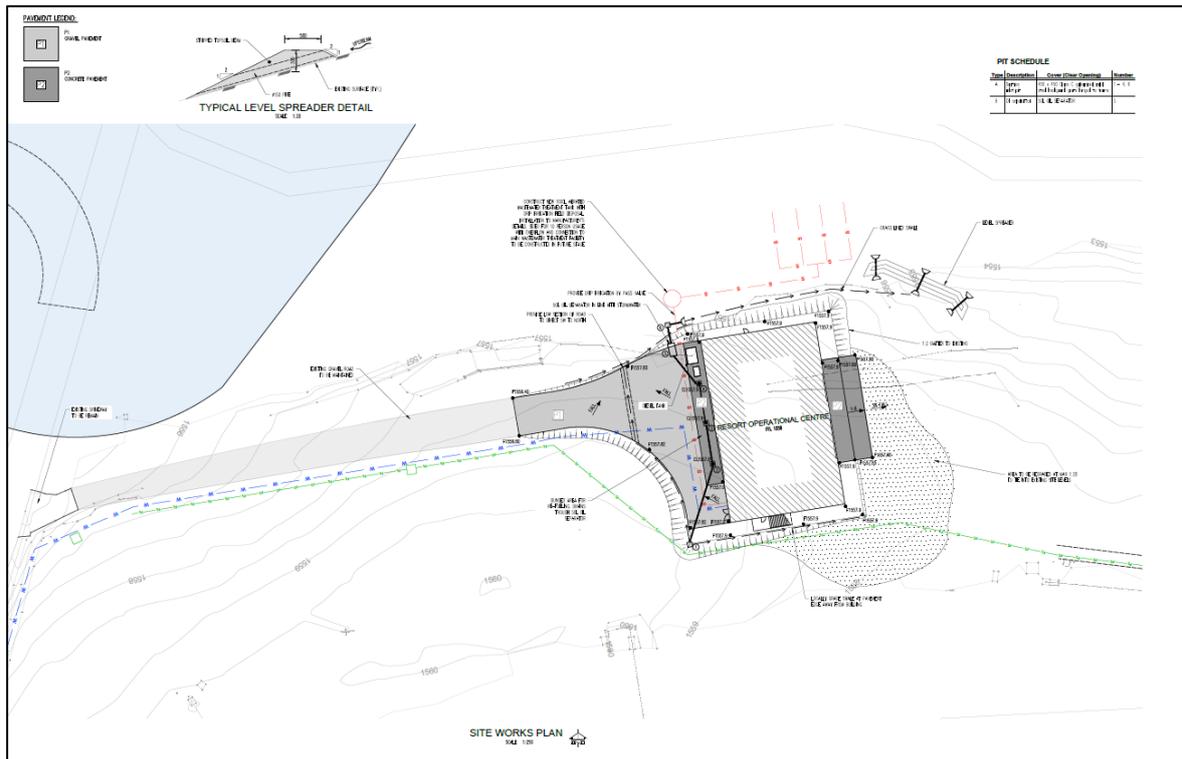
FIGURE 10 CIVIL ENGINEERING SITE WORKS PLAN

Wastewater is proposed to be collected and treated via an aerated on-site septic system. The proposed septic system will provide wastewater collection for up to 10 occupants and to be used in the summer months where up to 5 maintenance and operational staff could be present at any one time. It is proposed to be connected to the wastewater treatment facility. Wastewater measures provided for ten occupants will satisfy requirements for summer operations and the connection to the wastewater treatment facility will provide adequate wastewater services when occupants will increase during the winter season. Previous soil testing of the site found no major limitations to installing an on-site wastewater management and the proposed system to be installed will be the same as proposed for the Staff Accommodation as per civil engineering plans and report provided.

Stormwater is proposed to be drained to the north as per the drainage arrangements of the previous development with a peak discharge of 48l/s. A stormwater assessment by TTW found:

"Due to all the works area being previously developed and containing impervious areas, the peak stormwater discharge from the developed site did not increase over the existing conditions. As such a detention strategy is not required." (Appendix III).

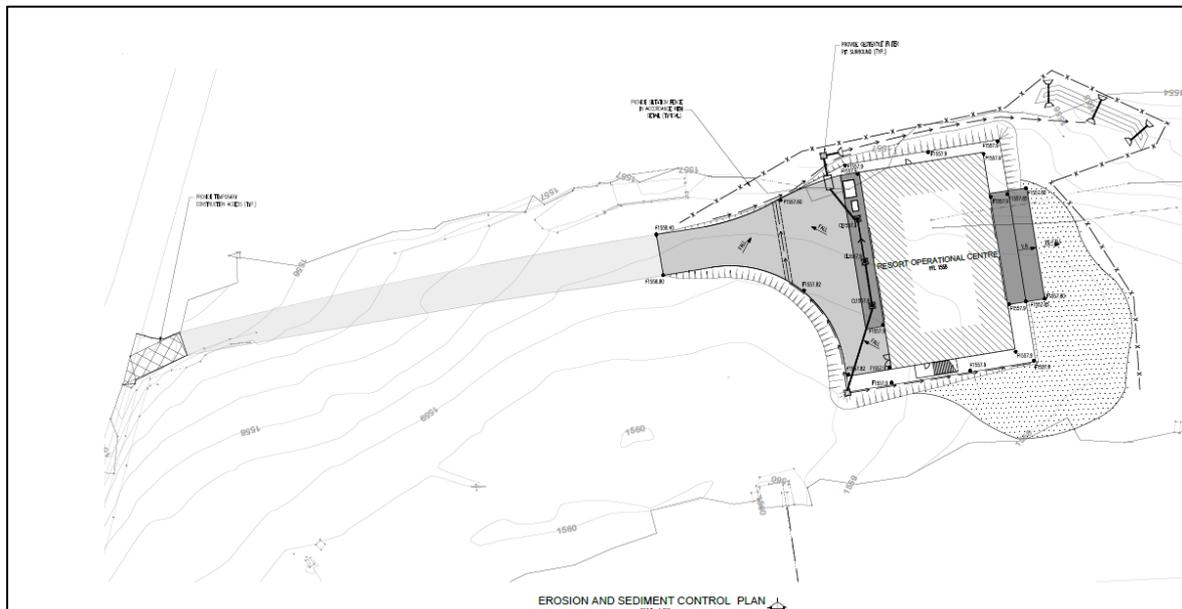
FIGURE 11 EROSION AND SEDIMENT CONTROL PLAN

Refer to Site Environment Management Plan provided within this report. There will be minimal soil disturbance for the construction of the Resort Operations Centre and OSSM. This area is already classified as disturbed land and the potential of Aboriginal artefacts is very low.

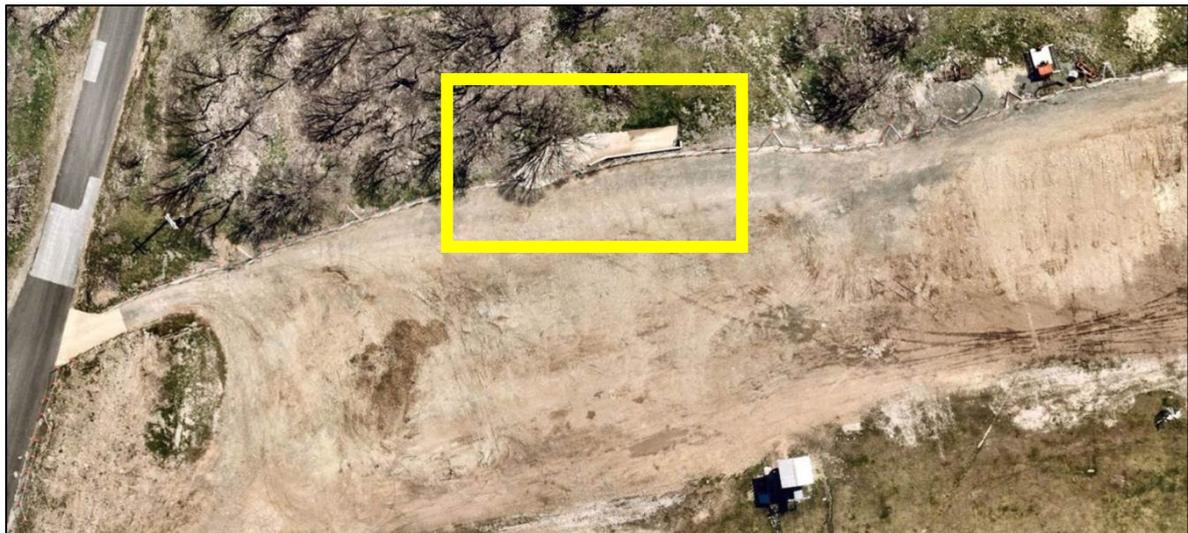
FIGURE 13 EXISTING WASTE MANAGEMENT SITE TO BE RE-ESTABLISHED

No changes proposed to existing waste minimization procedures. The Resort Operations Centre will utilize the existing waste management site accessible from the service road.

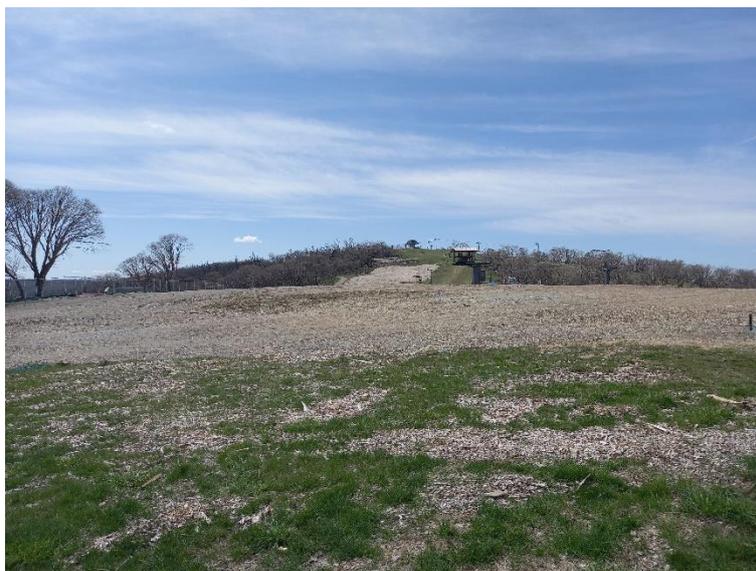
Image 1: Facing east, much of this cleared area is proposed to site the Guest Facilities. Projected further up the centre of the image will be the proposed ROC. A yet to be confirmed Sewerage Plant is tentatively proposed left of centre of the image.

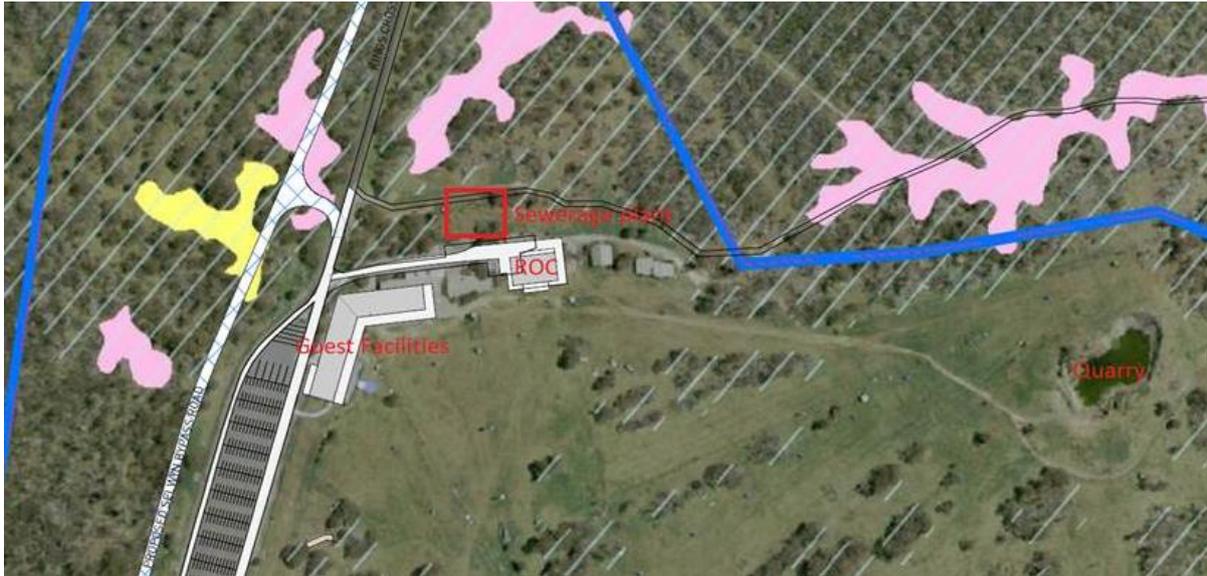
Figure 1: Location of the Guest Facilities, Resort Operation Centre and Quarry Dam. The Guest Facilities and ROC overlap with the footprint of the previous resort buildings that can be seen from the superimposed image taken before the January 2020 bushfire. Management and staff accommodation have been relocated to a proposed site further to the south adjacent to Kings Cross Road. Coloured polygons relate to significant environmental attributes (source: map provided by TSA Management).

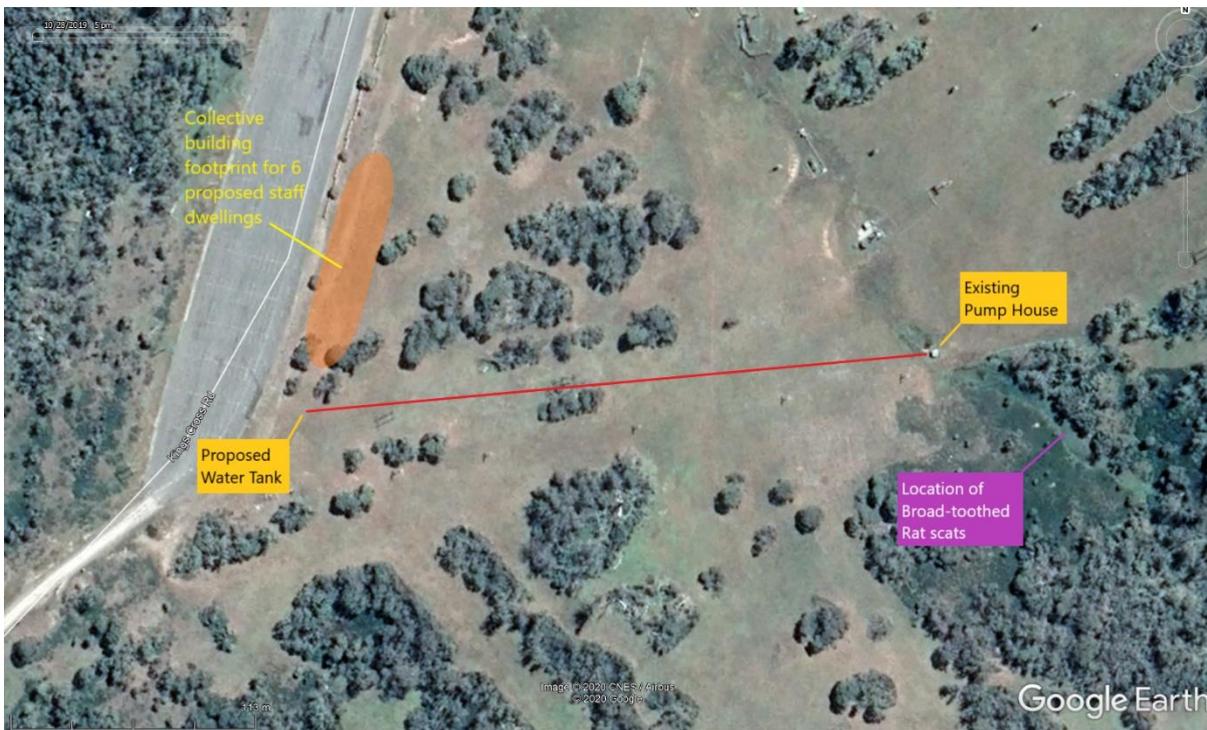
Figure 2: Location of the proposed Water Pipe, Water Tank and Staff Accommodation at Selwyn Snow Resort between the proposed water tank and existing pump house. These proposed assets are part of a separate development application, but some of the fauna habitat assessment was undertaken in this area and discussed in this report. The location of fresh Broad-toothed Rat scats is shown. The aerial image precedes the January 2020 bushfire. No tree canopy remains due to a bushfire in January 2020 (source: base map Google Earth, 2020).

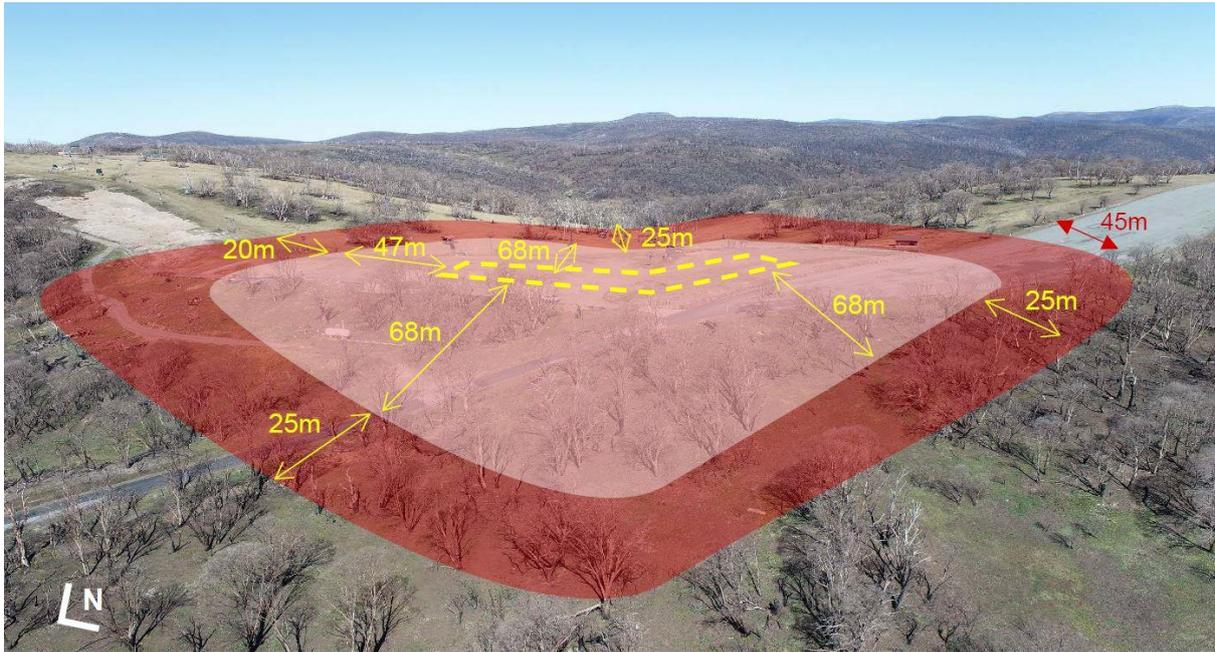
Figure 3: An oblique aerial view from the north-east with the proposed APZ superimposed from table calculations pertaining to the proposed Guest Facilities. The pink shading relates to the Inner APZ and the red shading relates to the Outer APZ (source: Complete Town Planning).

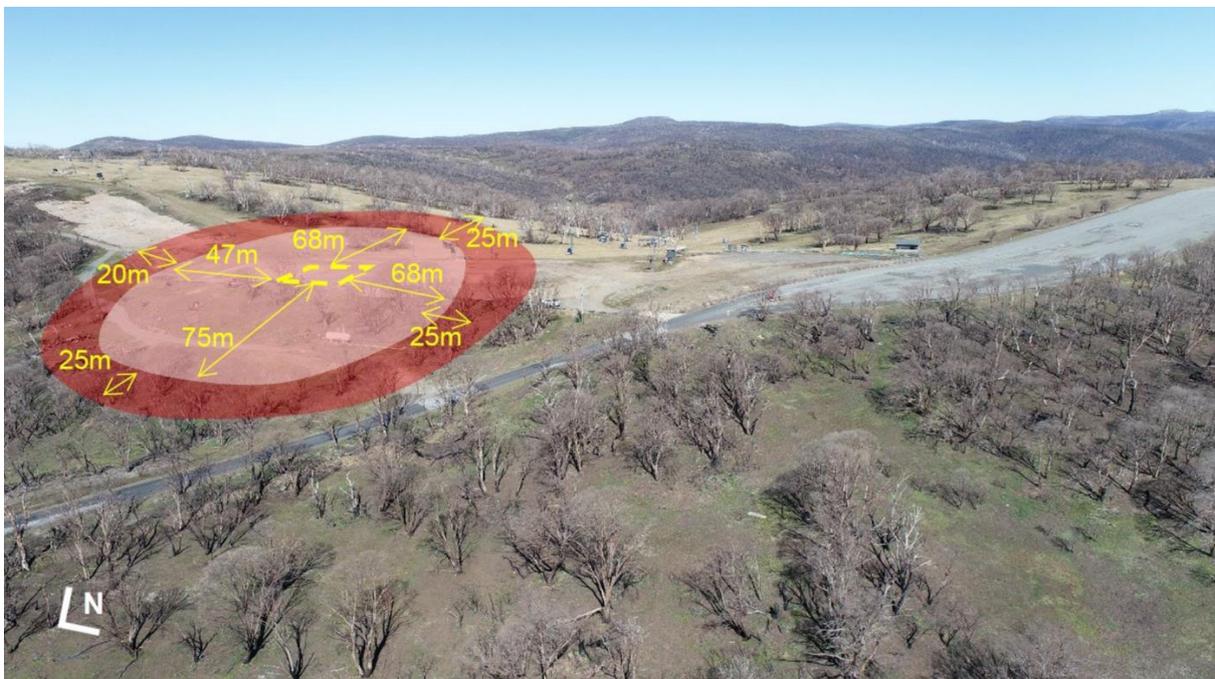
Figure 4: An oblique aerial view from the north-east with the proposed APZ superimposed from table calculations pertaining to the proposed Resort Operation Centre. The pink shading relates to the Inner APZ and the red shading relates to the Outer APZ (source: Complete Town Planning).

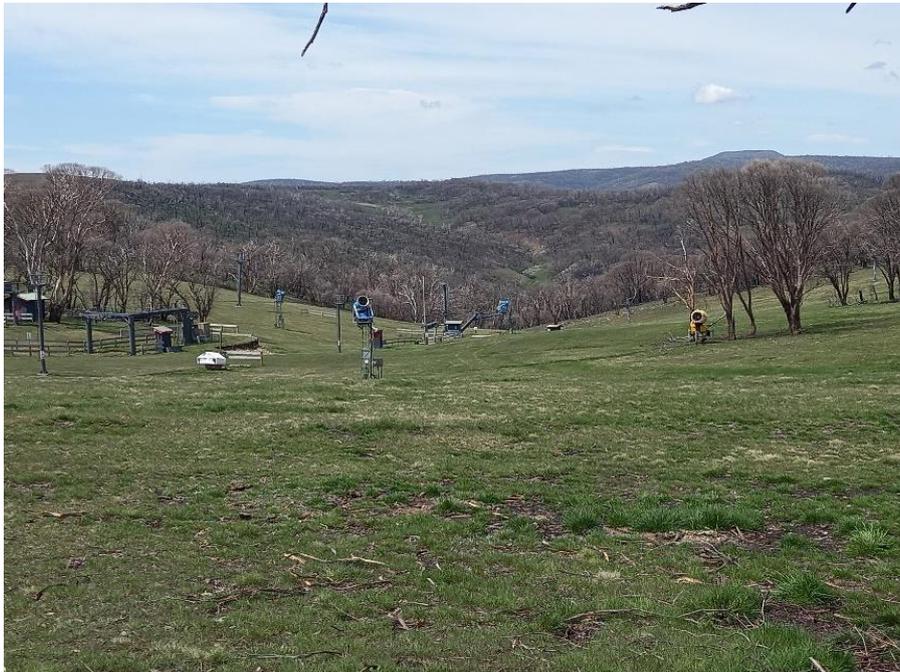
Image 2: A southerly view down Clear Creek from near the middle of the ski slope below the proposed new buildings. The recovery of ground vegetation on the ski slope since the bushfire was good, but patchy in tree covered areas. Little shrub understorey and stratum was present during the survey, both within and adjacent to the resort.

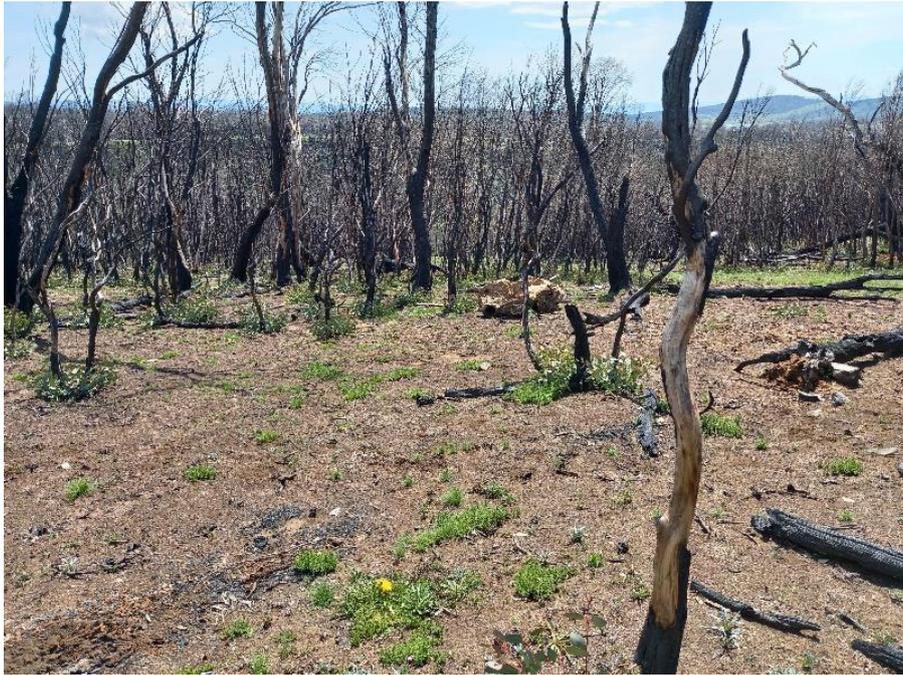
Image 3: Part of the northern APZ associated with the proposed Resort Operation Centre. Many trees in this area were not large to provide good fauna habitat opportunity (e.g. hollows), but tree crowns would have still provided foraging opportunities for a range of bird species. While the above ground tree trunks are dead, technically the tree is still alive as evident by the coppicing base of most trees in the APZ across the survey area. However, ground cover was patchy in some areas of the APZ as depicted in this image (compared to Image 2 [p.10] for southern areas of the ski slope in the same APZ).

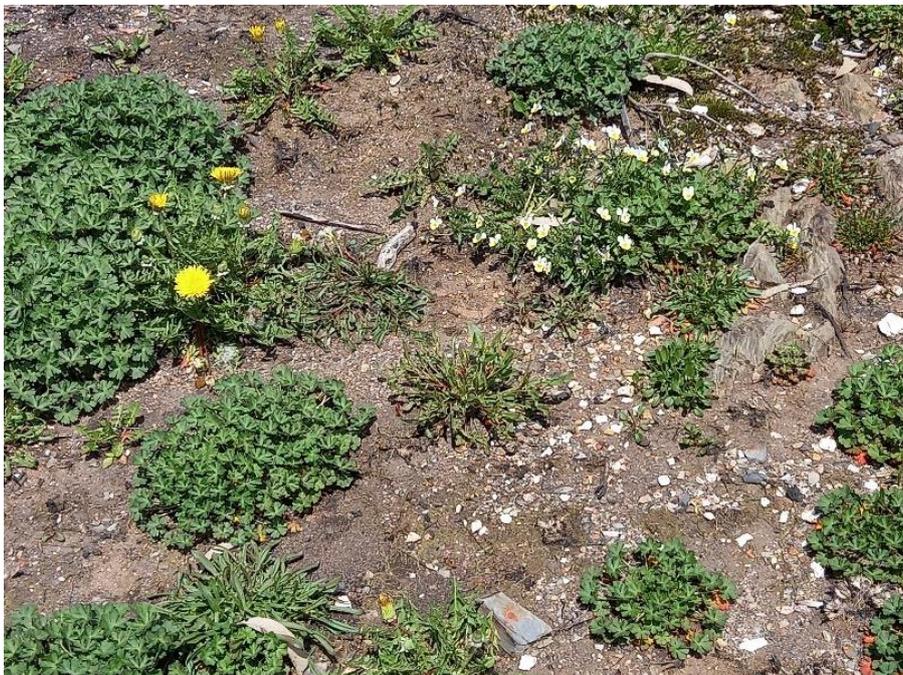
*Image 4: A close-up of the patch-like recovery in some northern parts of the APZ. The image shows a native Geranium sp. (largest leafy ground plant) surrounded by the introduced *Taraxacum officinale (yellow flower), *Viola arvensis (pale-coloured flower) and *Acetosella vulgaris (in flower but not easily seen in the image).*

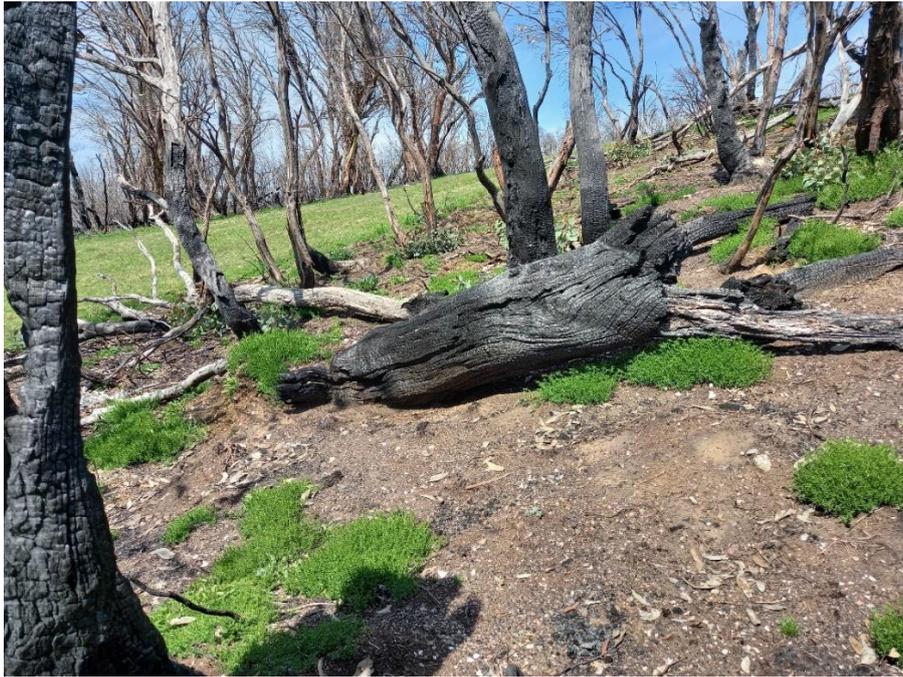
Image 5: The image was taken within a tree stand at the southern end of the ski slope adjacent to the proposed water pipe. However, it is presented here as a relatively better representation of habitat opportunity compared to many areas in the northern APZ. As tree material starts to fall to the ground and accumulate, then habitat complexity and subsequent fauna opportunity will increase – both for common and threatened species.

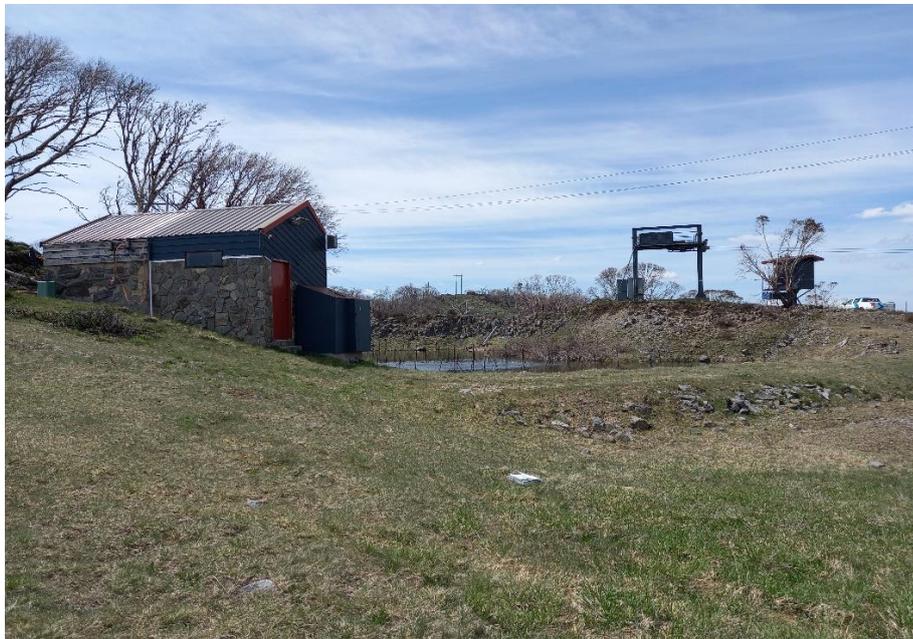
Image 6: The quarry dam showing little habitat complexity associated with the embankment that is proposed to increase in height by 1.5 m. However, the inner environment, some of which will be flooded when the dam increases to its new full potential, is more complex than surrounding areas. A separate species list for the area on and adjacent to the current embankment is presented in Appendix 2.

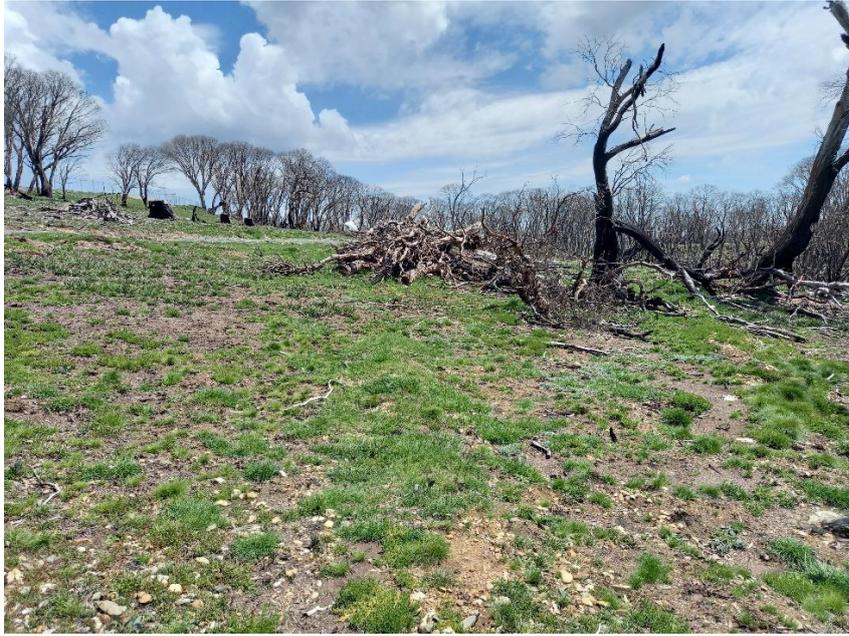
Image 6: Some tree material was cut down during the bushfire event in an attempt to protect some of the resort assets. Other material that had fallen since the fire and was obstructing access was pushed into a pile. As shown in the right of the image, large habitat trees were burnt. Habitat complexity in the northern areas of the APZ will take many years to return to the state that existed prior to the bushfire.

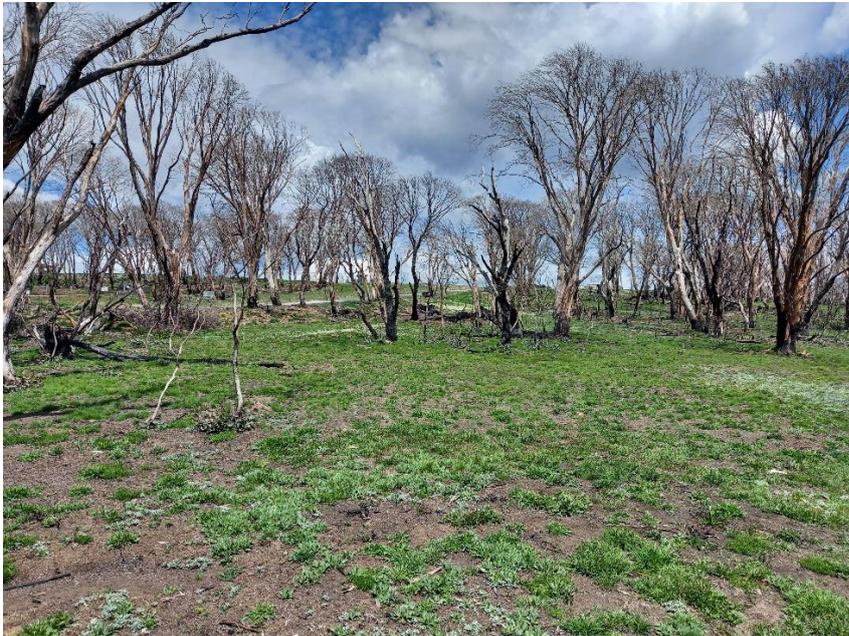
*Image 7: Part of the APZ area to the north-west of the proposed Guest Facilities. Patchy regeneration of native and exotic grasses and forbs, no shrub understorey and basal coppicing of *Eucalyptus pauciflora* was the typical environment present in most sub-alpine woodland when the flora and fauna assessment was undertaken approximately 10 months after the January 2020 bushfire.*
