SELWYN SNOW RESORT REDEVELOPMENT KINGS CROSS ROAD, CABRAMURRA, NSW

GEOTECHNICAL INVESTIGATION & SLOPE STABILITY RISK ASSESSMENT

JULY 2020

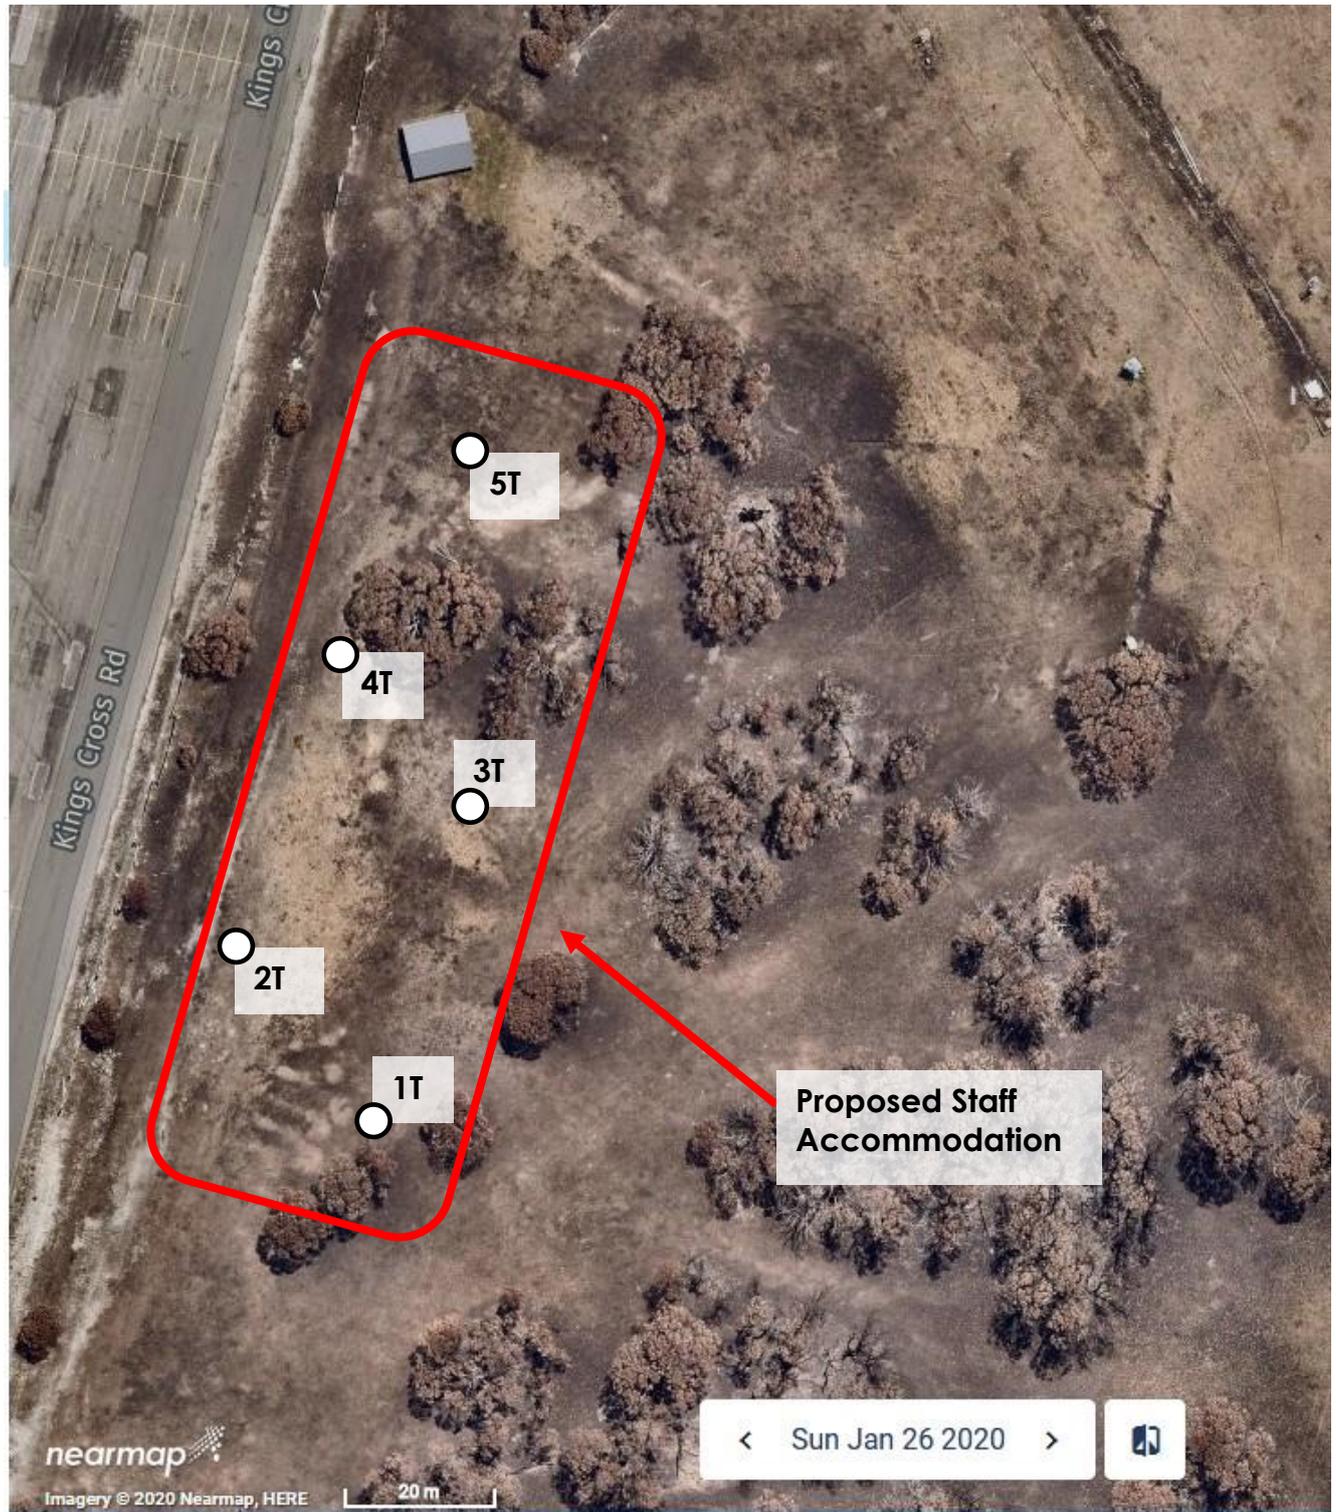
FIGURE 3

○ - Location of Test Pit

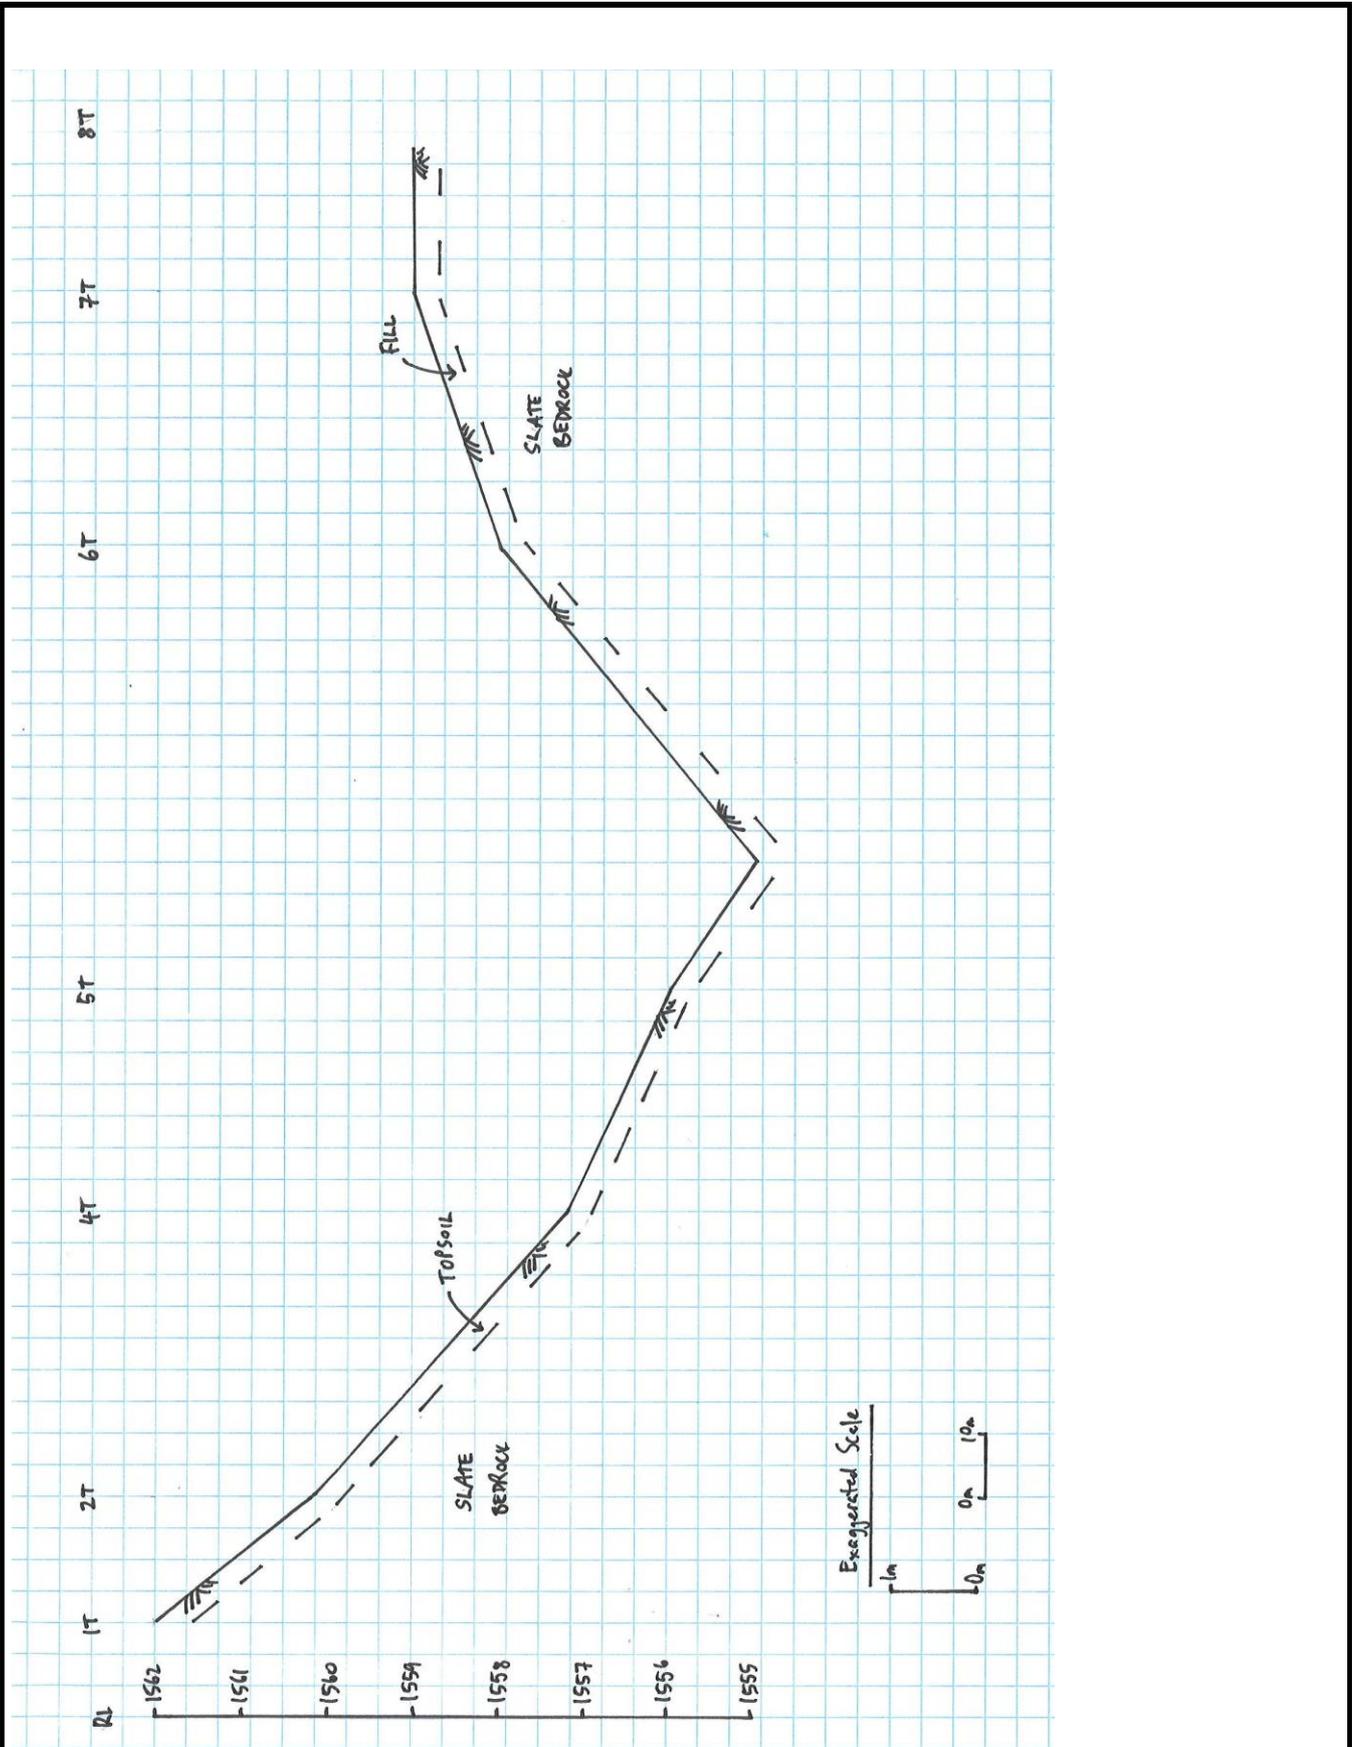
**TSA MANAGEMENT
 SELWYN SNOW RESORT REDEVELOPMENT
 GEOTECHNICAL MODEL – SUBSURFACE SECTION A-A'**

Sections 4.1.1 to 4.1.4 detail the subsurface conditions for the Staff Accommodation building, Guest Facilities building, Work Shop, and Access Road. Figures 6 and 7 provide geotechnical models of the site, showing subsurface sections through the site, as found by the investigation test pits.

4.1 (e)	Presentation of the geological model of the site and related land showing the proposed development, including an analysis of sub-surface conditions, taking into account thickness of the topsoil, colluvium and residual soil layers, depth to underlying bedrock, and the location and depth of groundwater.	See Section 4.1 “Subsurface Conditions”, Section 4.2 “Groundwater”, and Figure 4 “Subsurface Section”

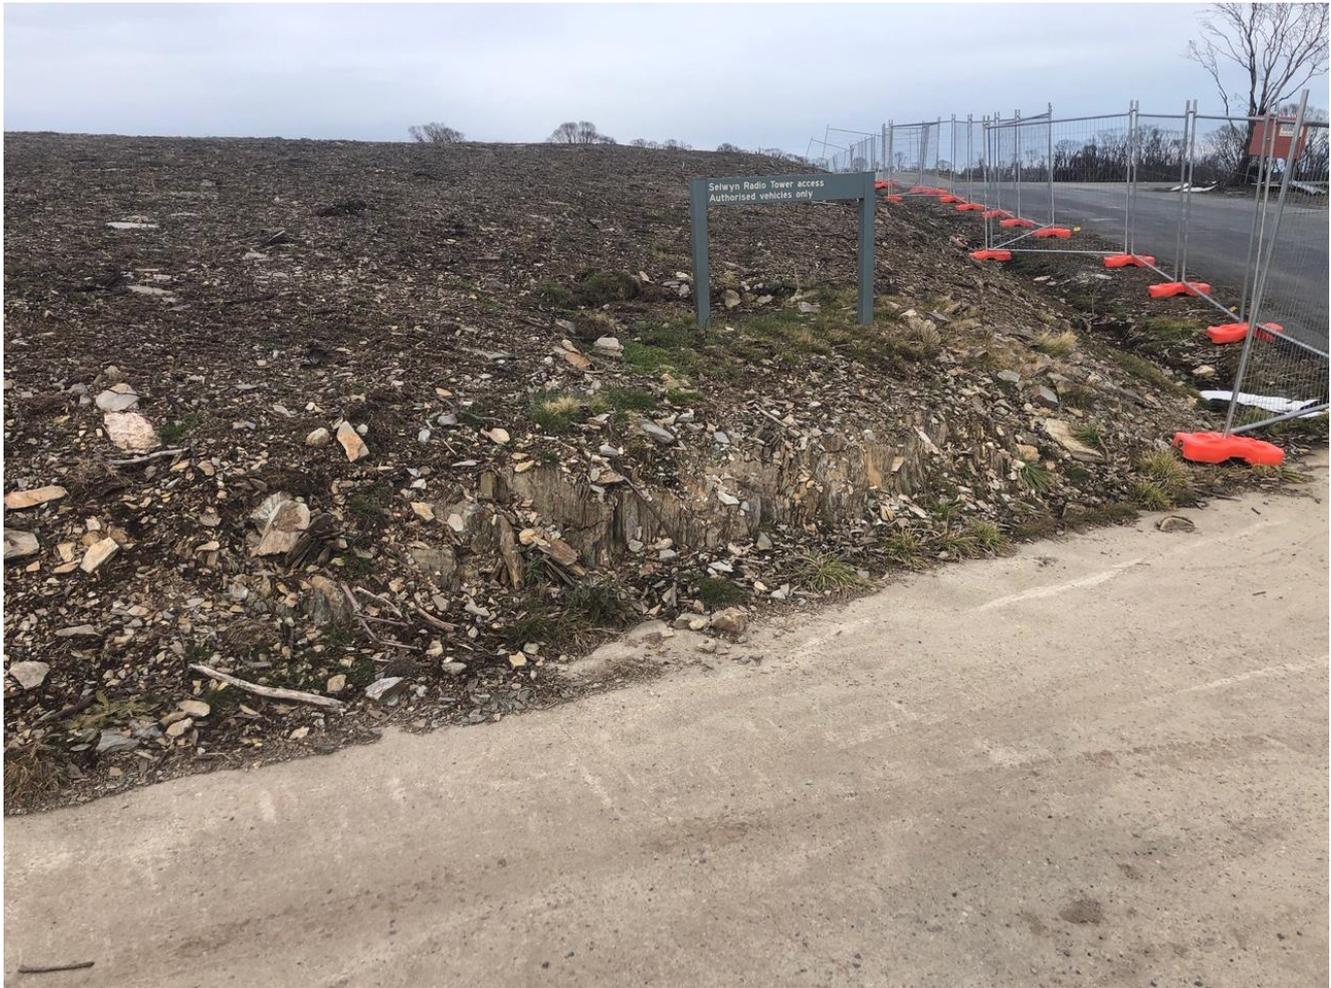
FIGURE 13

Photo 6 – 10/7/2020 – View of an existing cutting on the corner of Kings Cross Road and Selwyn Trail (near NW corner of the proposed Guest Facilities building), showing slate bedrock at shallow depth.

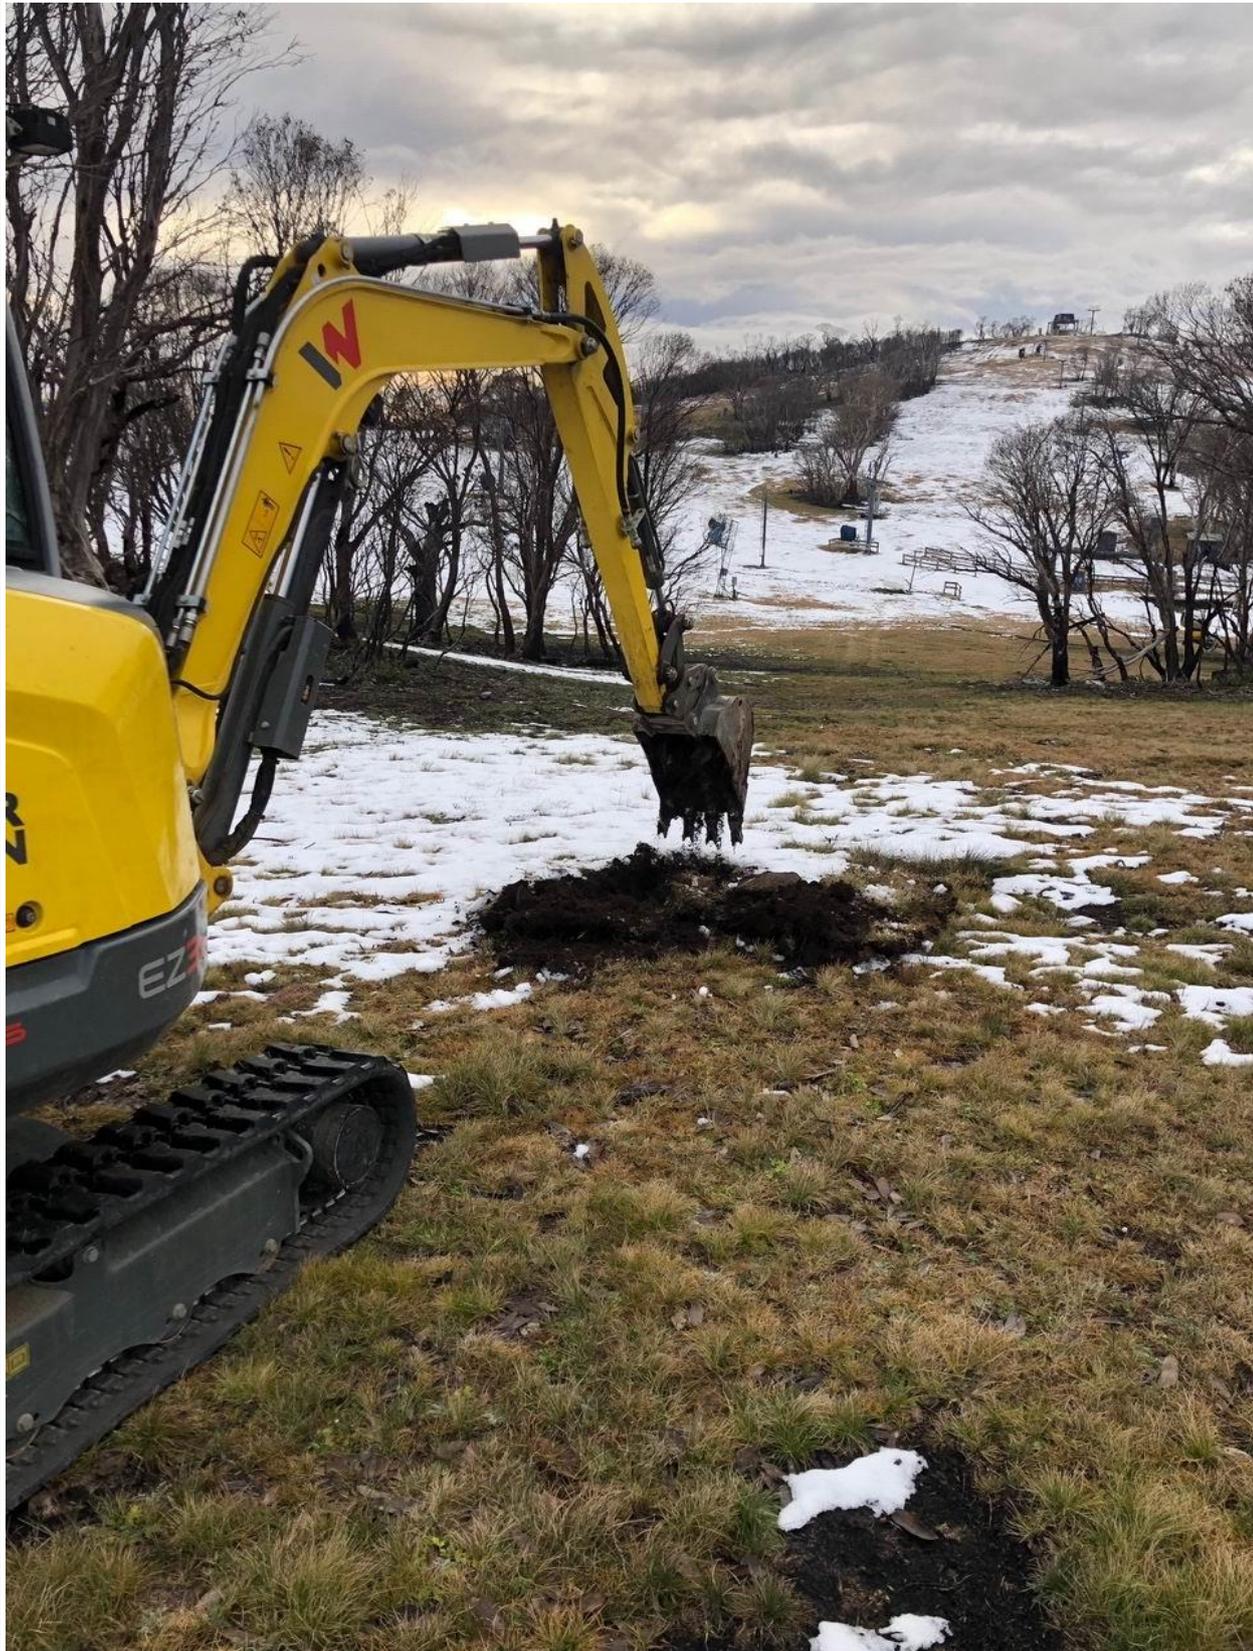
Photo 7 – 10/7/2020 – View of test pit 3T being excavated.

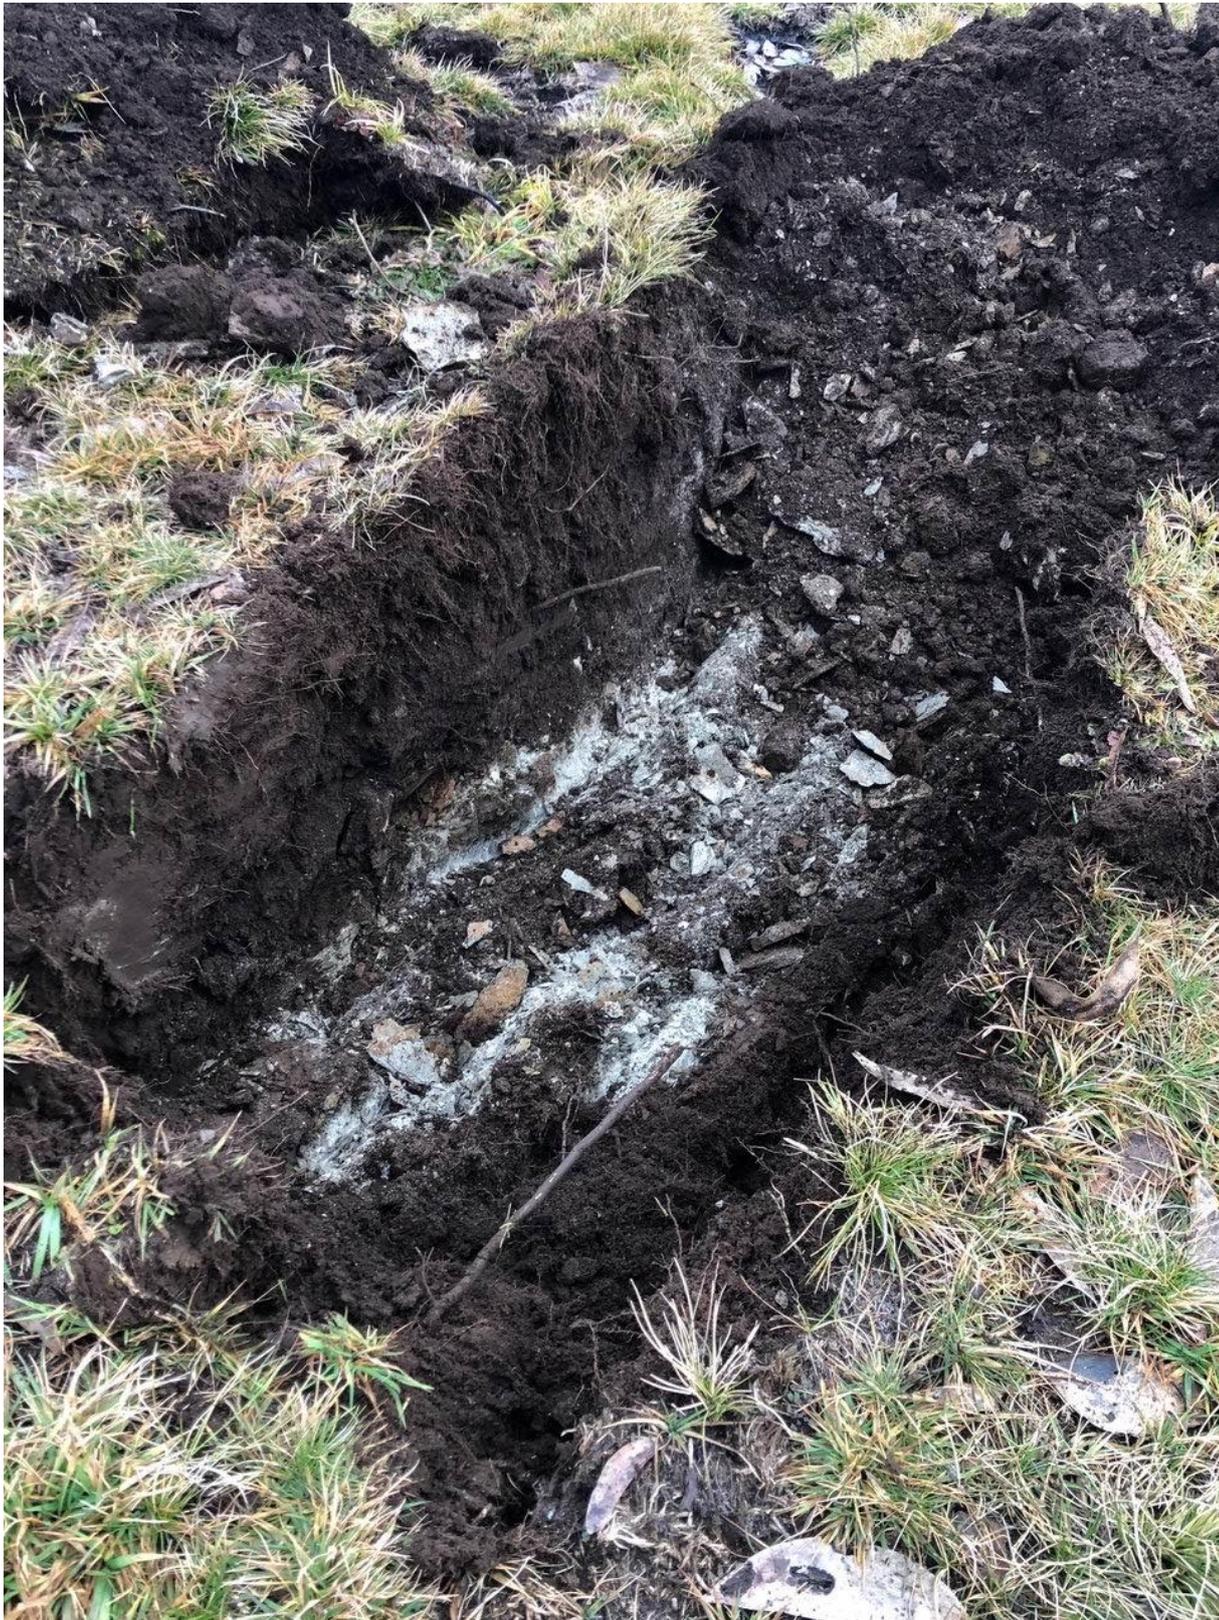
Geological Profile	Depth Interval	Description
TOPSOIL	0m to 0.1m/0.3m	CLAYEY SILTY SAND; fine to coarse sand, low plasticity fines, some angular slate gravels to 60mm, black, some grass roots, moist, loose.
BEDROCK	Below 0.1m/0.3m	MW SLATE; moderately weathered (MW), and medium strong rock. Grey, dark grey, some yellow-grey, thinly bedded, foliated in a N-S direction.

Photo 8 – 10/7/2020 – View of the subsurface profile of test pit 1T, showing topsoil, directly underlain by medium strong slate bedrock.

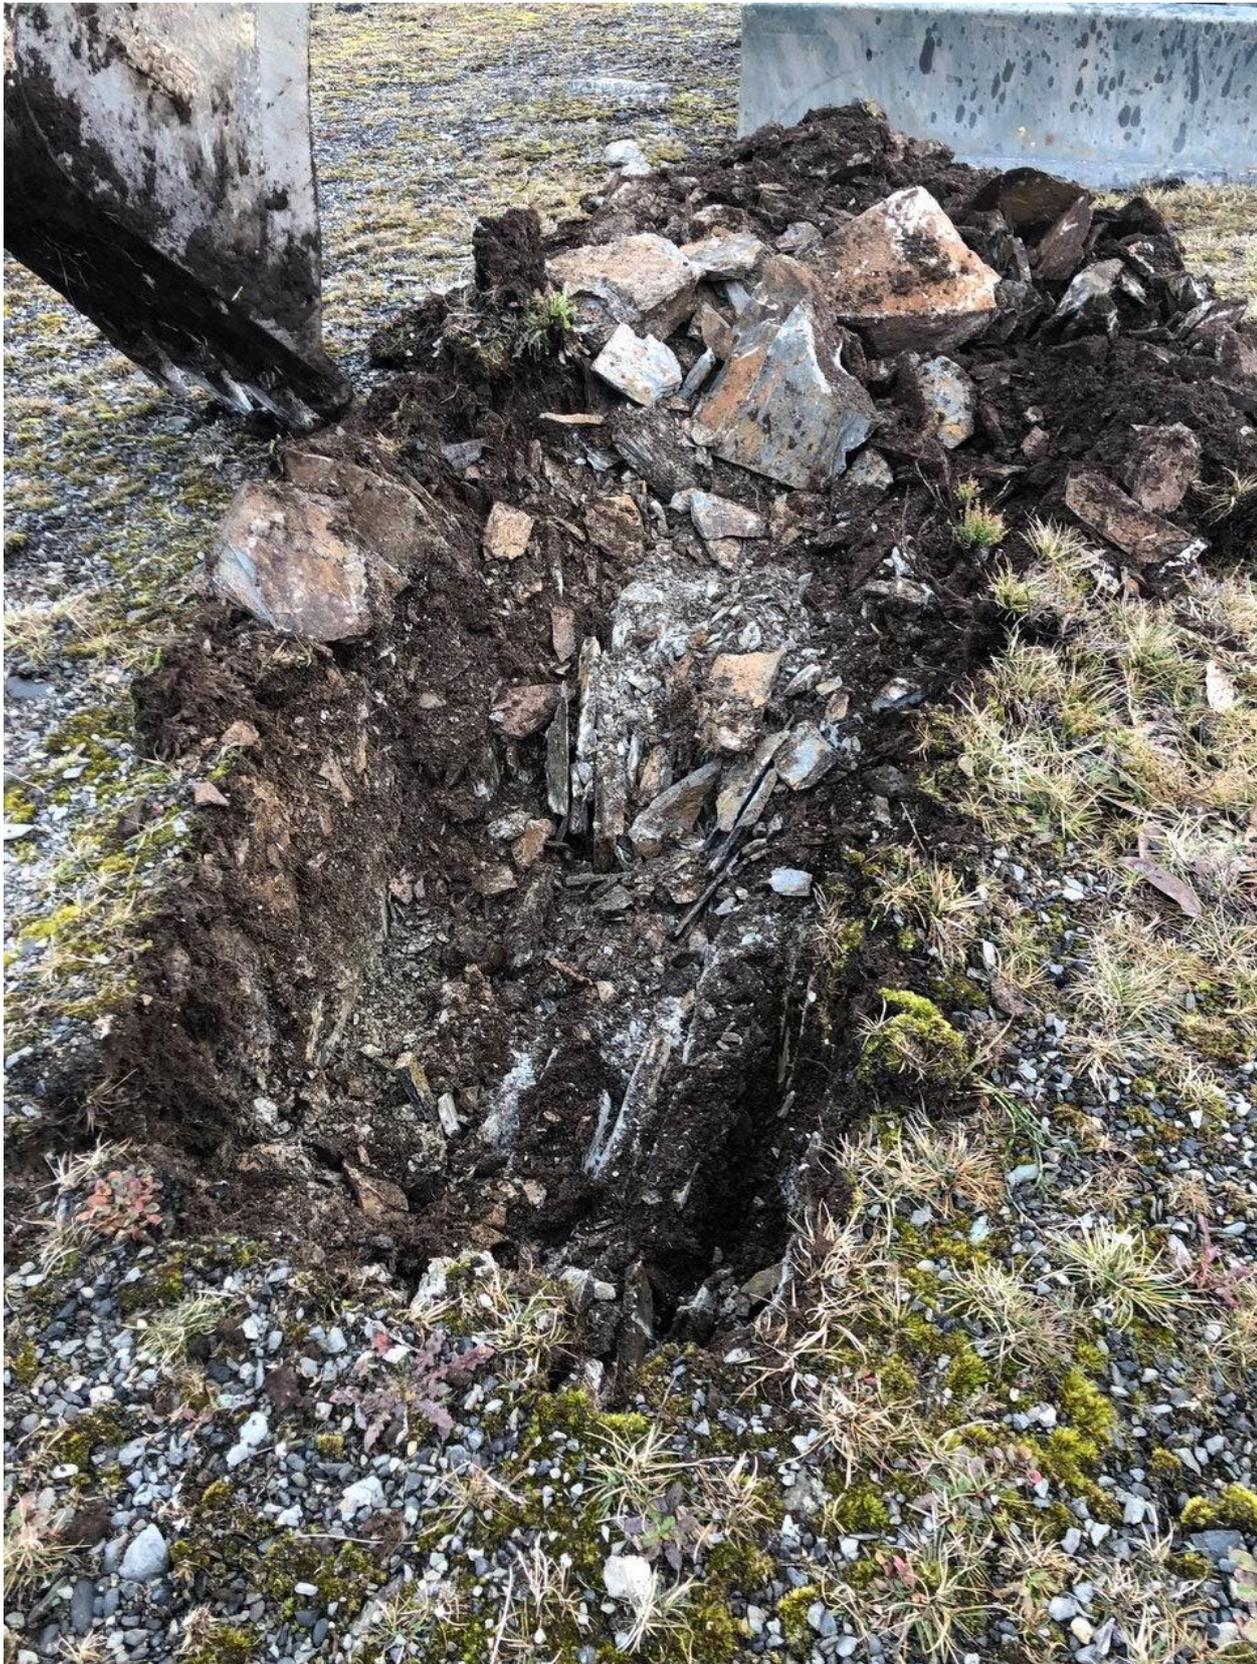
Photo 9 – 10/7/2020 – View of the subsurface profile of test pit 2T, showing shallow topsoil, directly underlain by medium strong slate bedrock.

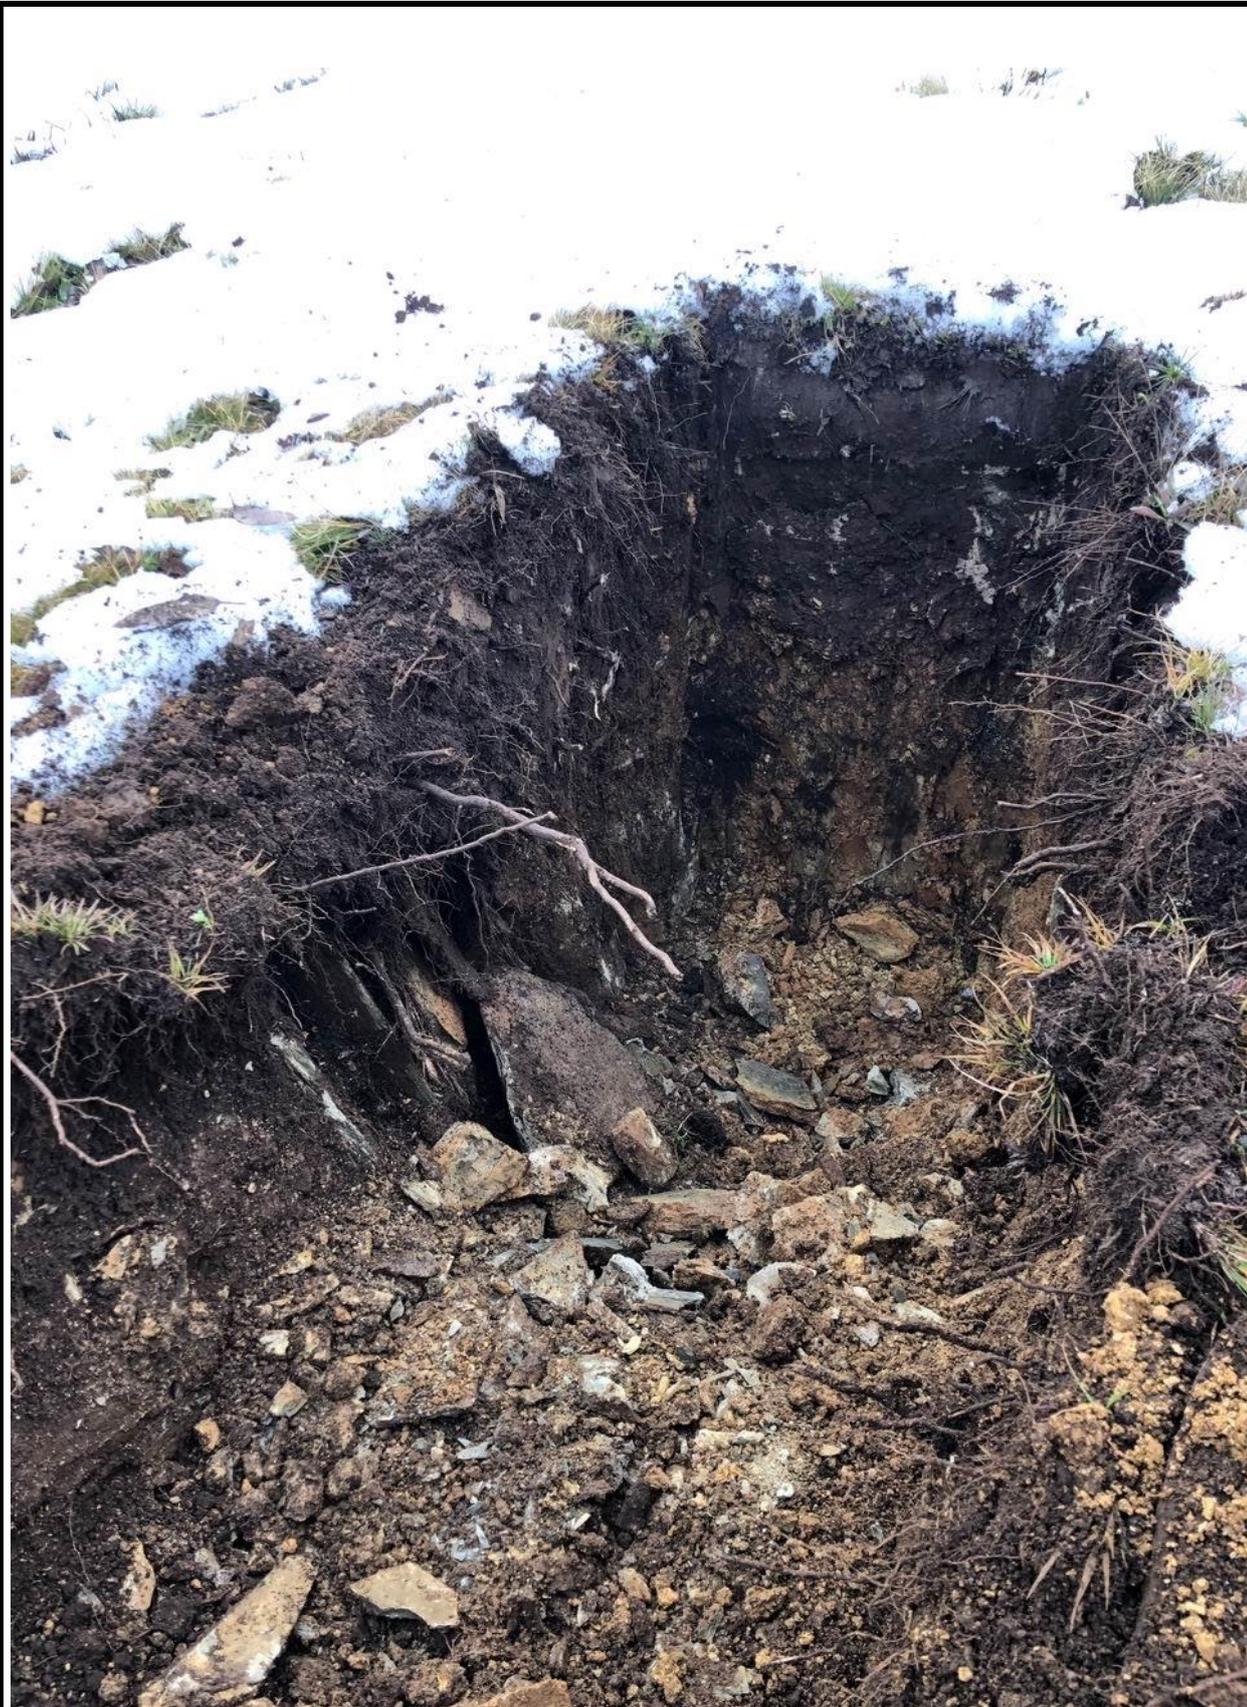
Photo 10 – 10/7/2020 – View of the subsurface profile of test pit 3T, showing topsoil, directly underlain by medium strong slate bedrock.

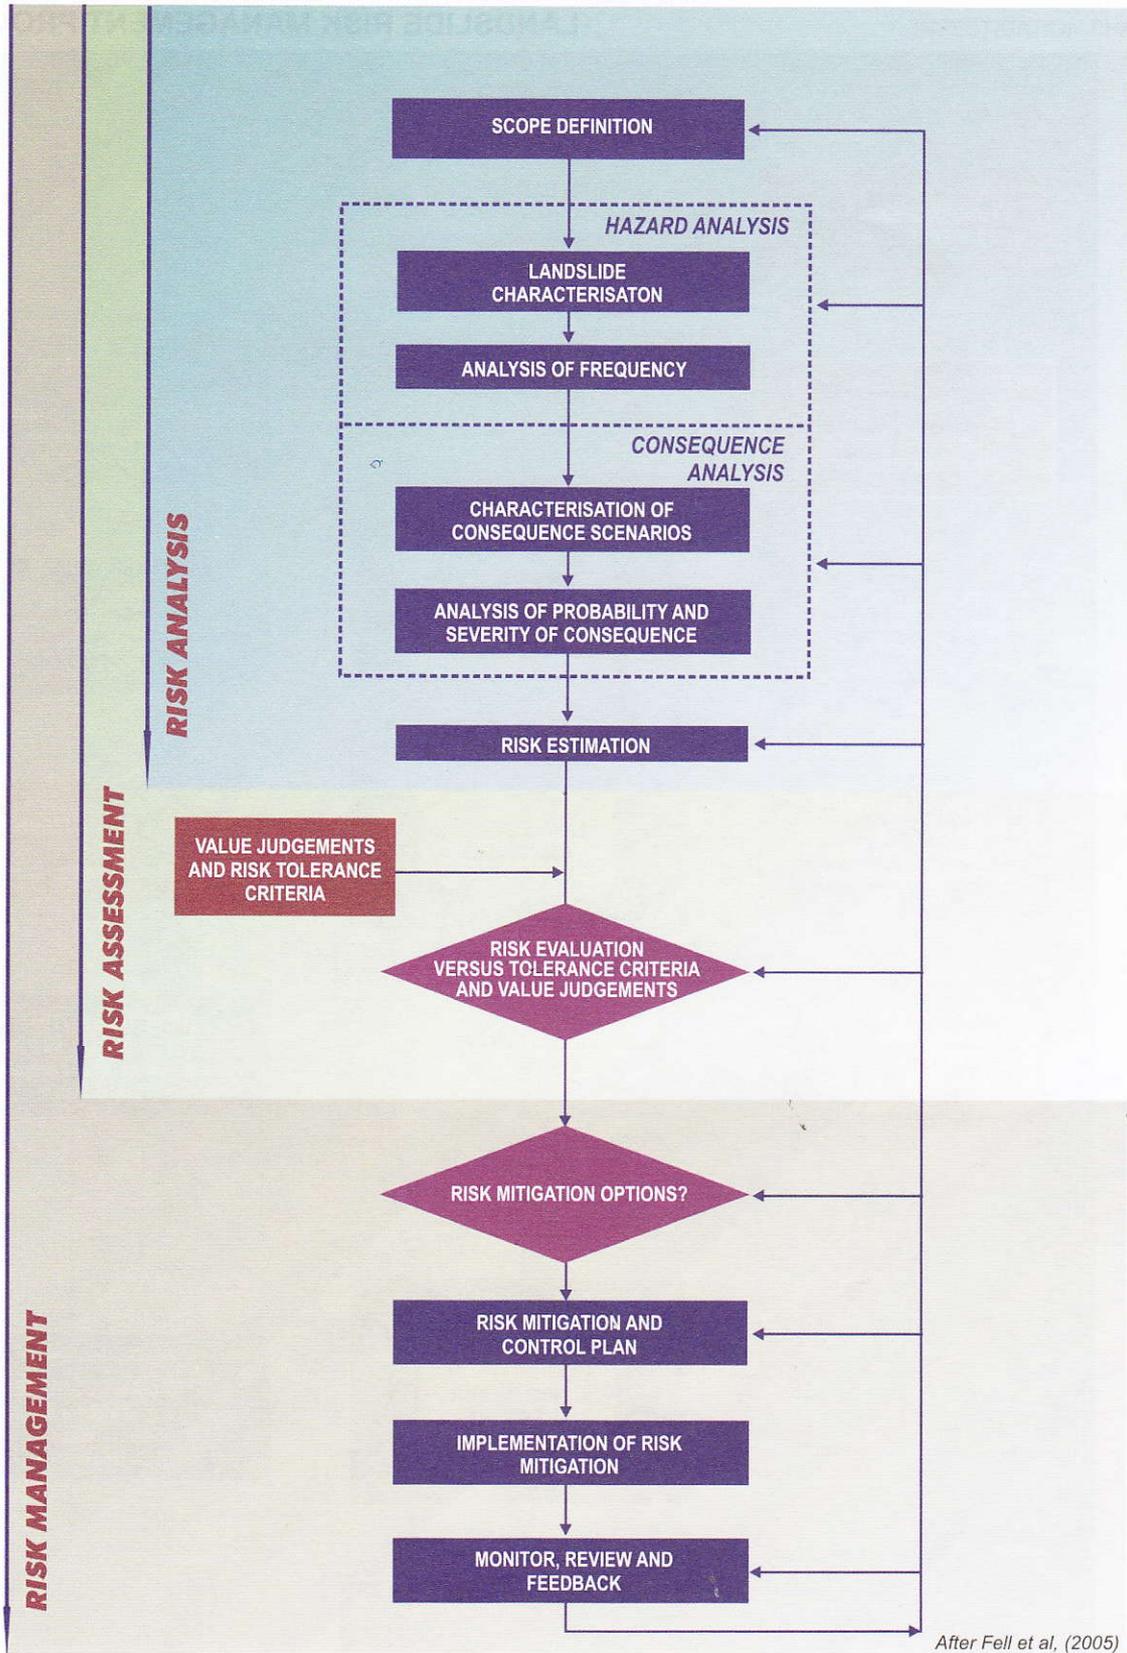
Figure 2: Abbreviated flowchart for Landslide Risk Management. Ref: AGS (2007a, 2007c)

FRAMEWORK FOR LANDSLIDE RISK MANAGEMENT

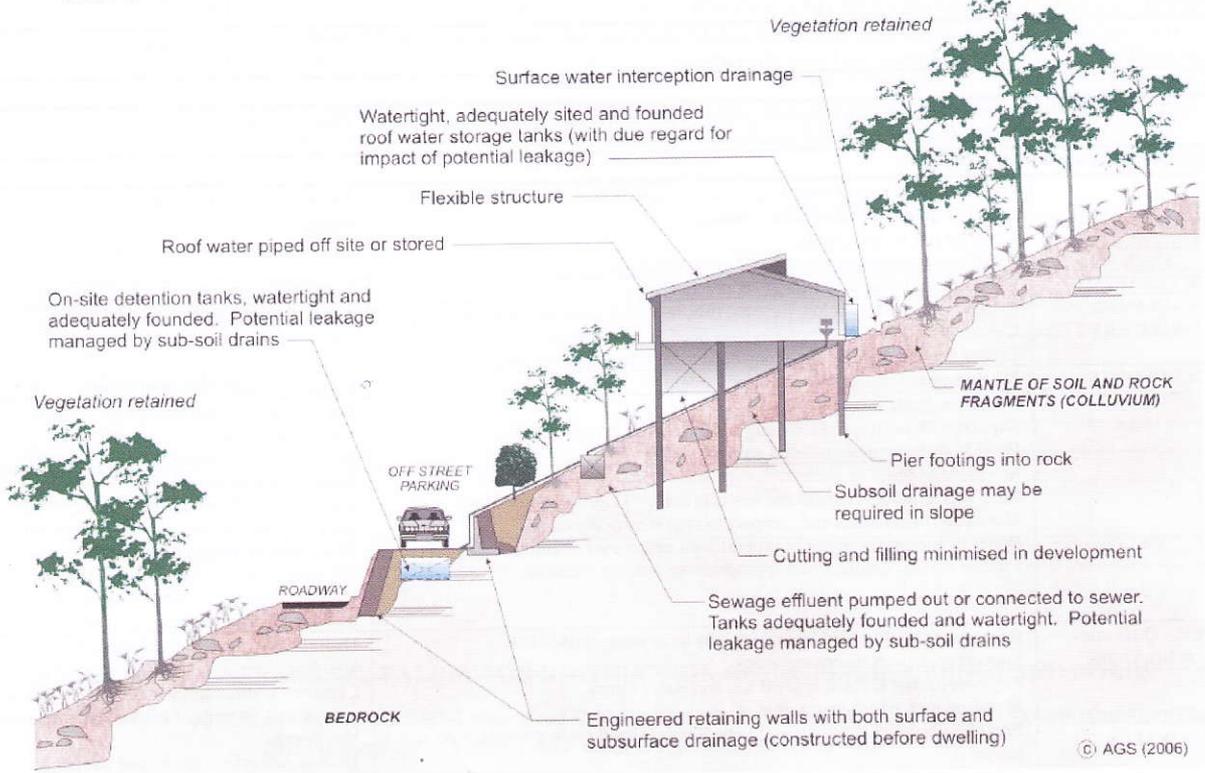
EXAMPLES OF **GOOD** HILLSIDE PRACTICE

EROSION CONTROL & LANDSCAPING	Control erosion as this may lead to instability. Revegetate cleared area.	Failure to observe earthworks and drainage recommendations when landscaping.
DRAWINGS AND SITE VISITS DURING CONSTRUCTION		
DRAWINGS	Building Application drawings should be viewed by geotechnical consultant	
SITE VISITS	Site Visits by consultant may be appropriate during construction/	
INSPECTION AND MAINTENANCE BY OWNER		
OWNER'S RESPONSIBILITY	Clean drainage systems; repair broken joints in drains and leaks in supply pipes. Where structural distress is evident see advice. If seepage observed, determine causes or seek advice on consequences.
