UPSS Decommissioning Validation Report

**Selwyn Snow Resort
213A Kings Cross Road
Cabramurra, NSW**

**27 November 2020
2020-GD003-RP2-FINAL**

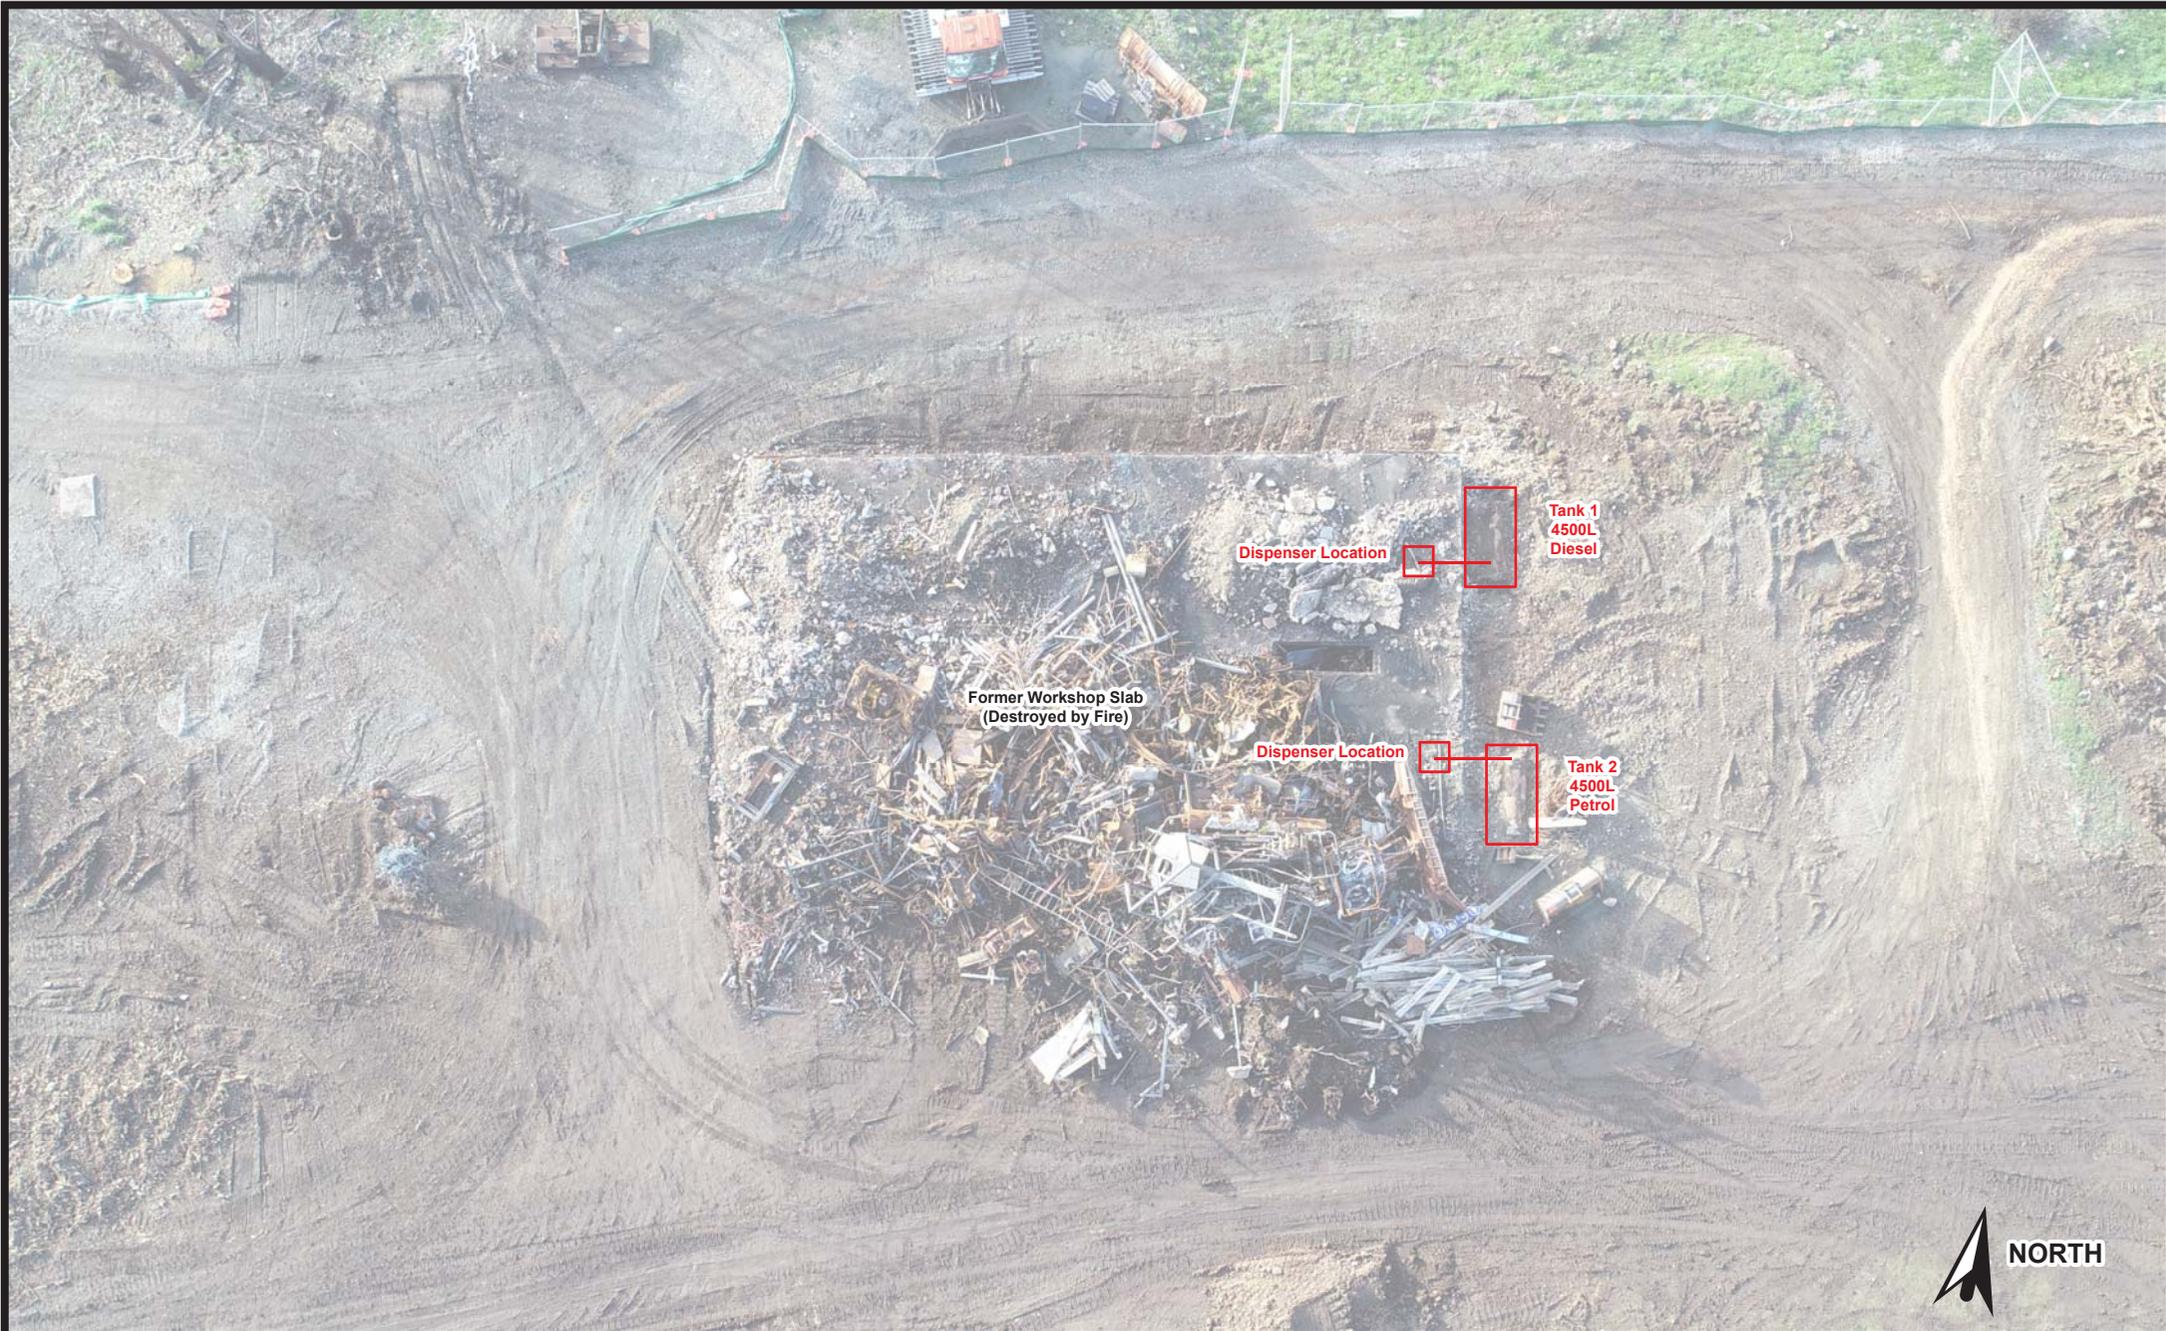
Site Features and UPSS Location

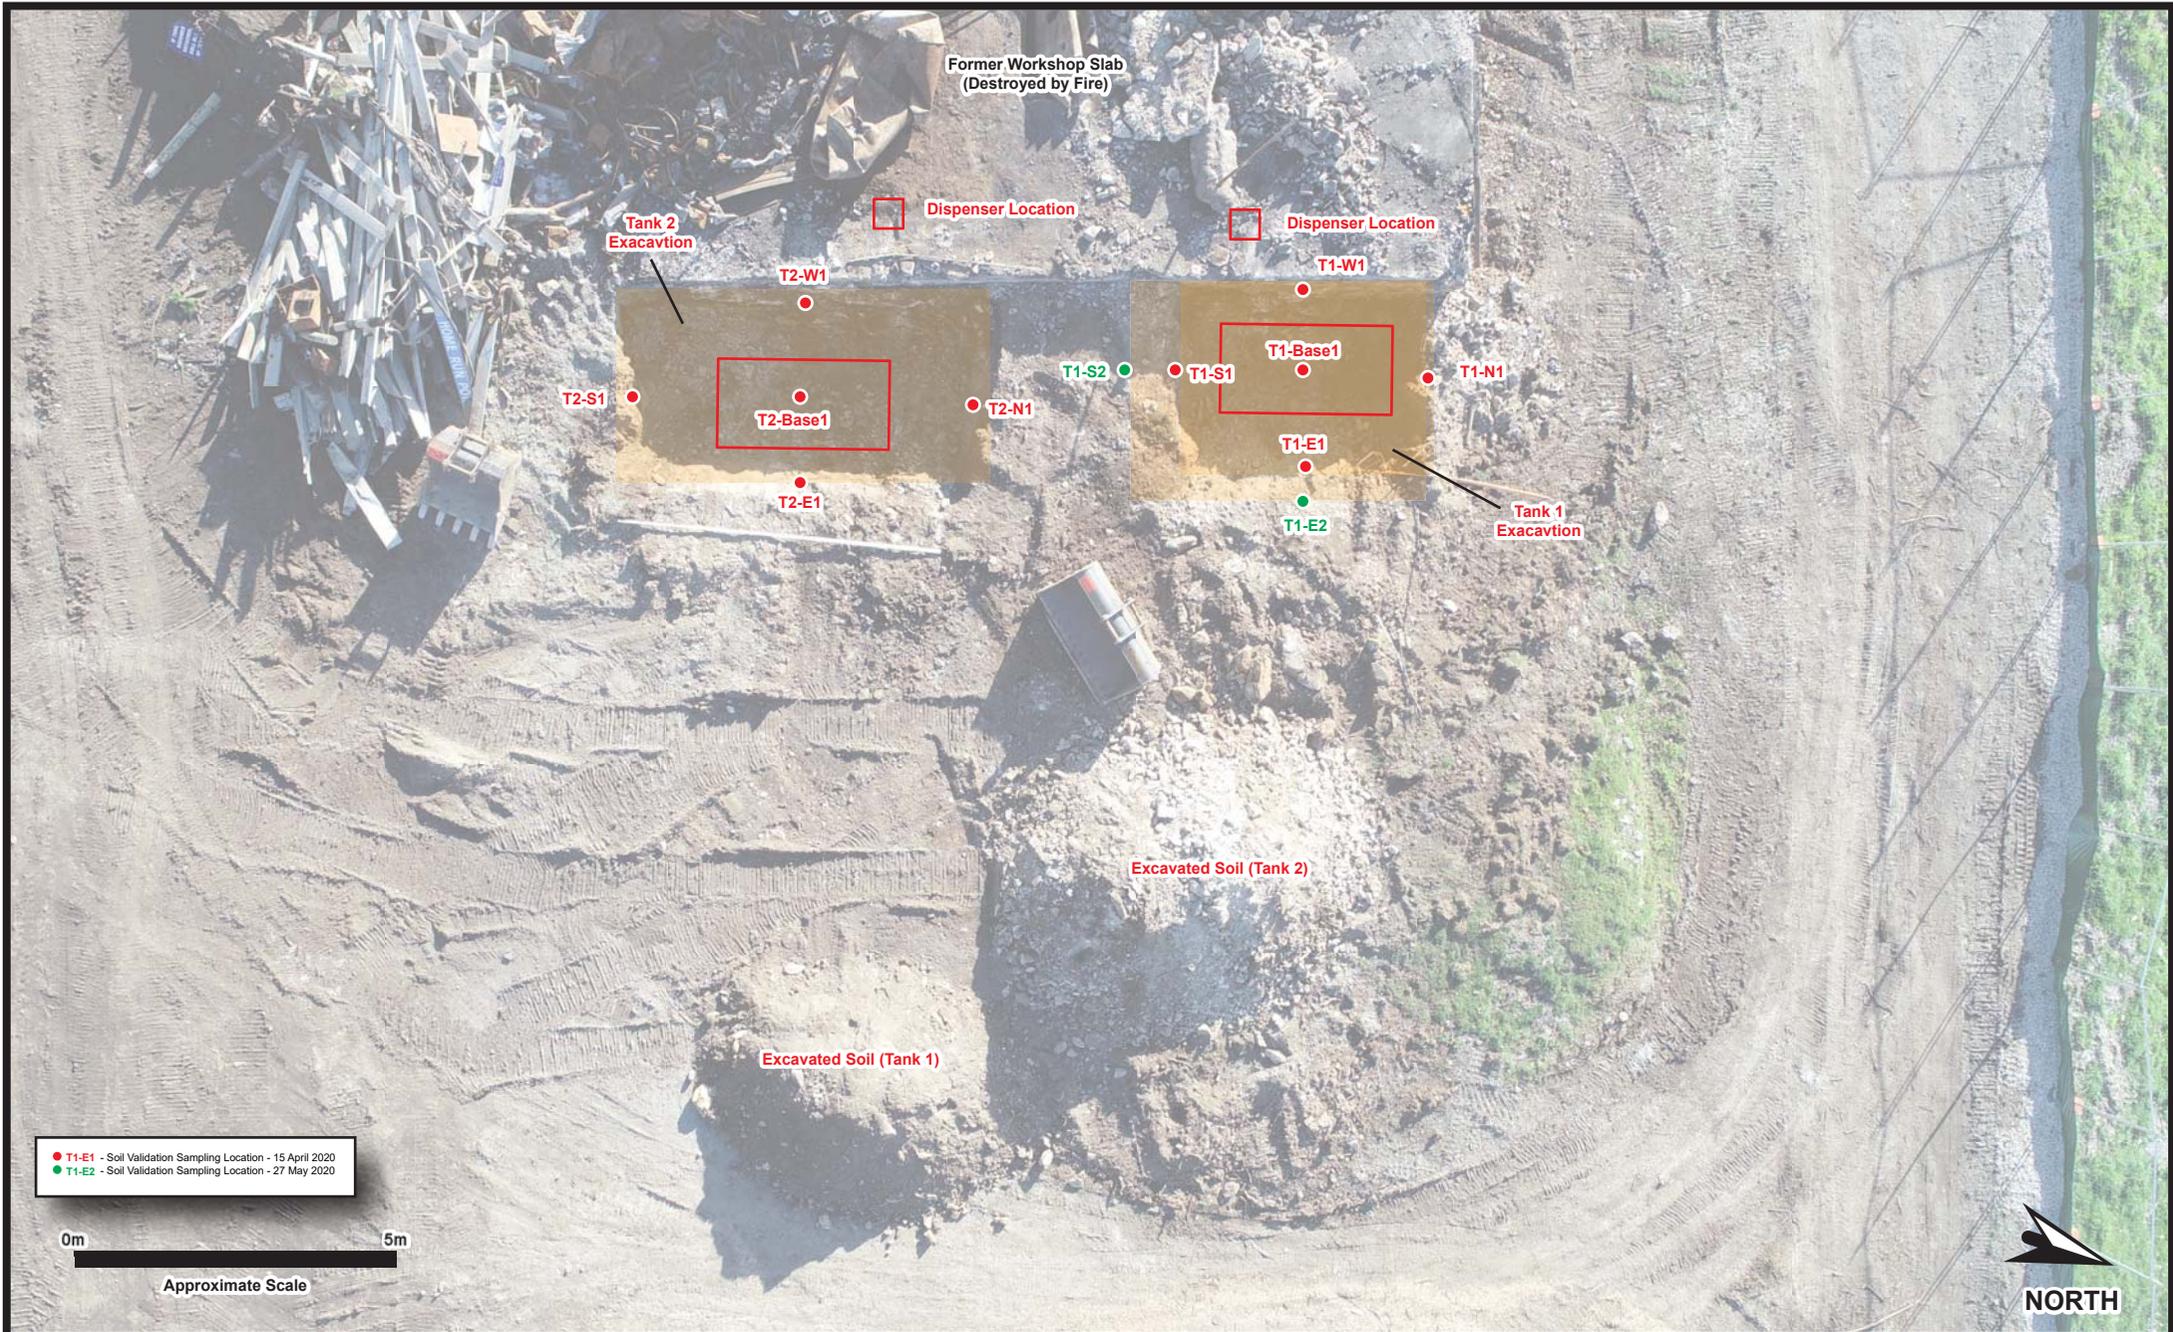
Figure 2

Former UPSS Layout and Features

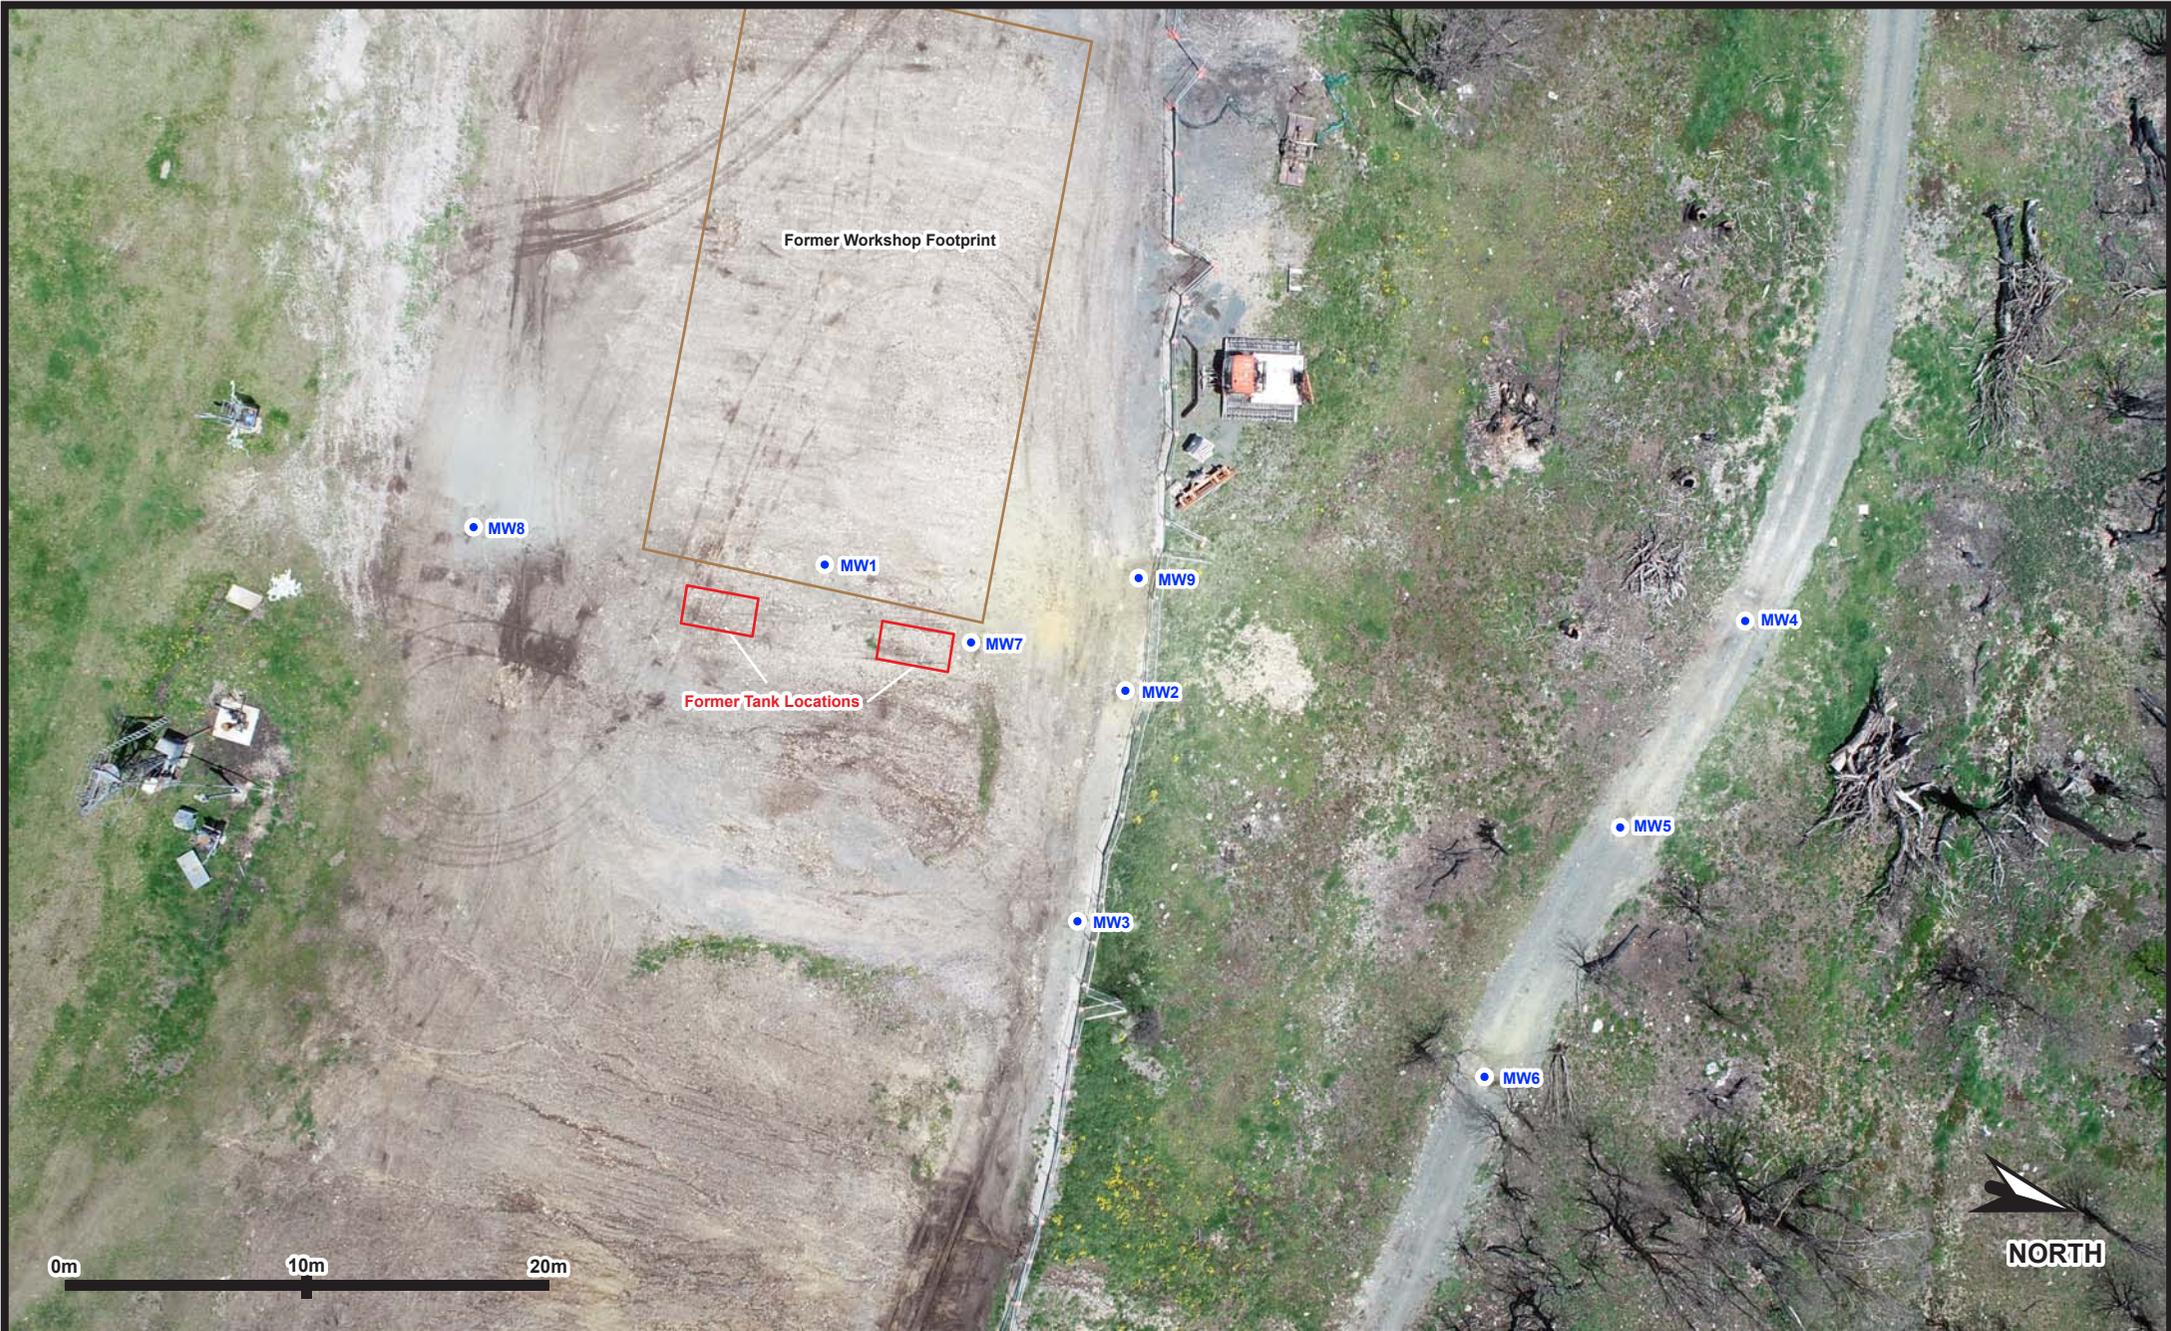
Figure 3

● T1-E1 - Soil Validation Sampling Location - 15 April 2020
● T1-E2 - Soil Validation Sampling Location - 27 May 2020

UPSS Excavations and Soil Validation Sampling Locations

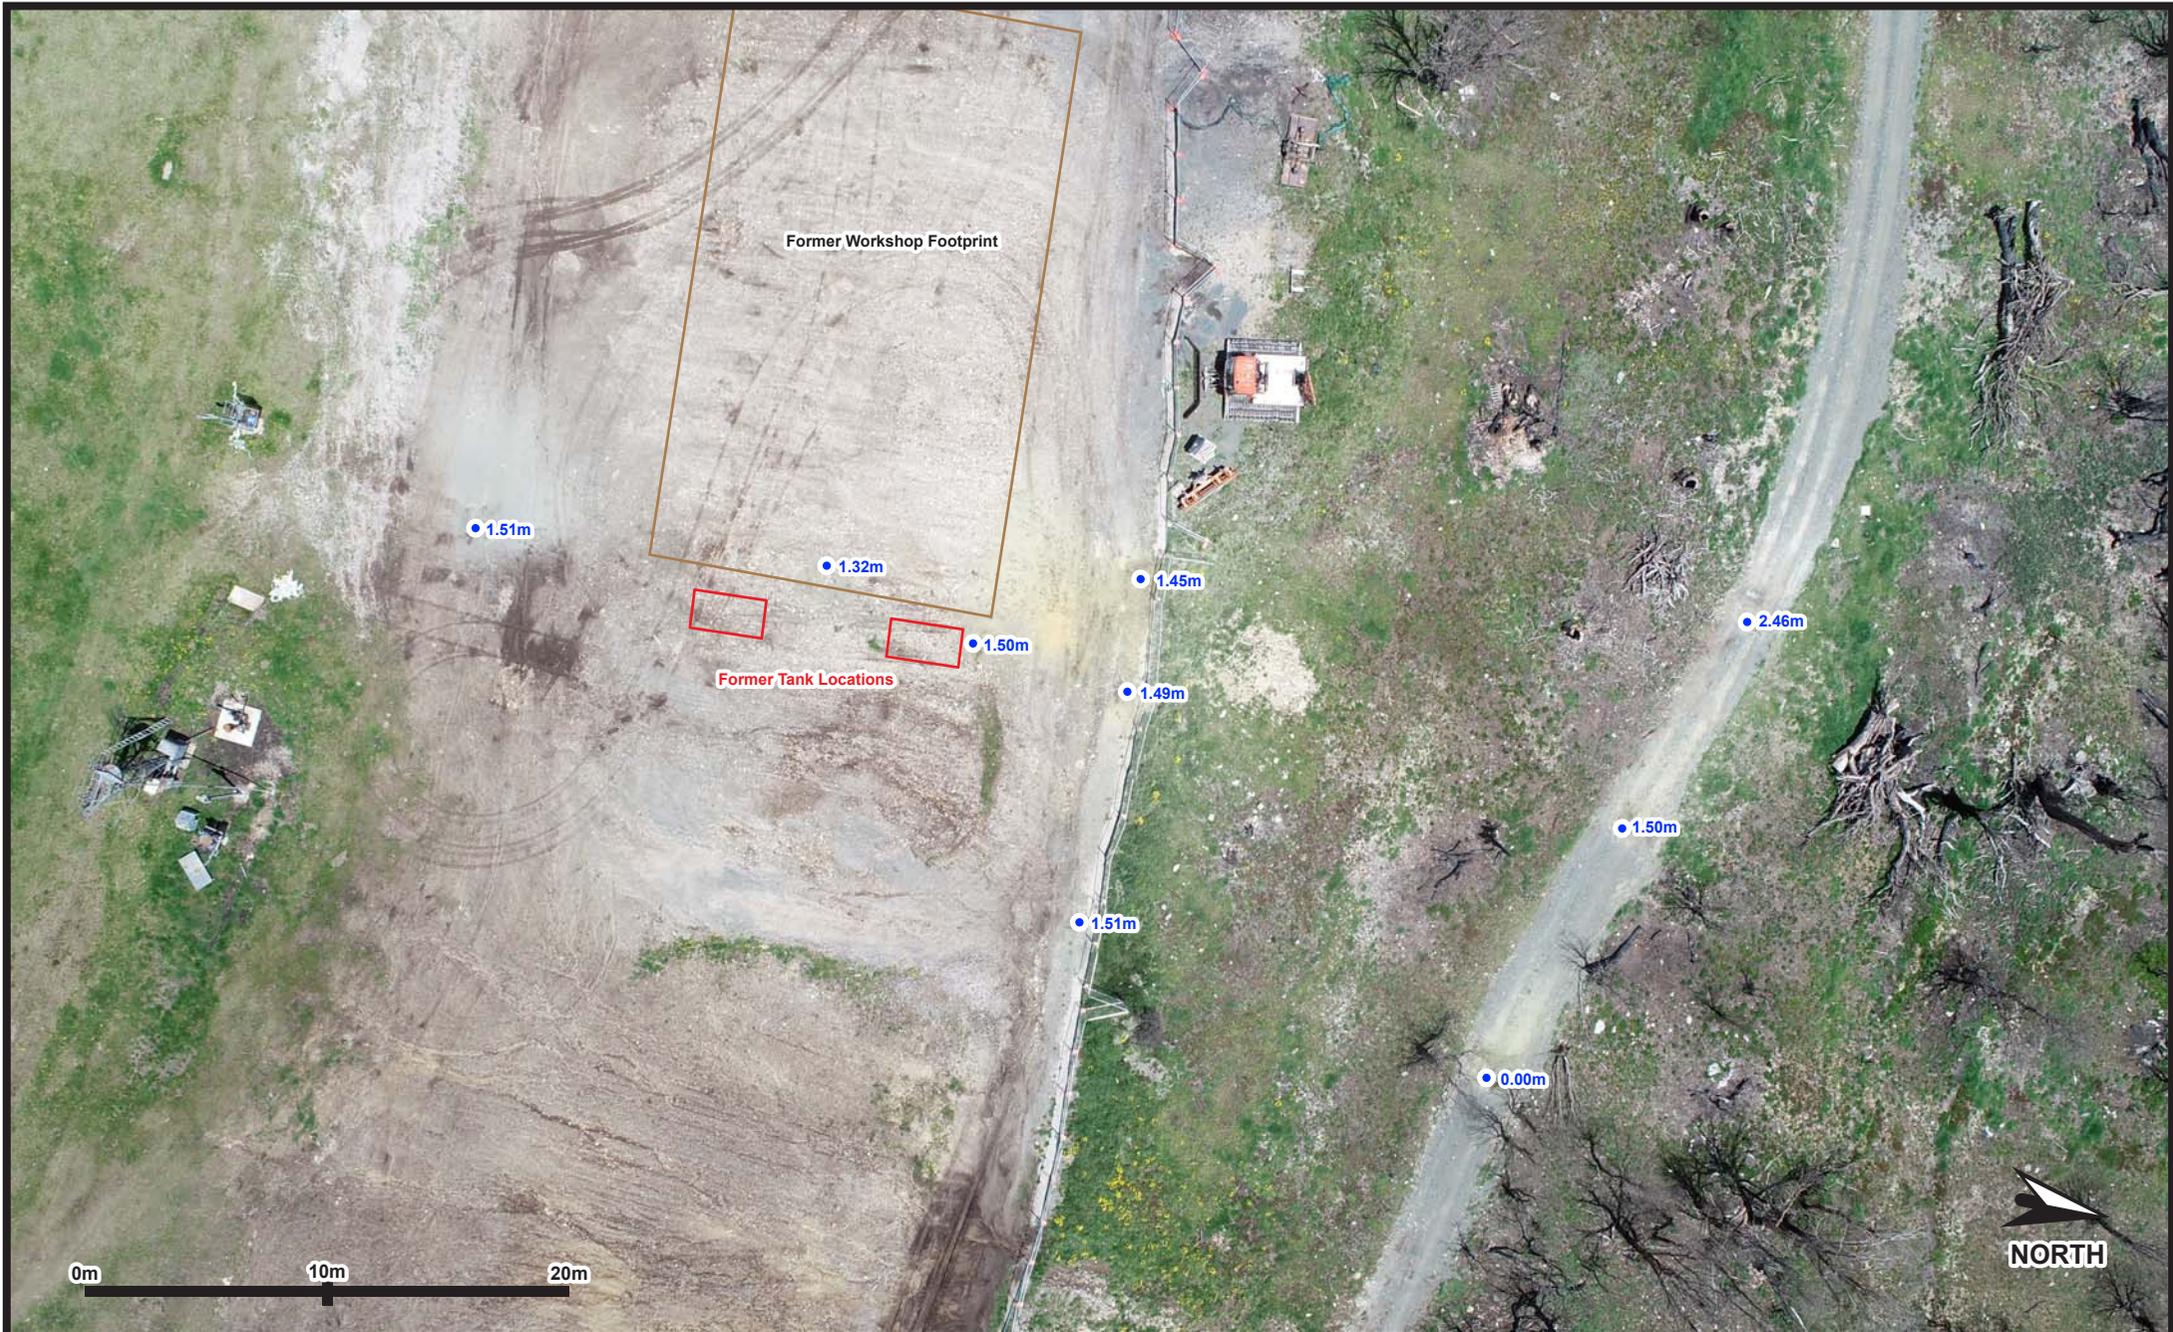
Figure 4

Groundwater Monitoring Well Locations

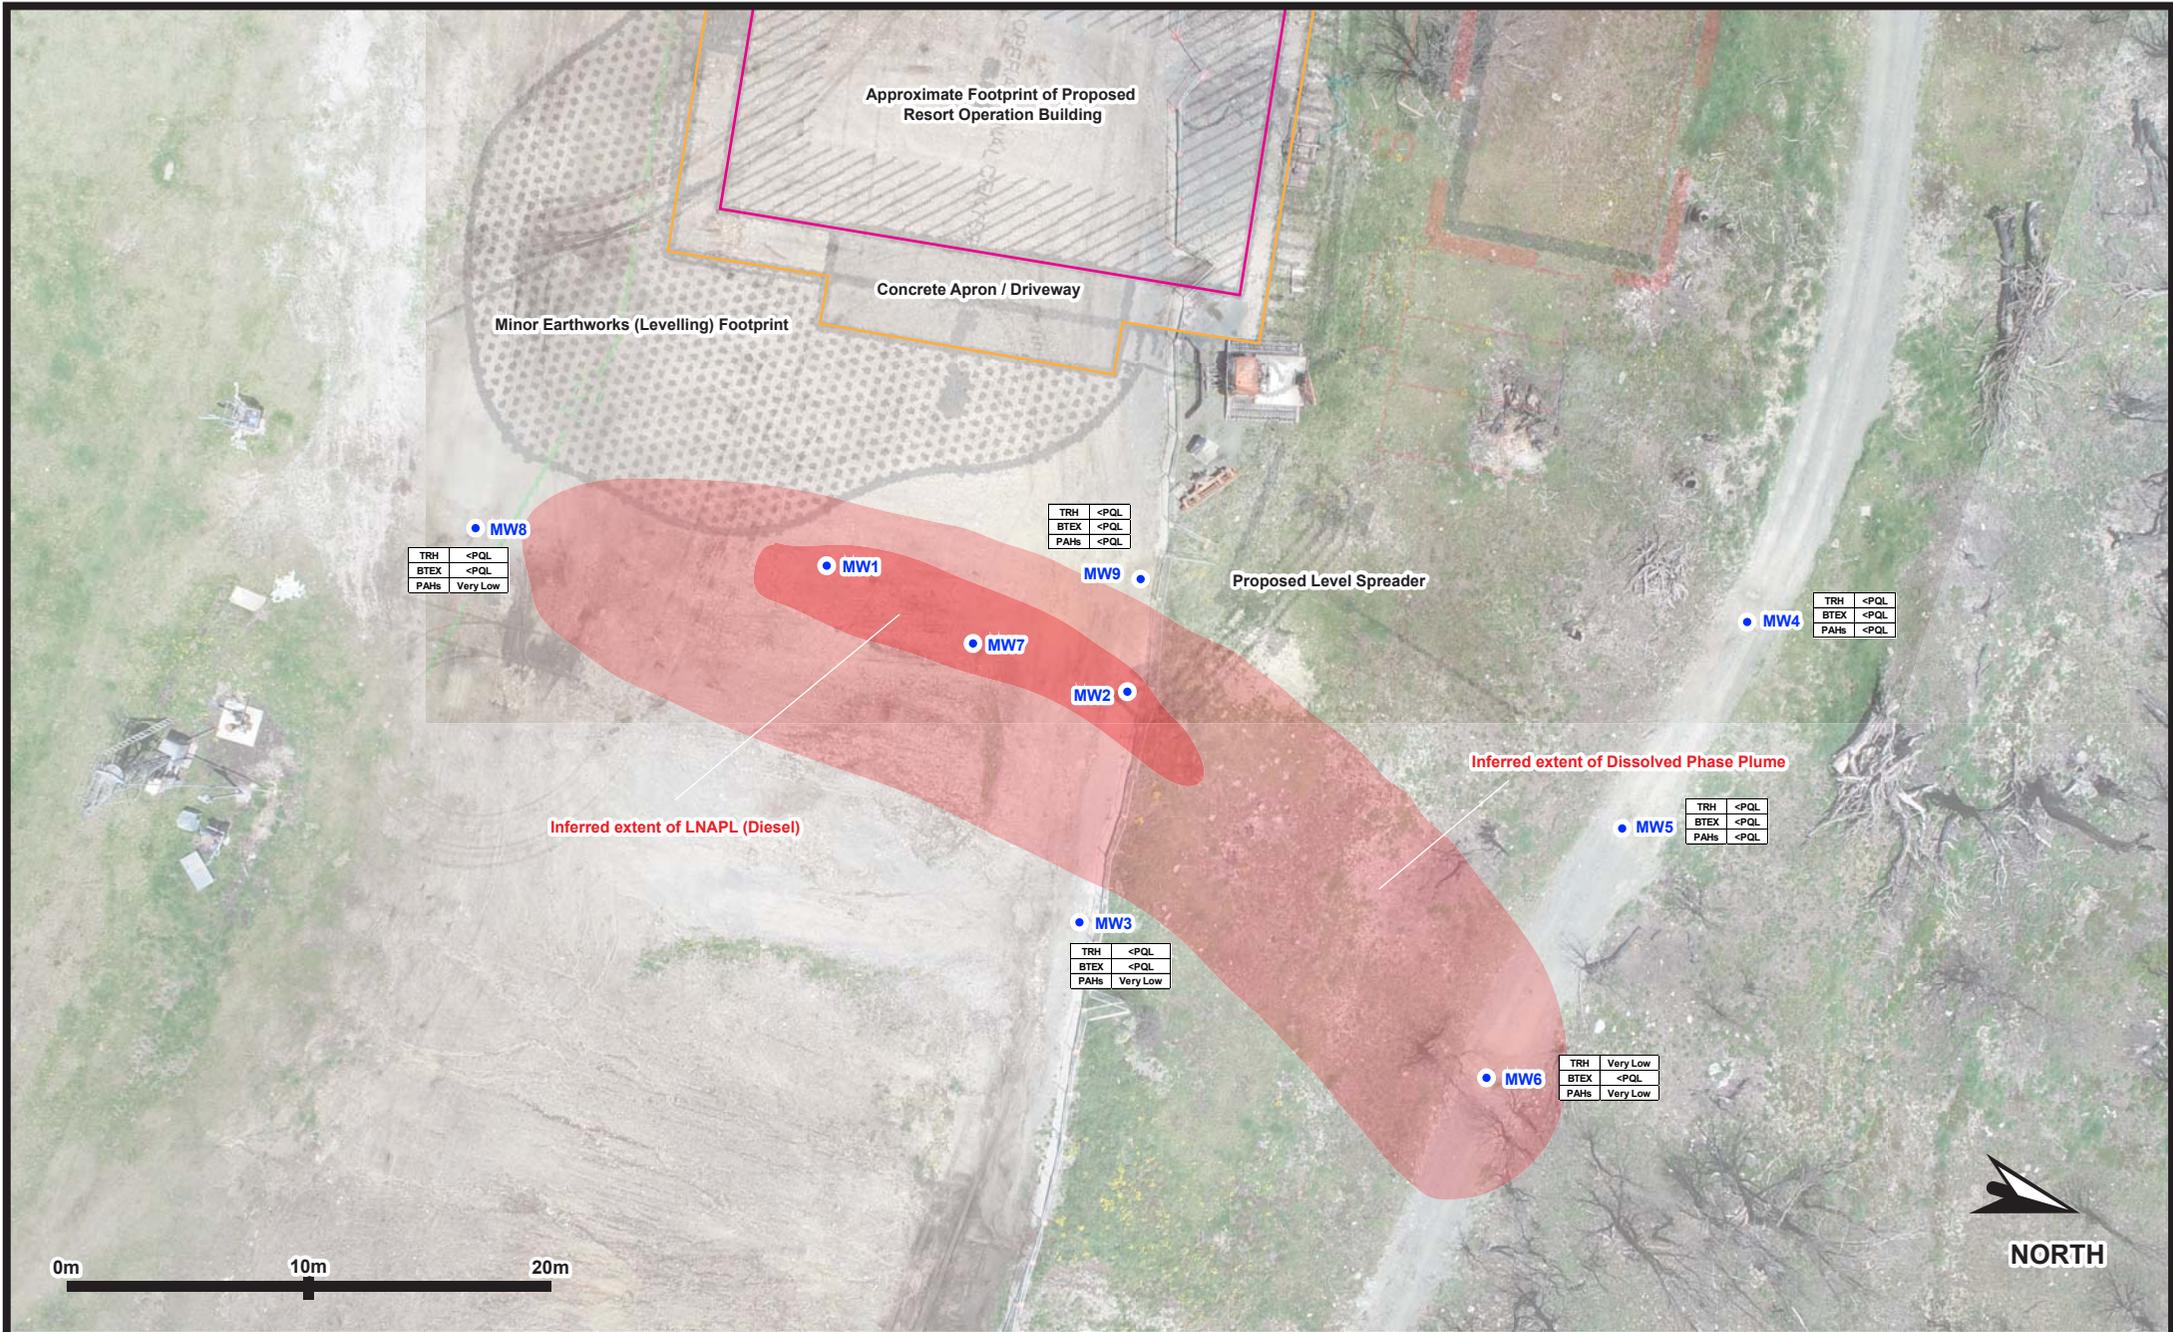
Figure 5

Relative Groundwater Elevations - 18 November 2020

- Groundwater elevation data is difficult to interpret with any certainty and is indicative of a complex fracture system. Relative groundwater elevation data is presented in *Figure 5 of Annex A*. The lowest relative groundwater elevation was observed at MW6. The detection of TRH at this location indicates that the dissolved phase plume travels in a northerly direction from the former UPSS toward MW6, consistent with surface topography.

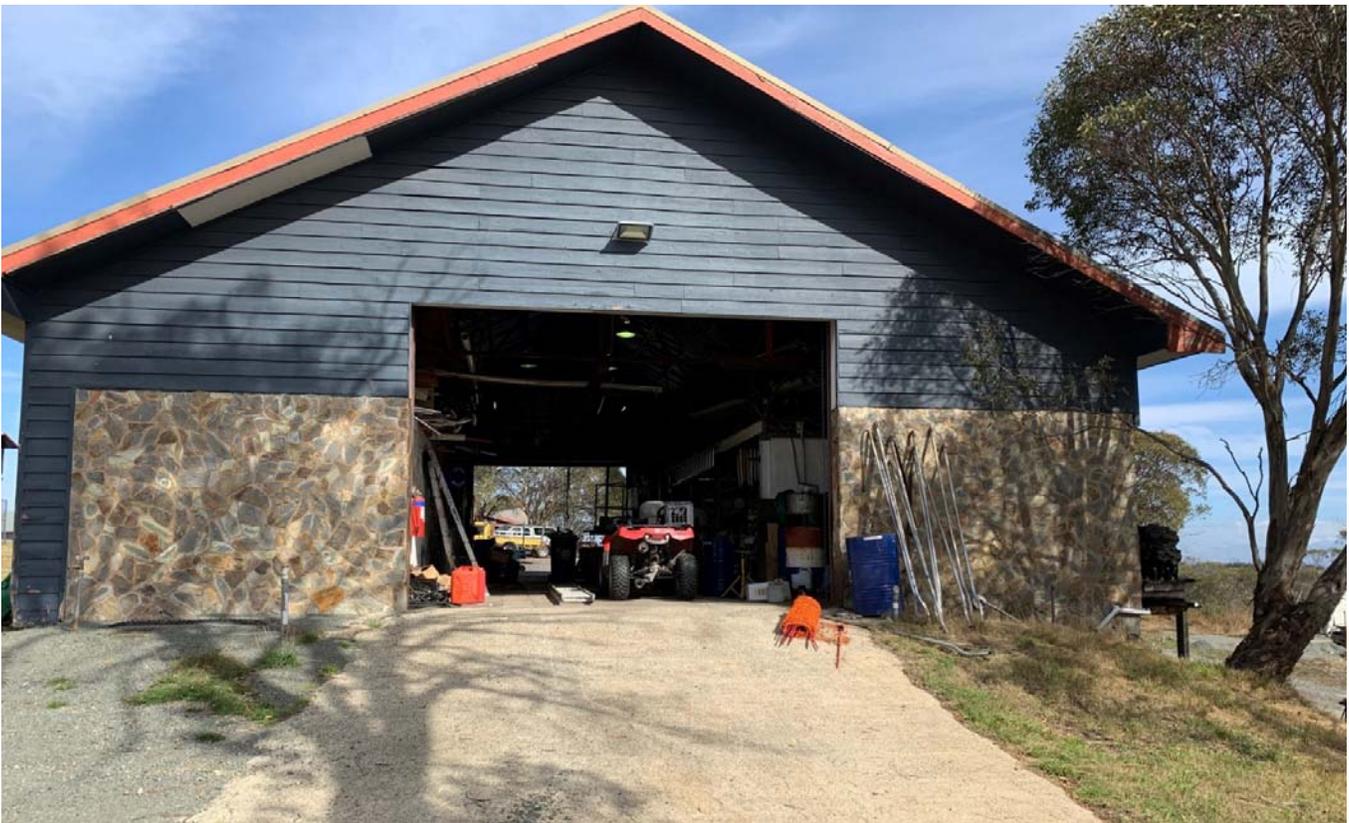
The former Workshop prior to the January 2020 bushfires. Fill pipes and vent pipes are either side of the driveway. Tank 1 on the right side and Tank 2 on the left side.

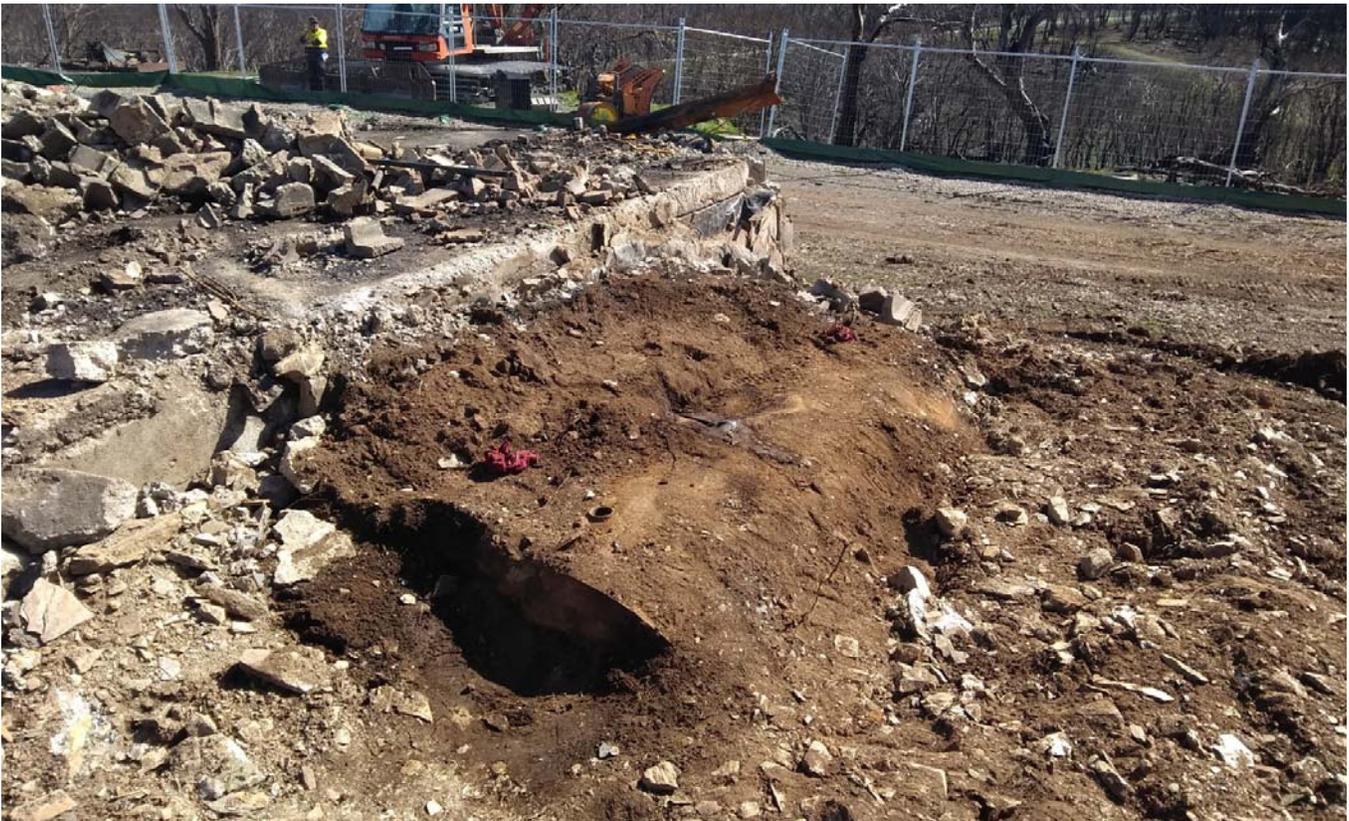
The exposed top of Tank 1 prior to removal.

Tank 1 was inspected at the time of removal. Ground Doctor did not observe any obvious holes in the tank. The tank was corroded. Lower sides of the tank had an oily sheen on the surface.

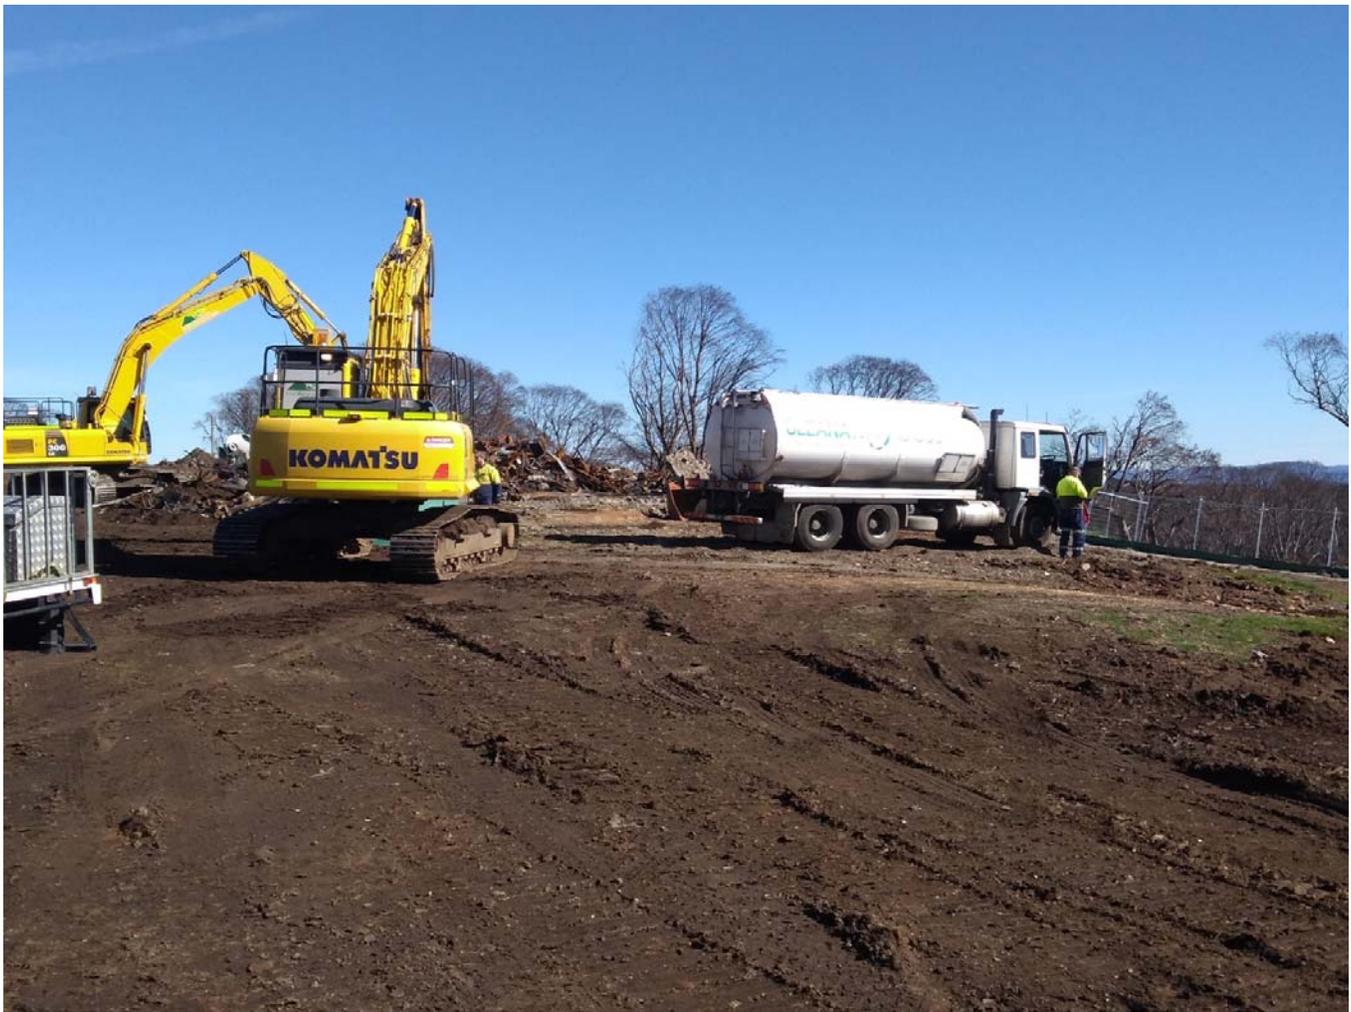
Liquid waste was collected and disposed by Cleanaway prior to tank removal.

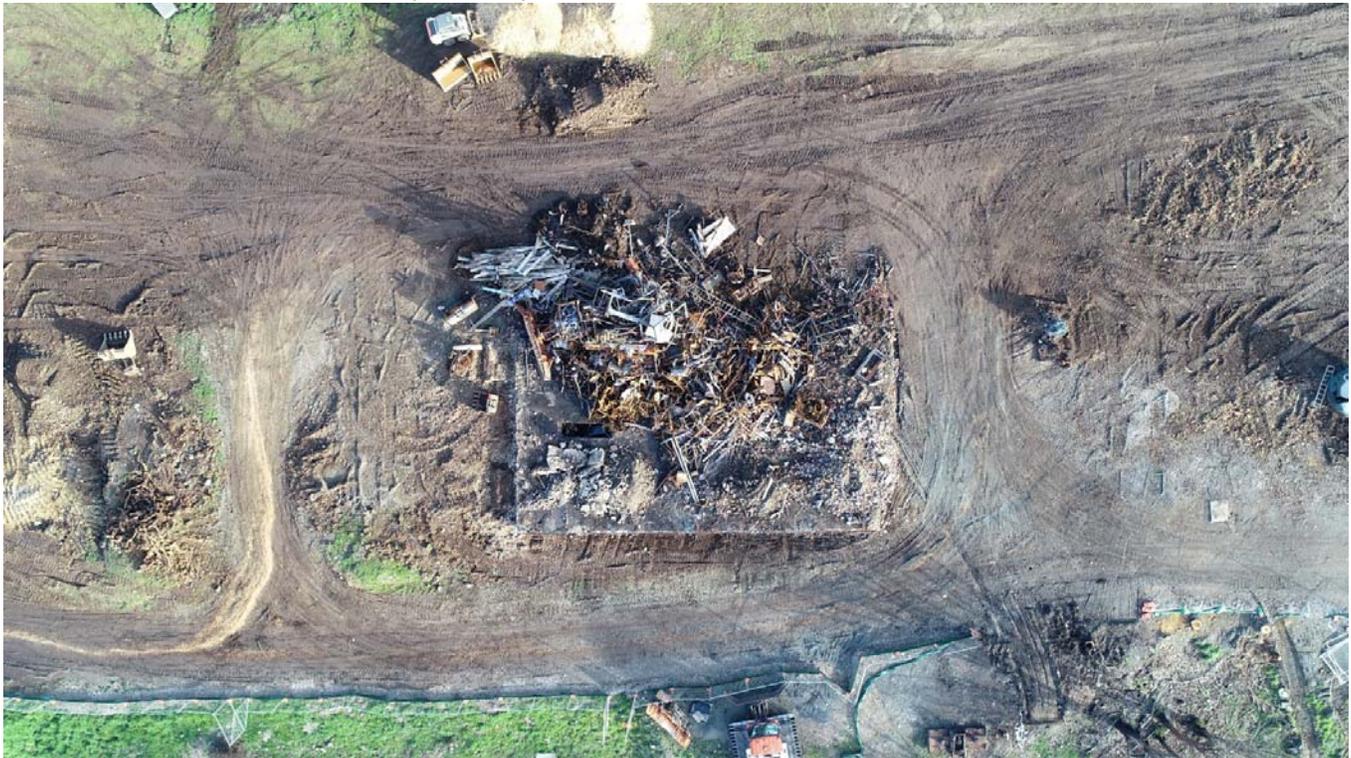
Aerial photo showing the concrete floor of the former workshop. Exposed tops of Tank 1 and Tank 2 are visible on the left hand side of the slab.

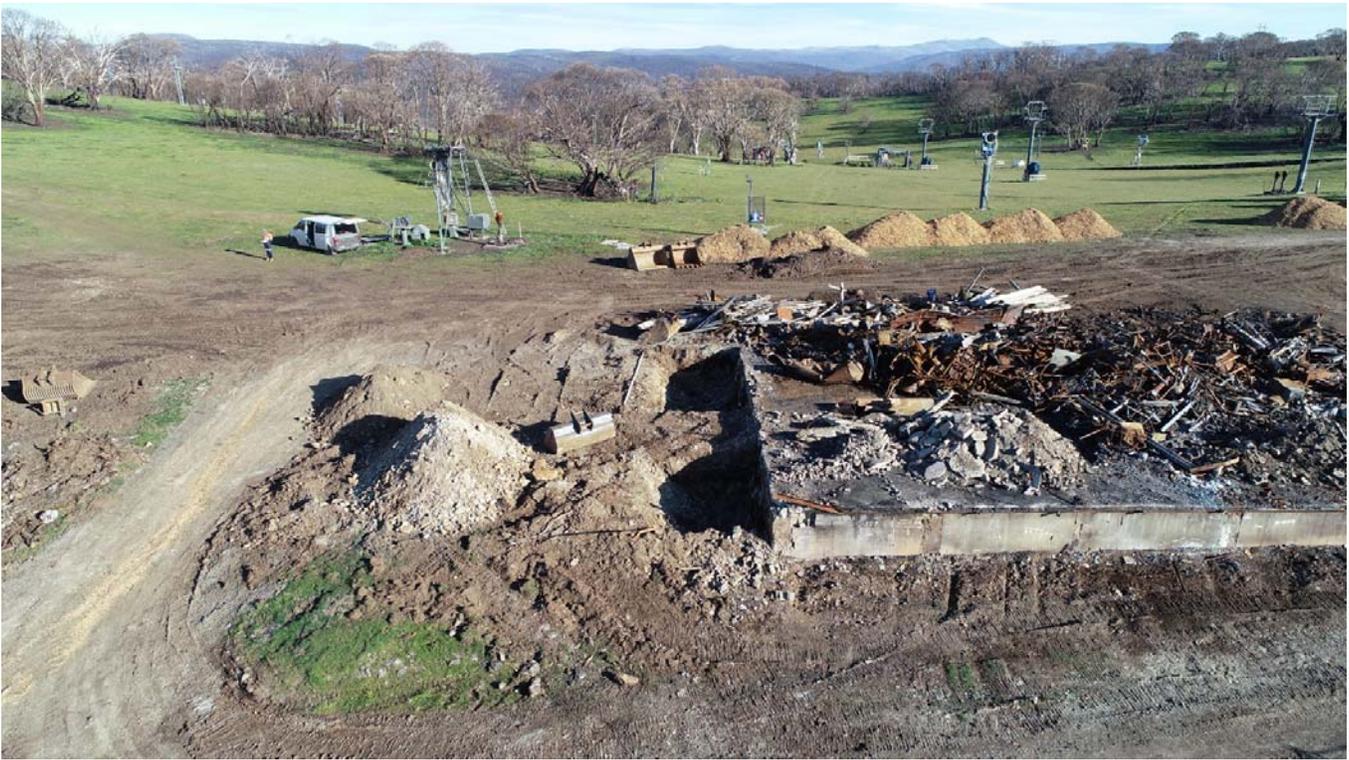
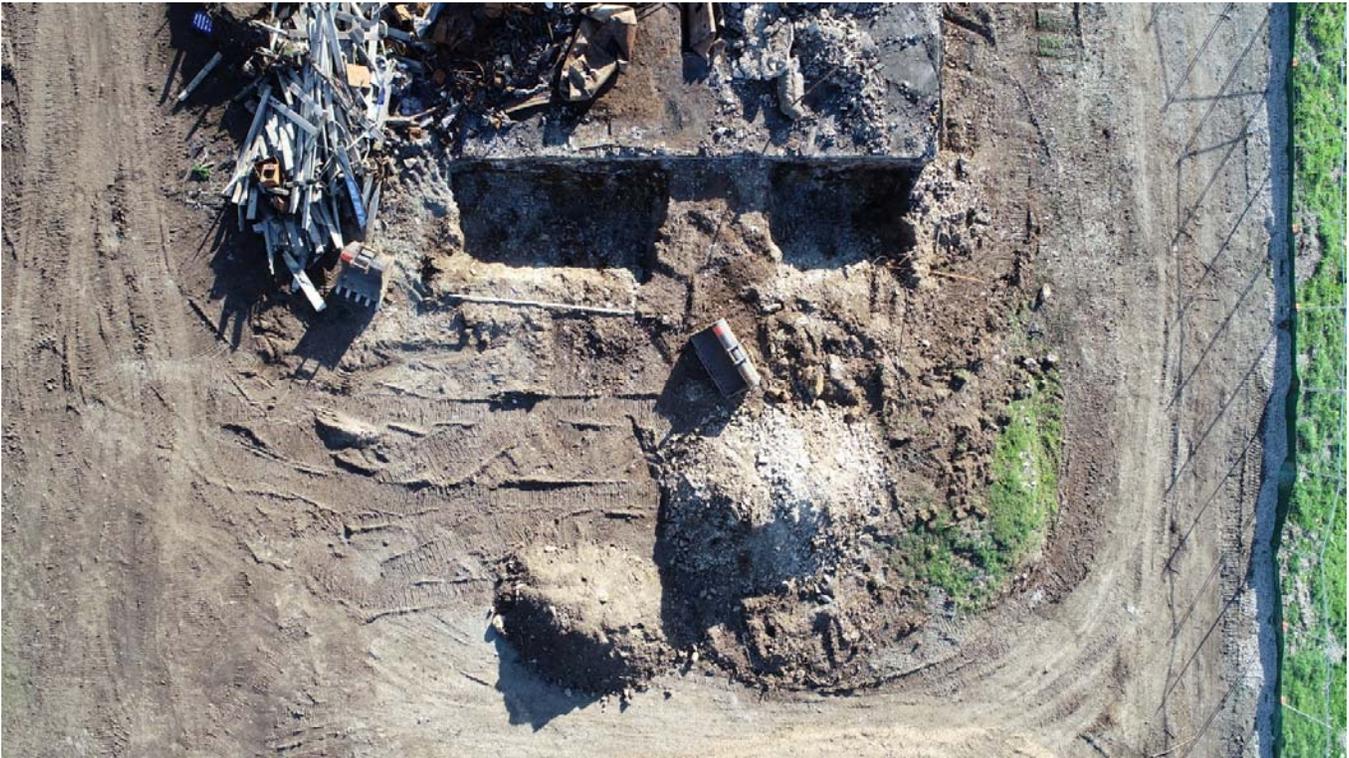
Tank excavations and stockpiled soil on the afternoon of 15 April 2020 following tank removal and soil validation sampling.

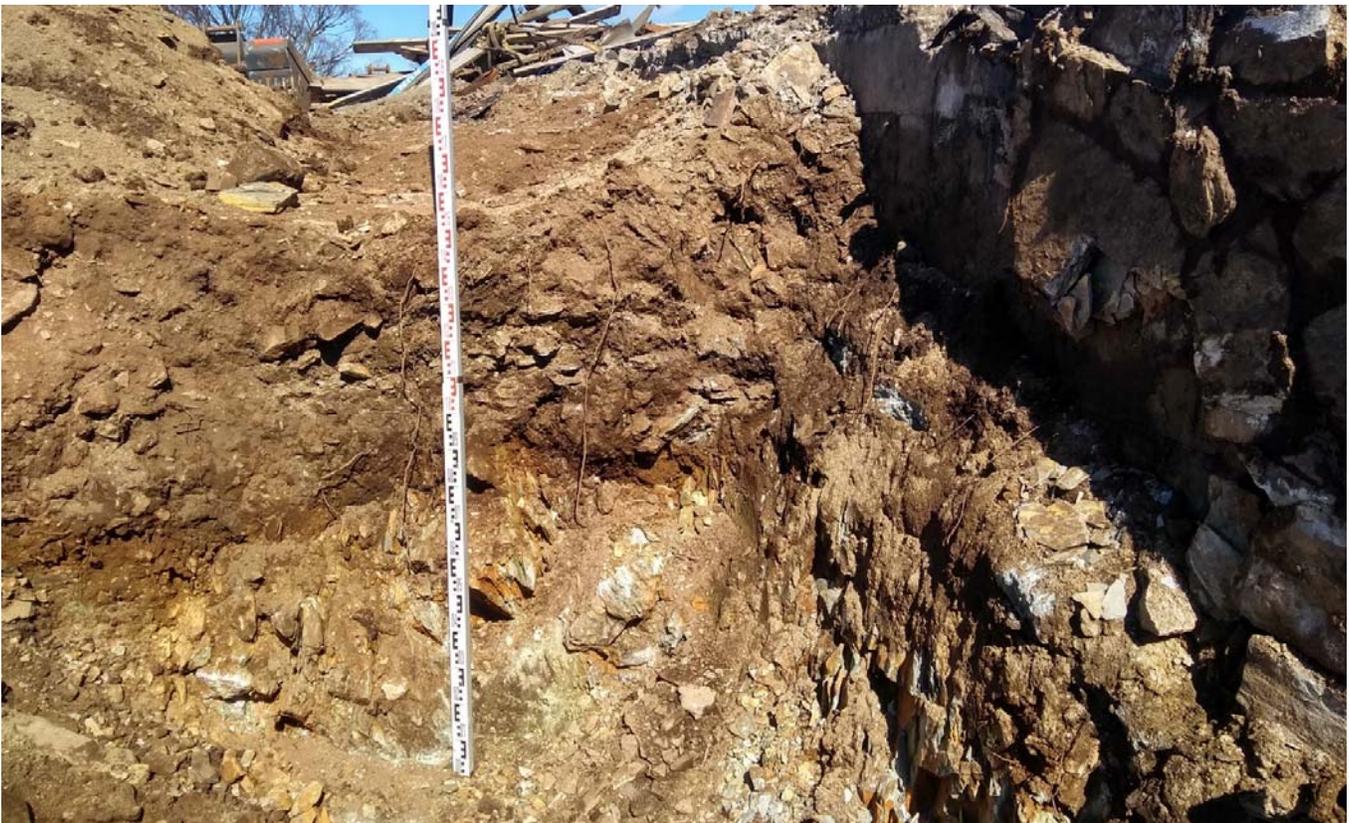
Tank 1 and Tank 2 were buried with the tops at the ground surface, presumably due to the presence of shallow bedrock. The upper 0.5-1.0m of soil surrounding the tanks was comprised of fill. The fill layer was free of synthetic inclusions such as building and demolition rubble indicating that it was most likely virgin excavated natural material sourced locally at the time of the Selwyn Snow Resort construction. The layer of fill was underlain by less than 0.3m of undisturbed natural soil that consisted of clayey silt and broken phyllite, grading to phyllite at depth.

Soil profile on the southern wall of the Tank 1 excavation. Phyllite bedrock was encountered less than 1m below the ground surface.
