UPSS Decommissioning Validation Report

**Selwyn Snow Resort
213A Kings Cross Road
Cabramurra, NSW**

**27 November 2020
2020-GD003-RP2-FINAL**

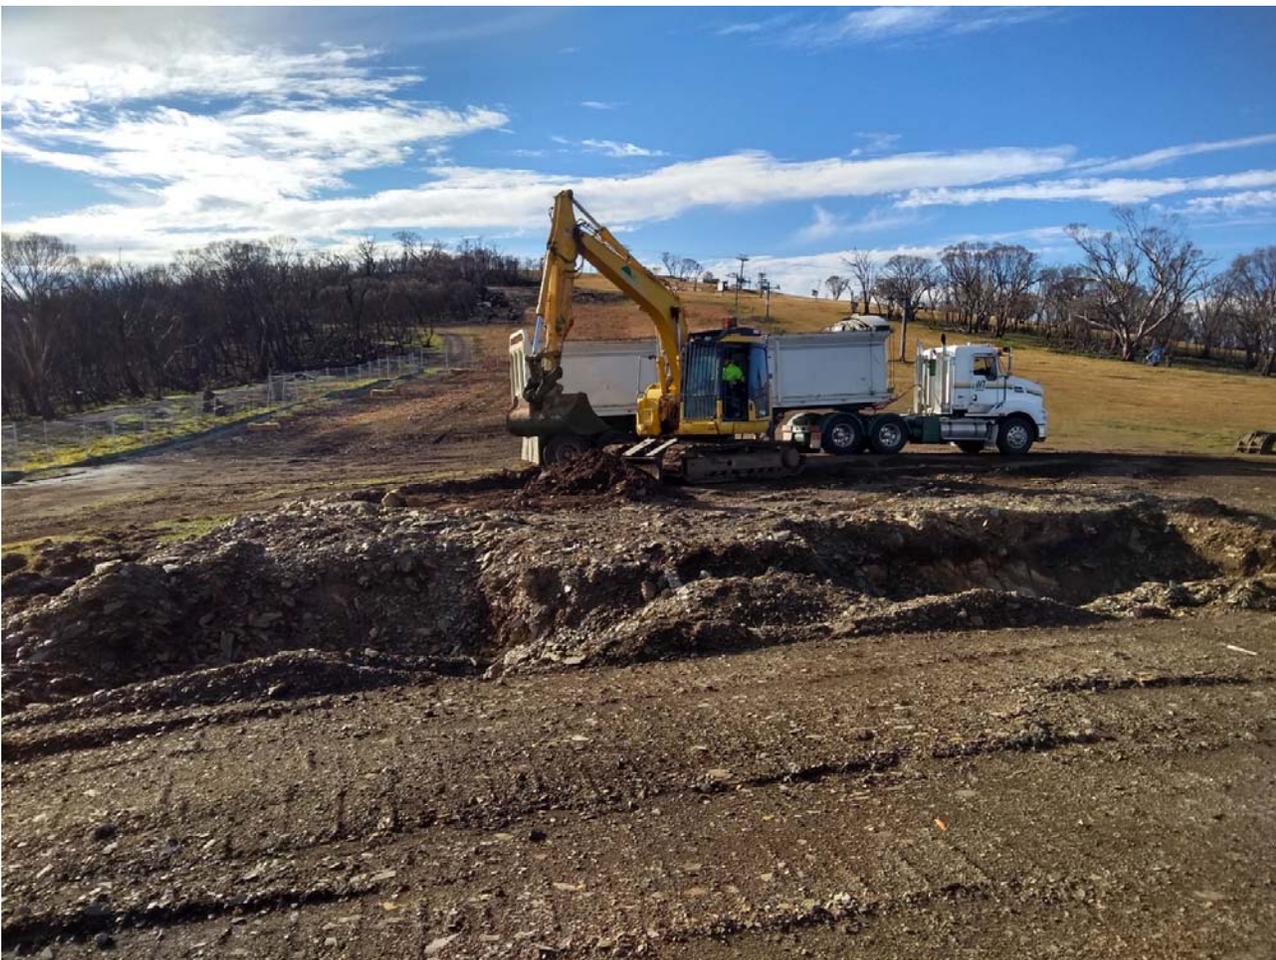
Loading out hydrocarbon impacted soil on 27 May 2020 for off-site disposal.

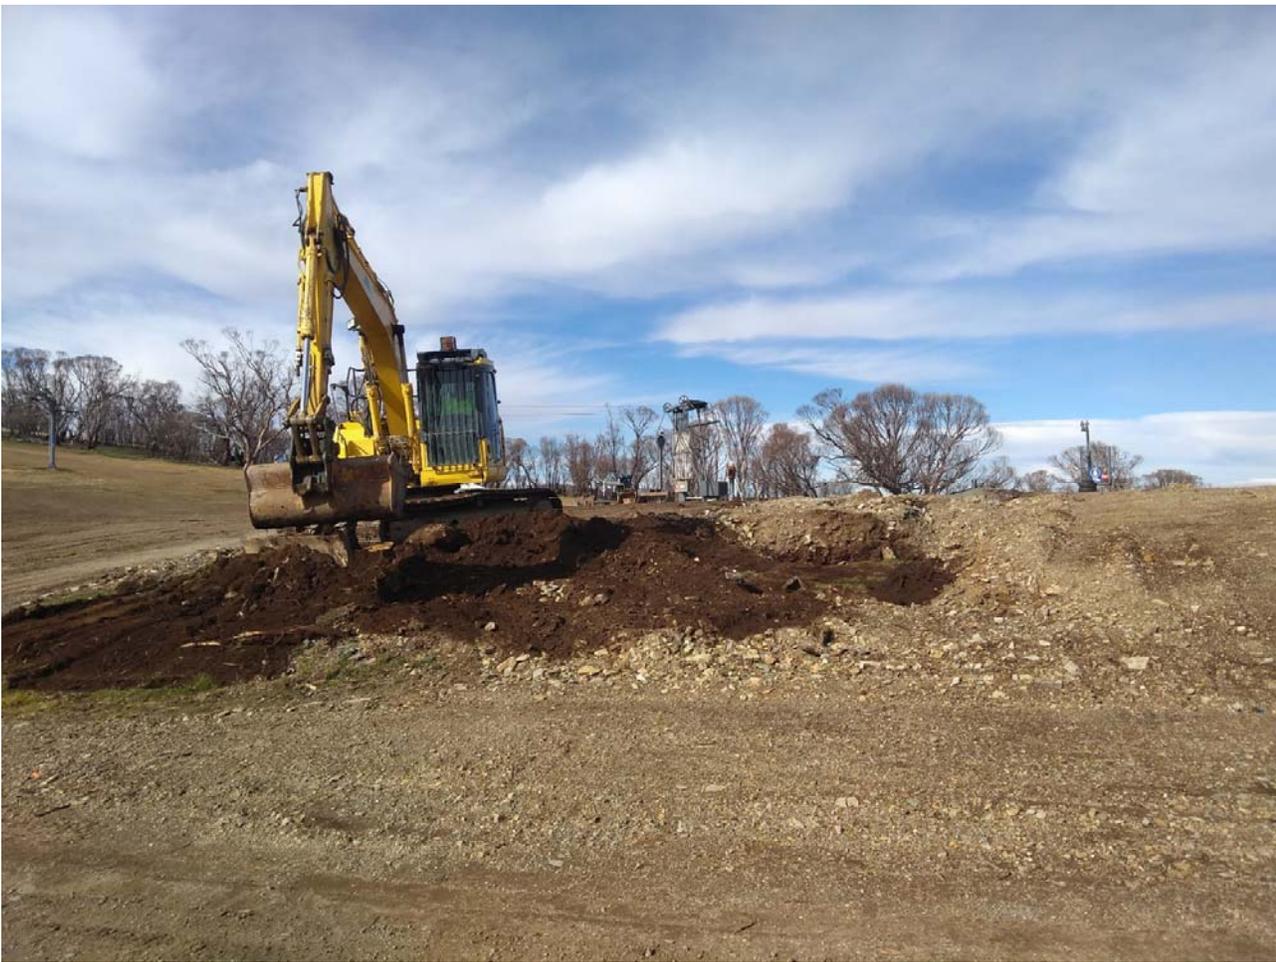
Excavation were backfilled with soil and rock borrowed from the immediate surrounds.

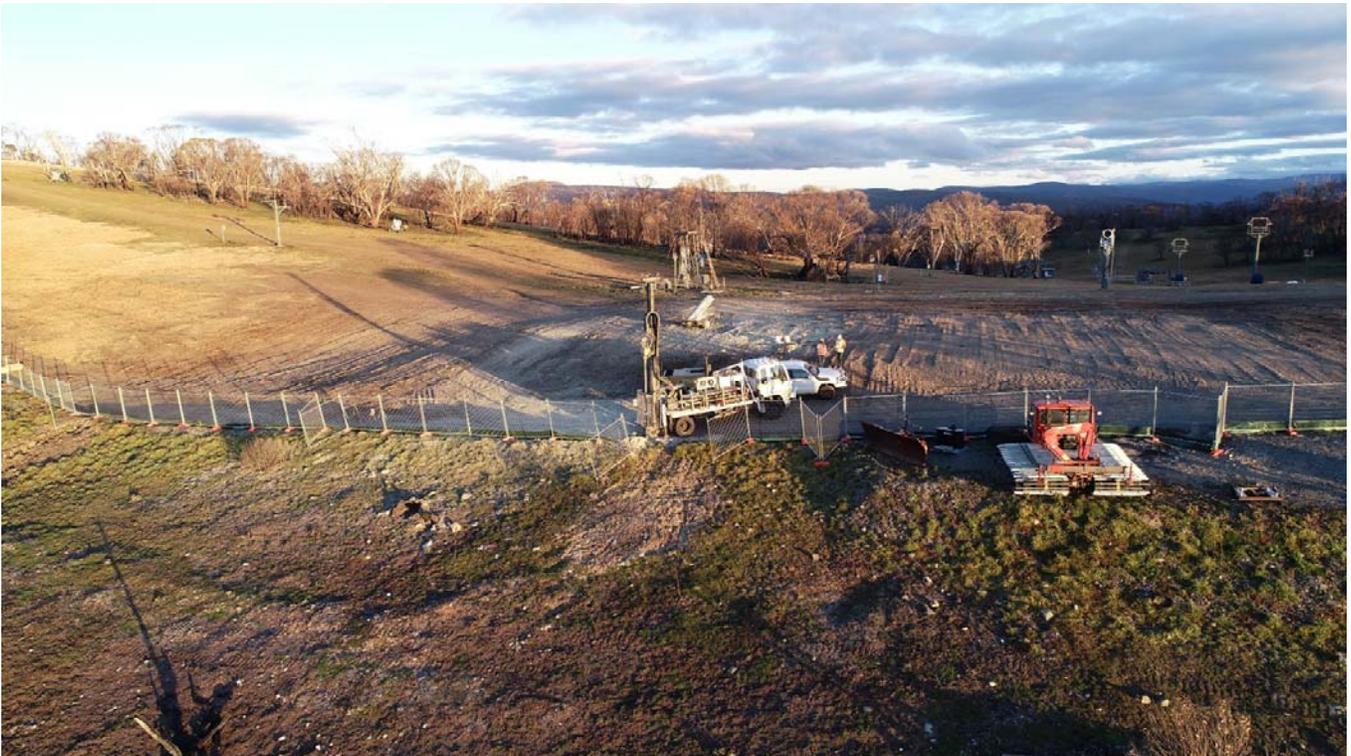
Groundwater monitoring well installation works – 28 May 2020.

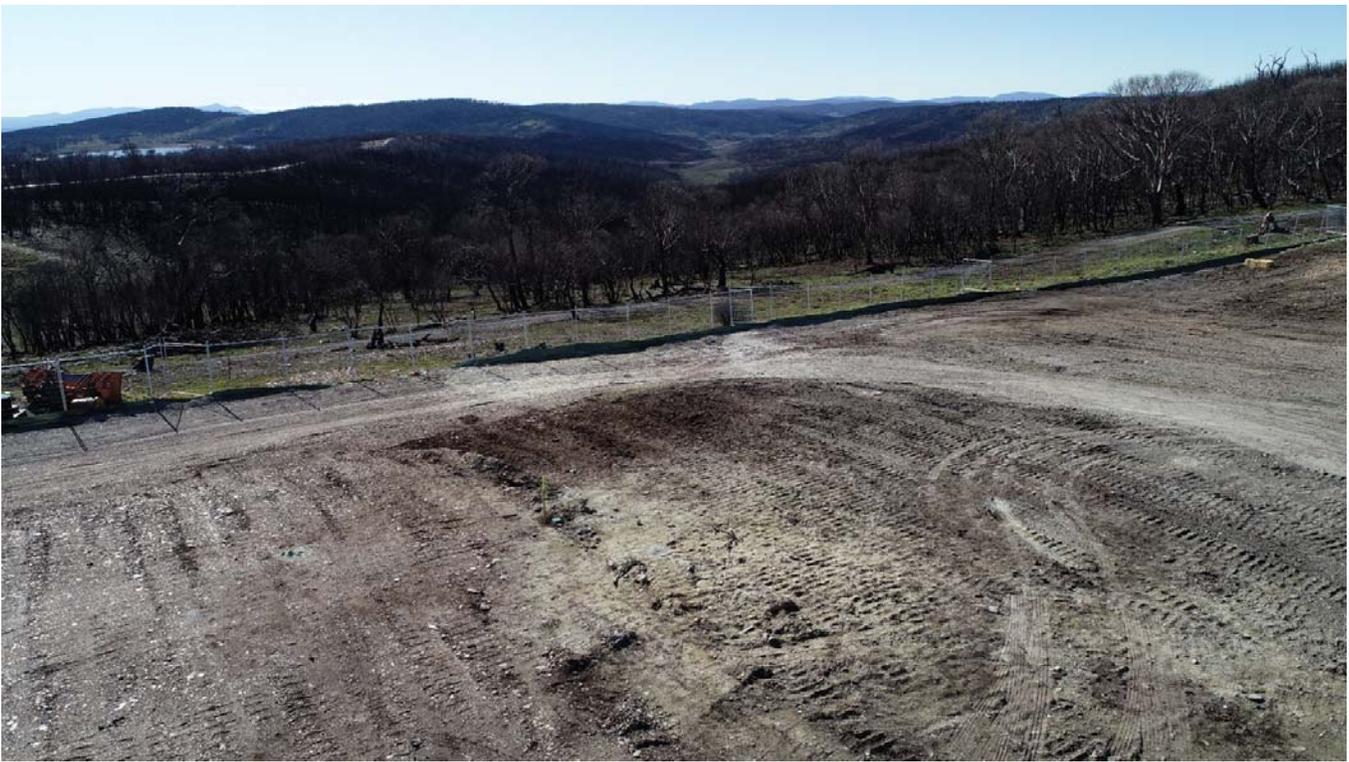
Looking northward across the former UPSS area toward Bullocks Head Creek. Monitoring wells are marked by wooden stakes with yellow paint on top. Groundwater elevation data indicates groundwater flow in the direction the photograph is taken.

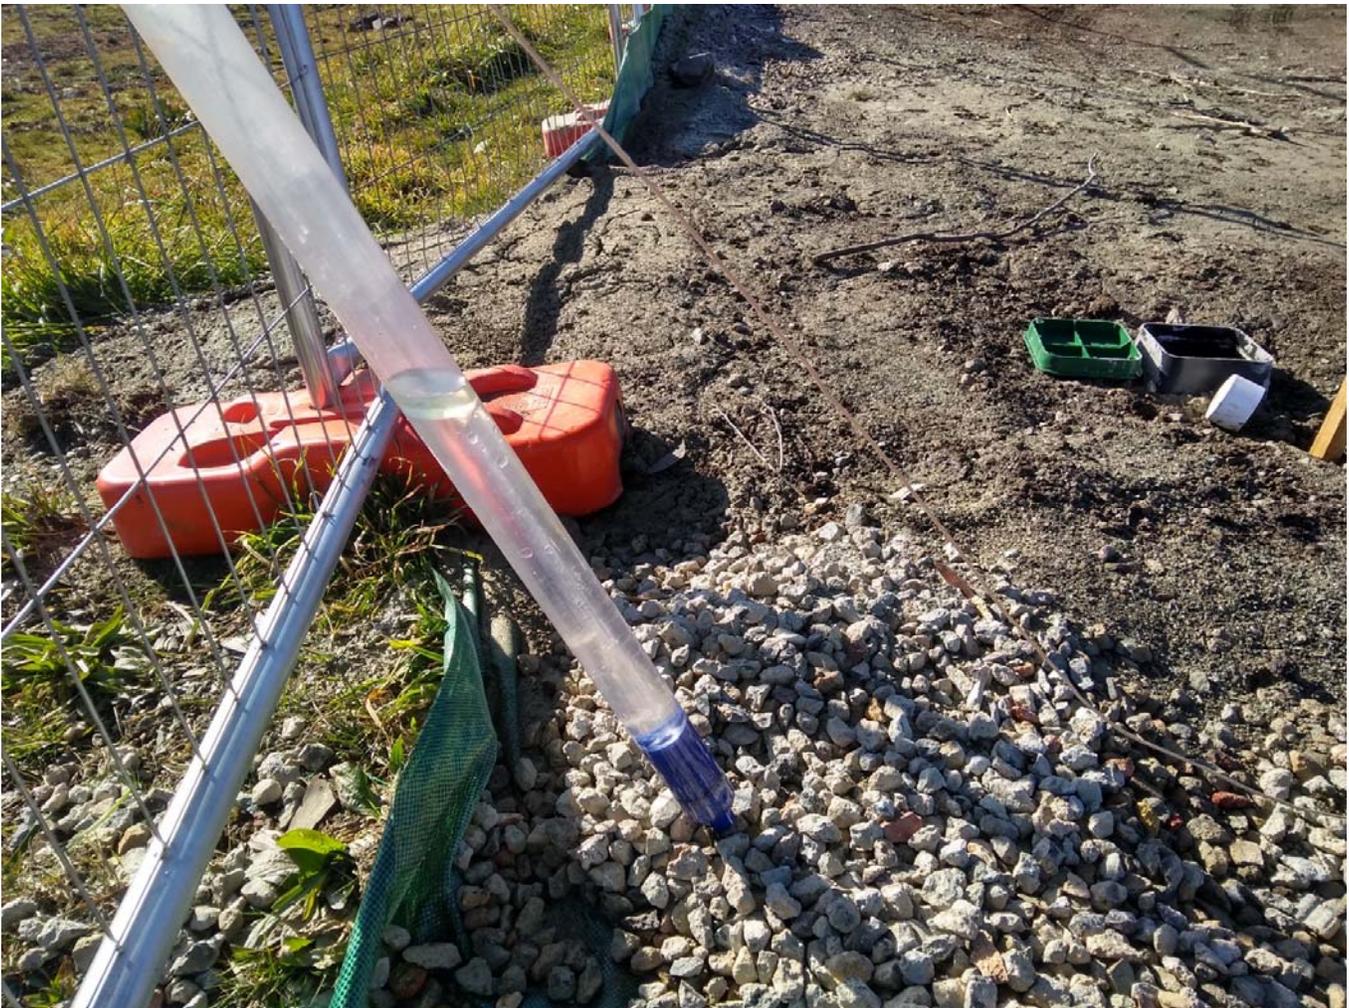
The maximum identified LNAPL thickness of 60mm occurred at MW2 in June 2020. Following removal of LNAPL during the June 2020 monitoring round the maximum observed LNAPL thickness in MW1 and MW2 was approximately 5mm.

A small amount of LNAPL (diesel) was identified on the surface of groundwater within MW2.

Ground Doctor recommends that six monthly groundwater monitoring occur at the site for a period of at least two years to assess any changes to the identified LNAPL and dissolved phase plumes. The conclusions made in this validation assessment should be revised if significant changes to groundwater status are identified. The monitoring works should include:
