Kosciuszko Thredbo Pty Ltd

**Proposed Merritts Gondola
Thredbo, NSW**

Geotechnical Assessment

Our ref: 4474-R1 Rev 1
22 August 2019

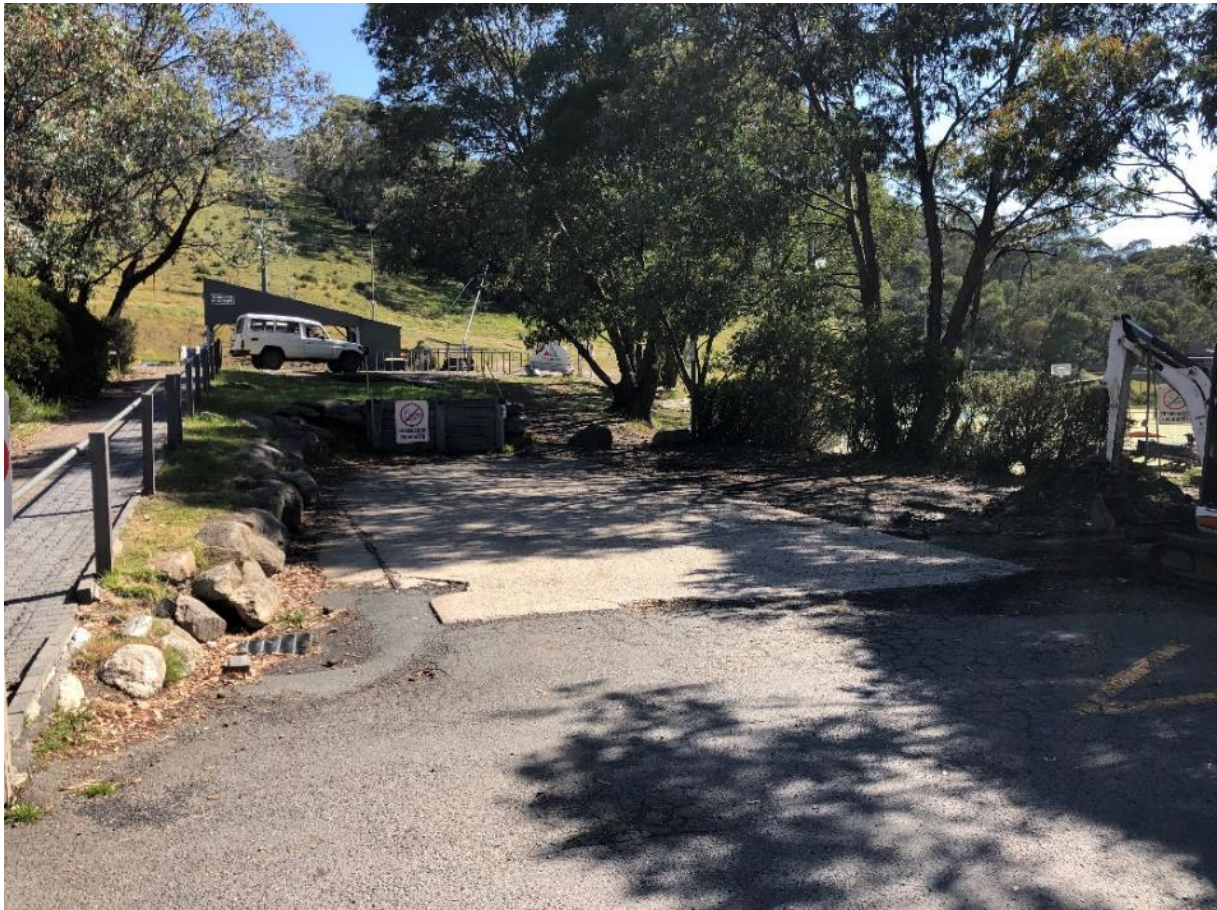
Plate 1

The Thredbo River is located approximately 20 m to 25 m to the south-east. The valley terminal and ticket office buildings are located to the south, and workshop buildings and the Snow Gums Chair Lift are located to the west and north-west respectively, as indicated in the attached Figure 2.
