3438-R1.docx  
6 December 2015

**PROPOSED RILEYS RUN LODGE EXTENSION, LOT 610 MOUNTAIN DRIVE, THREDBO  
GEOTECHNICAL ASSESSMENT**

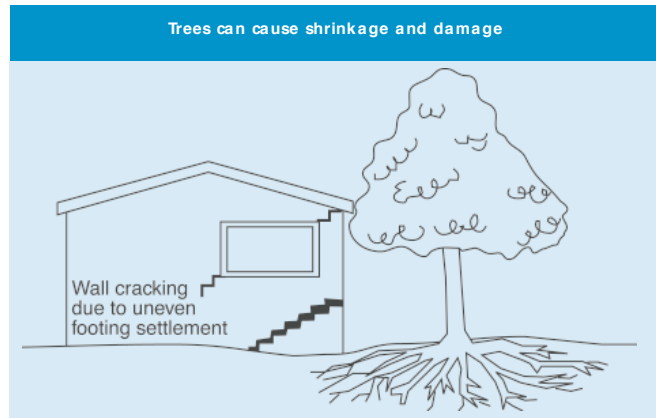
As the moisture absorption process completes its journey to the innermost areas of the building, the internal footings will rise. If the spread of moisture is roughly even, it may be that the symptoms will temporarily disappear, but it is more likely that swelling will be uneven, creating a difference rather than a disappearance in symptoms. In buildings with timber flooring supported by bearers and joists, the isolated piers will rise more easily than the strip footings or piers under walls, creating noticeable doming of flooring.

As the weather pattern changes and the soil begins to dry out, the external footings will be first affected, beginning with the locations where the sun's effect is strongest. This has the effect of lowering the external footings. The doming is accentuated and cracking reduces or disappears where it occurred because of dishing, but other cracks open up. The roof lines may become convex.
