Proposed Alterations to Lampada Ski Lodge, Perisher Valley

Statement of Environmental Effects

August 2016

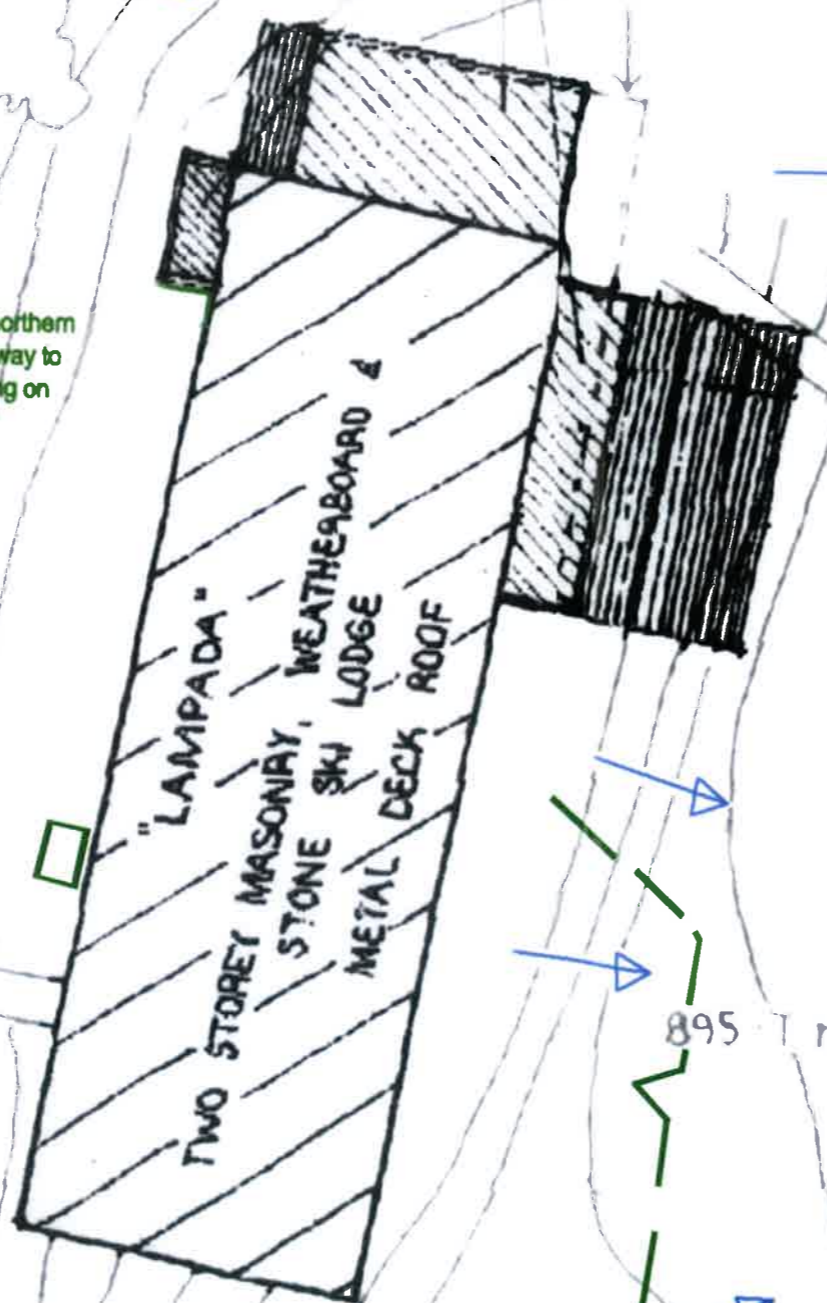
Straw bales within the northern section of the passage way to minimise runoff impacting on the works site.

Soil stockpile site should be located in a flat hard stand, low gradient, previously disturbed area. Sediment fencing should be installed immediately around the circumference approximately 2m from the perimeter to divert runoff and capture runoff.

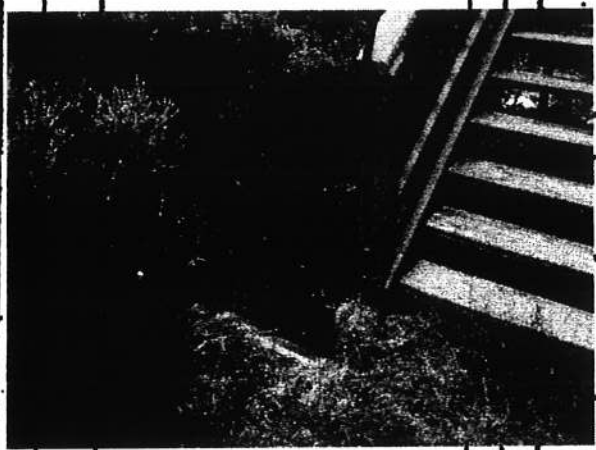
<p>Initial testing, groundwater observations, rigging, well construction details, additional information</p>
	0.4	SM	RED-BROWN CLAYEY SAND, GRANITE ROCKS 50-100mm Ø. RESIDUAL/COLLUVIAL DECO GRANITE SOIL					
	0.6		HOLE TERMINATED AT 0.6m DUE TO PRESENCE OF GRANITE ROCK Ø 0.5m					
	0.8

CLIENT: Allan McFarland	PROJECT: Geotechnical Investigation For Extension To Lampada Lodge, Perisher Valley, Kosciuszko National Park	TITLE: Test Pit Log For TP2
DESIGNED: TMD DRAWN: TMD DATE: 10 Jun 05	APPROVED: DATE: STATUS:	PROJECT NO.: 43197173
NOT TO SCALE		URS

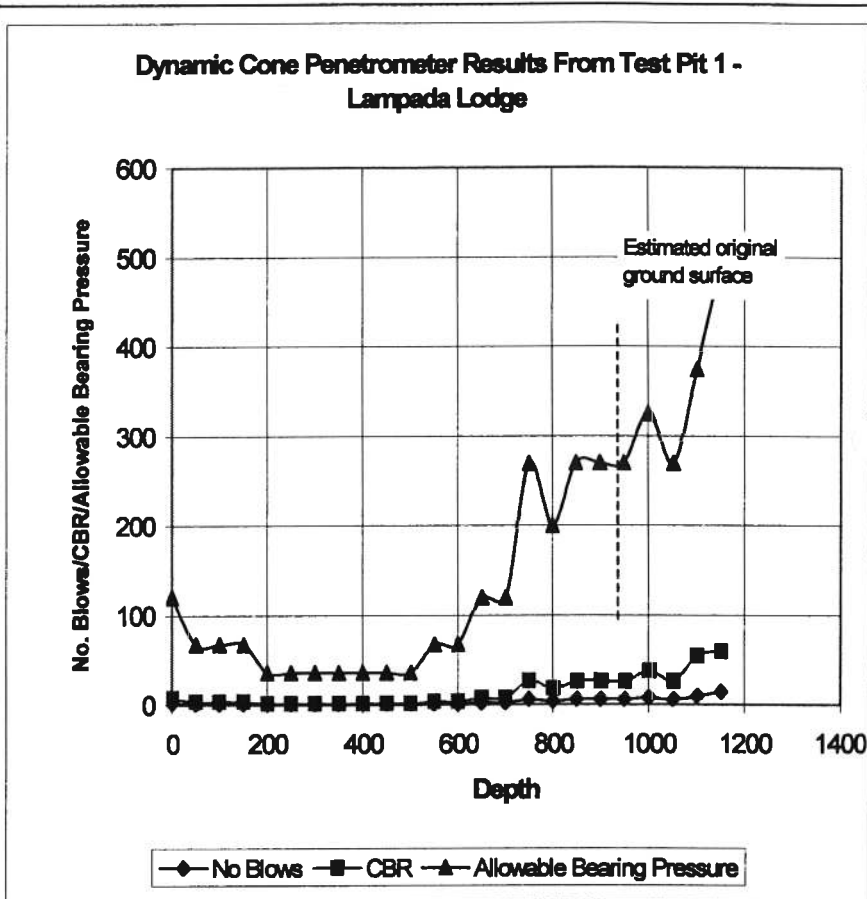
Appendix 3 – Results Of DCP Test

Depth	No. Blows	CBR	Inferred Bearing Pressure
0	2	7.8	120
50	1	3.6	68
100	1	3.6	68
150	1	3.6	68
200	0.5	1.5	36
250	0.5	1.5	36
300	0.5	1.5	36
350	0.5	1.5	36
400	0.5	1.5	36
450	0.5	1.5	36
500	0.5	1.5	36
550	1	3.6	68
600	1	3.6	68
650	2	7.8	120
700	2	7.8	120
750	6	27	270
800	4	18	200
850	6	27	270
900	6	27	270
950	6	27	270
1000	8	38	325
1050	6	27	270
1100	10	55	375
1150	15	60	490

Conversion from No. blows to CBR based on AS1289.6.3.2-1997

Conversion from CBR to estimated allowable bearing pressure base on M.J. Stockwell,
"Determination of Allowable Bearing Pressure Under Small Structures", New Zealand Engineering,
(32, 6) 15 June 1977
