Bush Fire Protection Assessment

ELIZABETH PUGH
BUILDING DESIGN

This is a Bush Fire Protection Assessment for the
proposed construction works on 'Athol Lodge 02'
7 Diggings Terrace, Thredbo NSW

Bush Fire Protection Assessment
Proposed Alterations
Athol Lodge 02, Thredbo Village

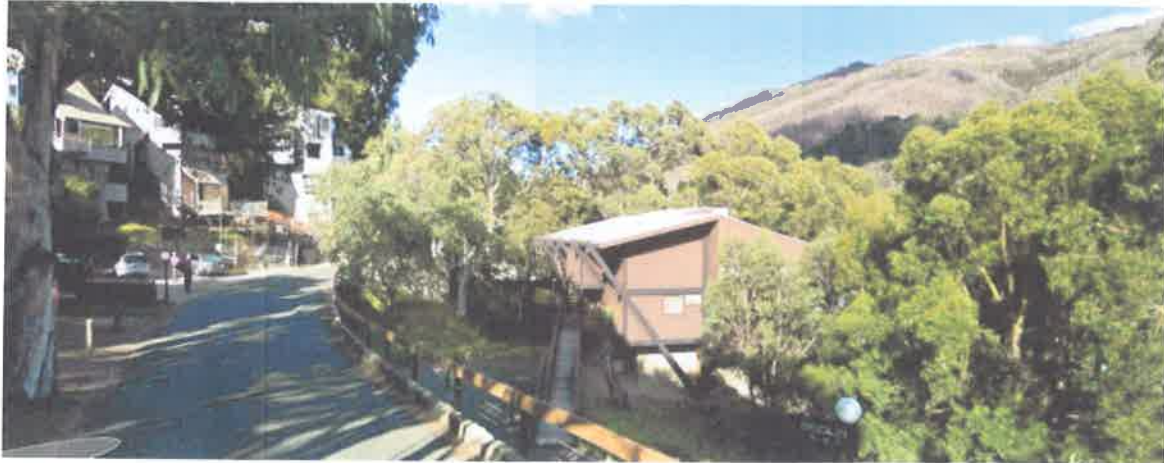
Substantial woodlands are located in a North-Westerly direction, down-slope, from the building, refer to Figure 4. Yet because this is outside the required Asset Protection Zone, more than 140m away, this vegetation is not considered to be a concern. This vegetation is also managed by National Parks and requires a sustainable environmental approach. Athol Lodge is surrounded wholly by National Park's land and management of this flora will be the main responsibility of National Parks. There is also a number of public, sealed, roads (acting as a fire break) located inbetween the lodge and this set of North-West woodlands. The site is predominately urbanized in this direction.

Figure 4 North-West view from Diggings Terrace displaying predominant vegetation located outside the Asset Protection Zone (Athol Lodge located to left of image).

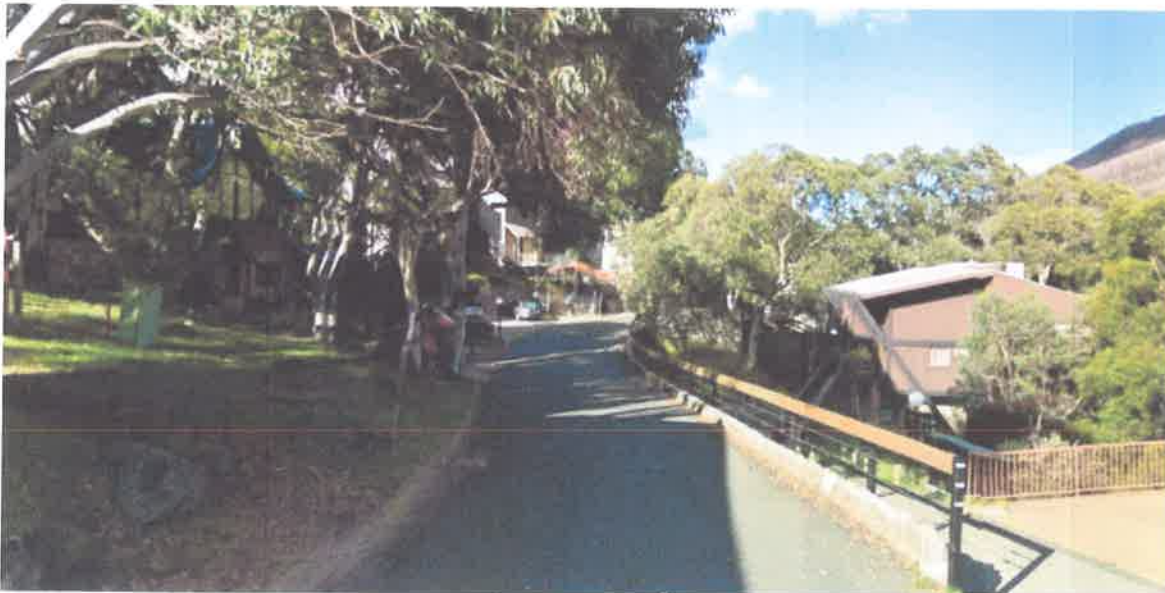
Figure 5 North-West view from Diggings Terrace showing Athol Lodge to the left of image.

There is a fire hydrant outlet located on the North East corner of the site, Refer to Figure 5

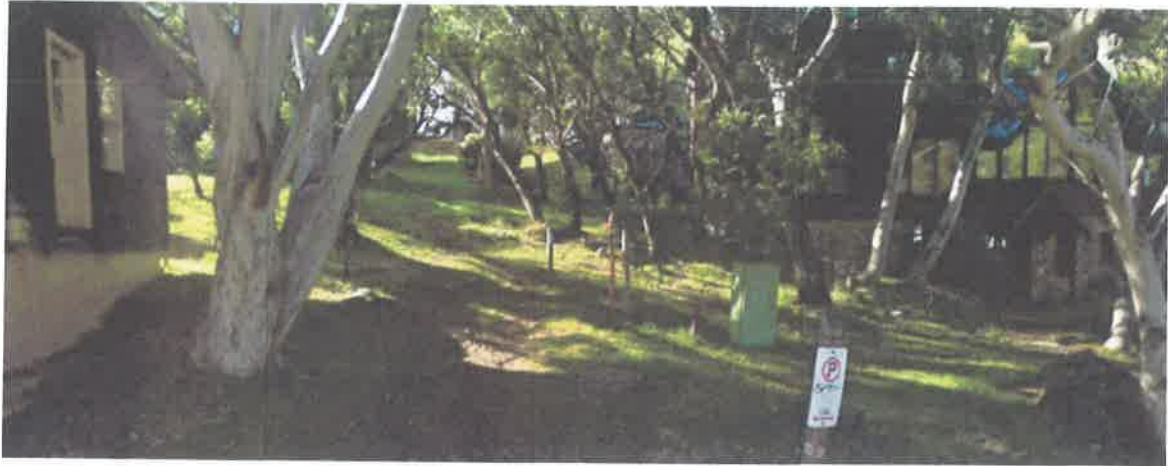
Conditions in this direction are similar to that in the North, along with other existing lodges and commercial venues in this direction. The sealed road continues in this route also. There are some scattered native trees, yet no significant forest within the 140m zone.

Figure 6 South view from Diggings Terrace, showing woodland located approximately 8m upslope. Athol Lodge located to the right of image.

- We have allowed for maintaining a clearing of a 3m perimeter of the woodland area on all elevations of the dwelling. And a clearing and removal of dead timber, limbs and shrubs with in the proposed APZ of 8m.

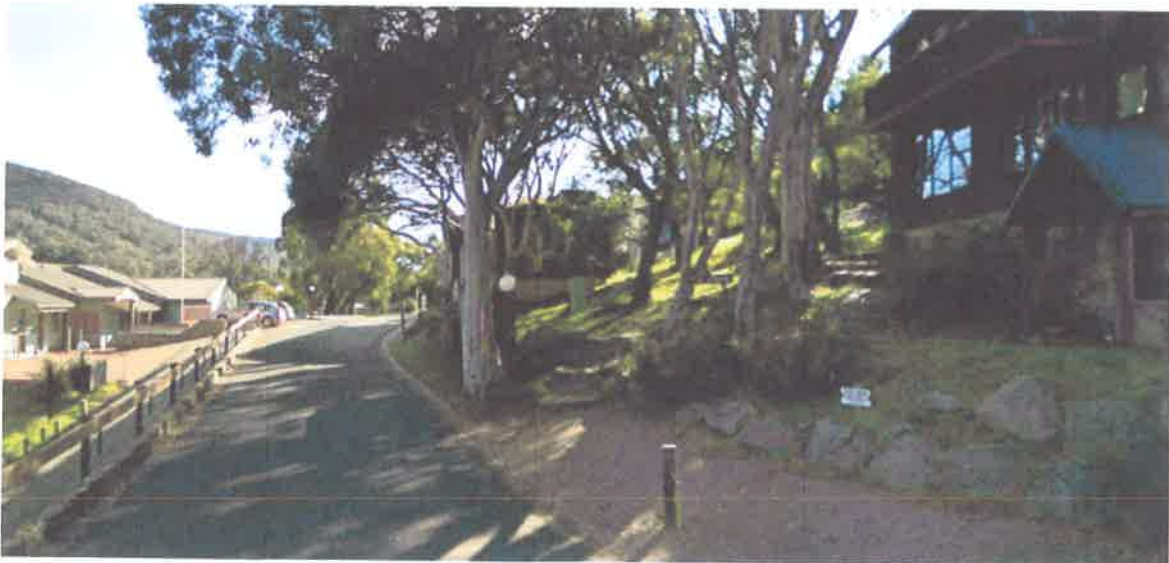
Within this APZ path there are a number of existing lodges, and vegetation conditions are alike to the North and South directions. The site is predominately urbanized in these directions.

Figure 7 Eastern view from Diggings Terrace towards the village centre (urban).
