OF
Company/organisation: JK GEOTECHNICS

Report Title: GEOTECHNICAL INVESTIGATION - PROPOSED FRIDAY FLAT CAR PARK 2

Author: ADRIAN HULSTAMP Dated: 5 March 2019

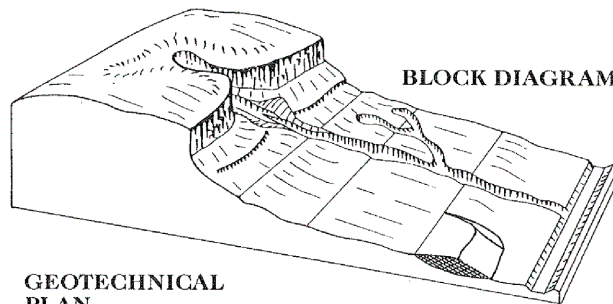
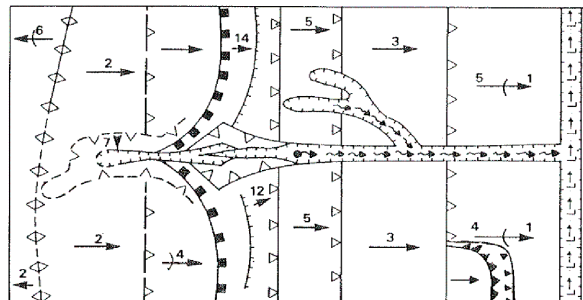
Title: **GEOTECHNICAL MAPPING SYMBOLS**

EXAMPLE OF USE OF TOPOGRAPHIC SYMBOLS:

GEOTECHNICAL
PLAN

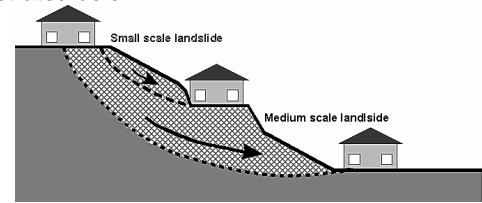
Figure 1

Rotational or circular slip failures (Figure 1) - can occur on moderate to very steep soil and weathered rock slopes (Table 1). The sliding surface of the moving mass tends to be deep seated. Tension cracks may open at the top of the slope and bulging may occur at the toe. The ground may move in discrete "steps" separated by long periods without movement. More rapid movement may occur after heavy rain.

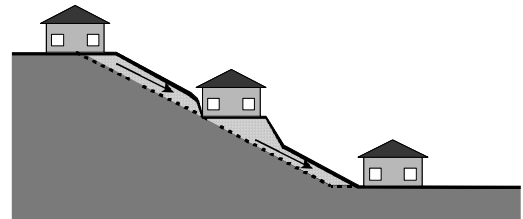
Figure 2

Translational slip failures (Figure 2) - tend to occur on moderate to very steep slopes (Table 1) where soil, or weak rock, overlies stronger strata. The sliding mass is often relatively shallow. It can move, or deform slowly (creep) over long periods of time. Extensive linear cracks and hummocks sometimes form along the contours. The sliding mass may accelerate after heavy rain.

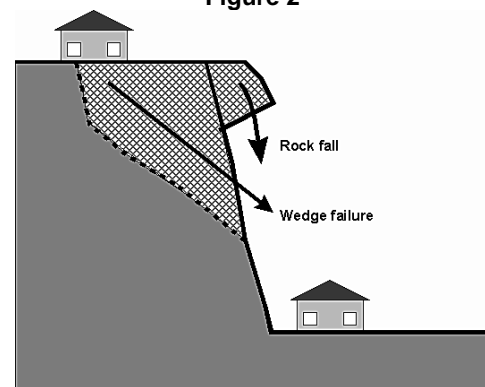
Figure 3

Wedge failures (Figure 3) - normally only occur on extreme slopes, or cliffs (Table 1), where discontinuities in the rock are inclined steeply downwards out of the face.

Rock falls (Figure 3) - tend to occur from cliffs and overhangs (Table 1).

Cliffs may remain, apparently unchanged, for hundreds of years. Collections of boulders at the foot of a cliff may indicate that rock falls are ongoing. Wedge failures and rock falls do not "creep". Familiarity with a particular local situation can instil a false sense of security since failure, when it occurs, is usually sudden and catastrophic.

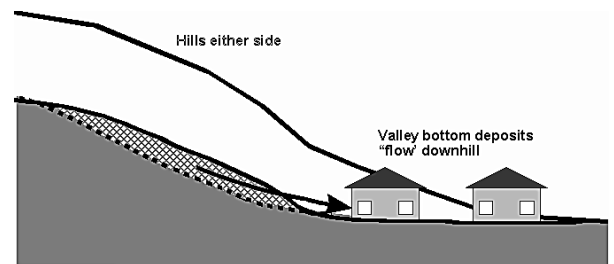
Figure 4

Debris flows and mud slides (Figure 4) - may occur in the foothills of ranges, where erosion has formed valleys which slope down to the plains below. The valley bottoms are often lined with loose eroded material (debris) which can "flow" if it becomes saturated during and after heavy rain. Debris flows are likely to occur with little warning; they travel a long way and often involve large volumes of soil. The consequences can be devastating.

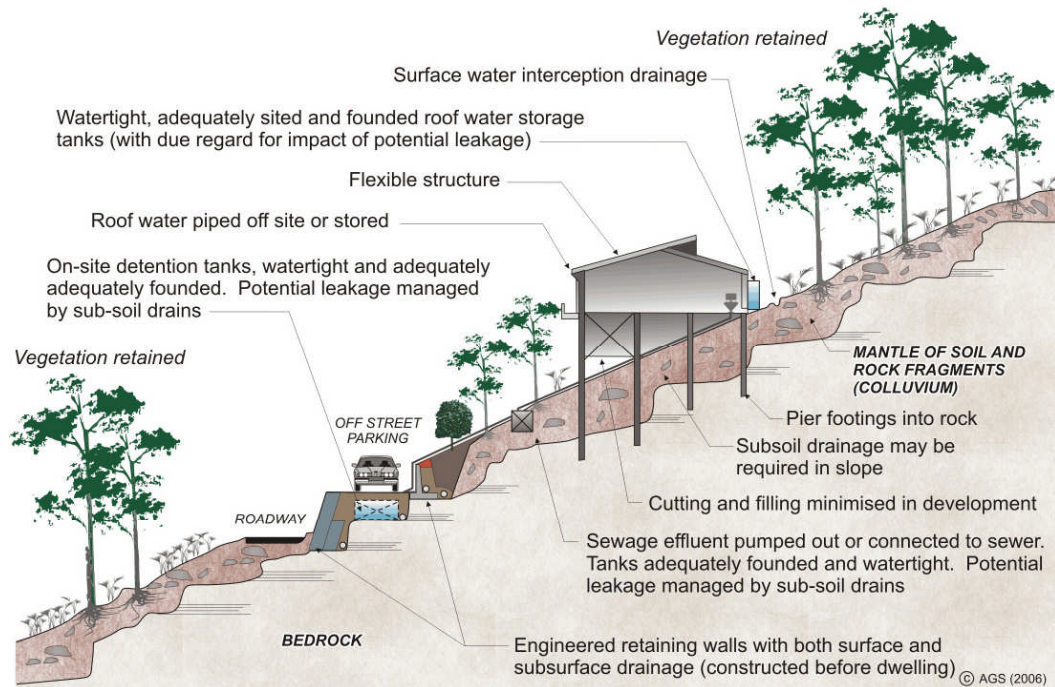
EXAMPLES FOR **GOOD** HILLSIDE CONSTRUCTION PRACTICE

WHY ARE THESE PRACTICES GOOD?

Roadways and parking areas - are paved and incorporate kerbs which prevent water discharging straight into the hillside (GeoGuide LR5).

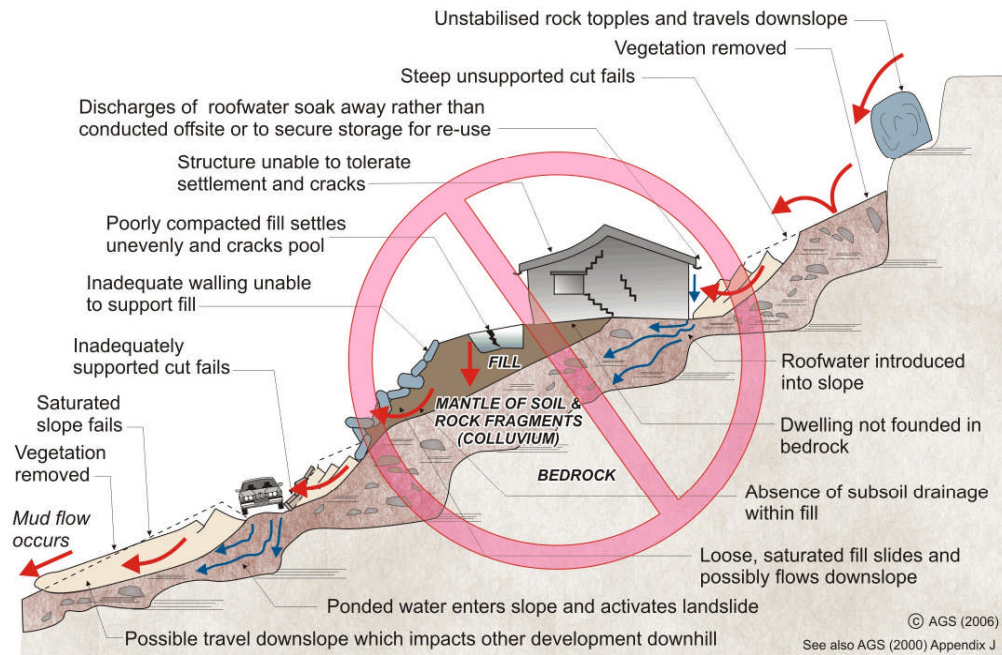
EXAMPLES FOR **POOR** HILLSIDE CONSTRUCTION PRACTICE

WHY ARE THESE PRACTICES POOR?

Roadways and parking areas - are unsurfaced and lack proper table drains (gutters) causing surface water to pond and soaks into the ground.

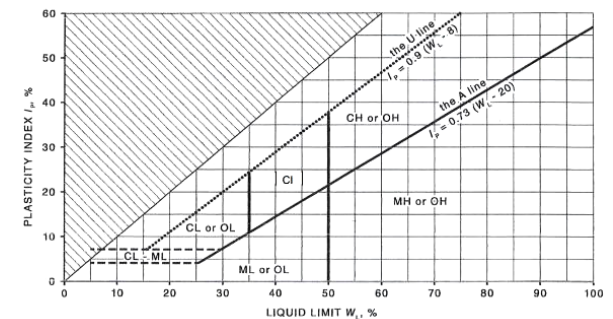
Modified Casagrande Chart for Classifying Silts and Clays according to their Behaviour
